Town of Franklin
Sidewalk Capital Improvement Plan
&
Condition Survey

Adopted May 4, 2020

Prepared by the Town of Franklin Planning Department
Town Planner Justin Setser

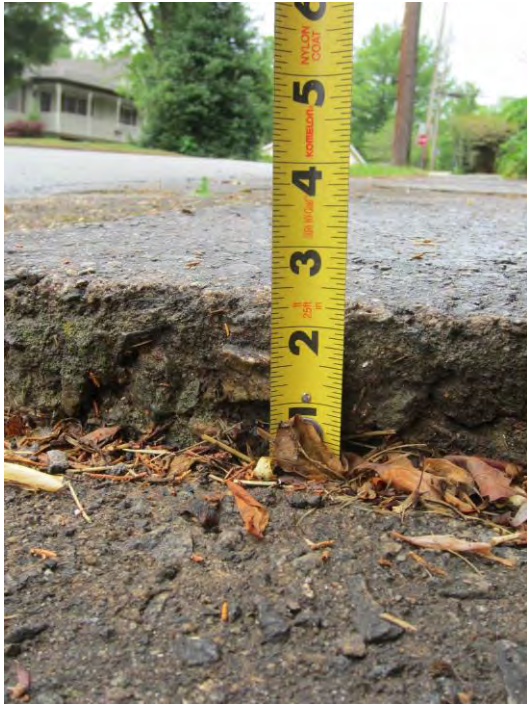
Toe Trip (Bidwell St)

Toe Trips – Where a vertical offset of $\frac{1}{2}$ " or greater is present.

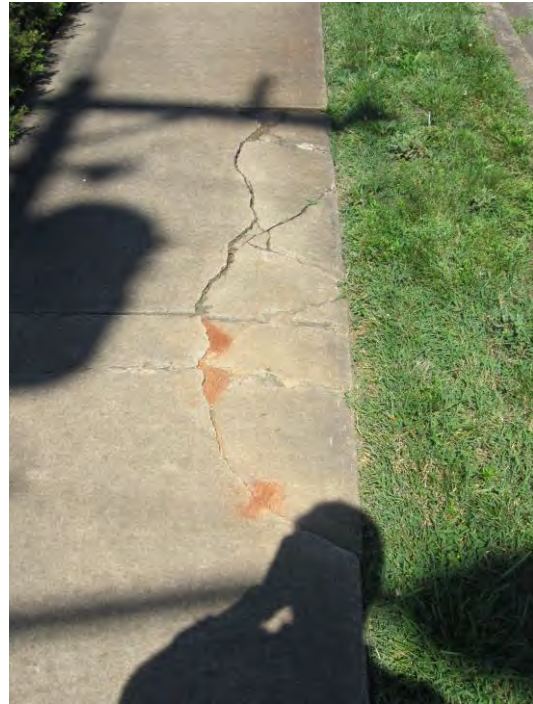
Sunken (White Oak ST)

Sunken – Where surface is broken and sunken a minimum of $\frac{1}{4}$ ".

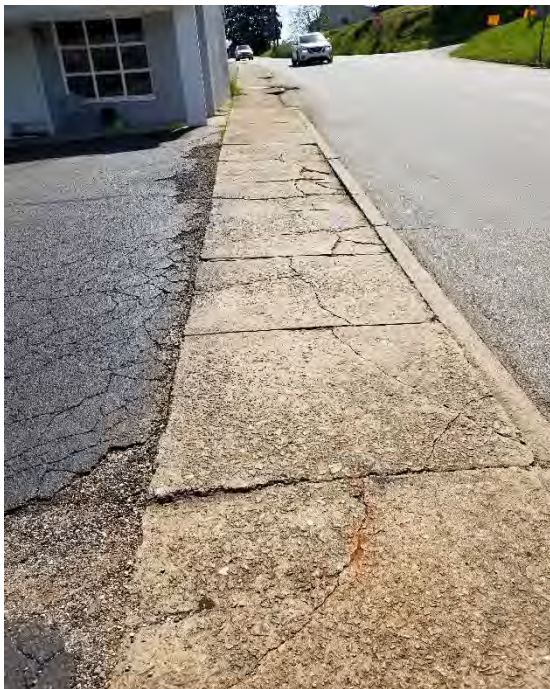
Spalling – Surface deterioration of $\frac{1}{4}$ " or greater on the sidewalk.

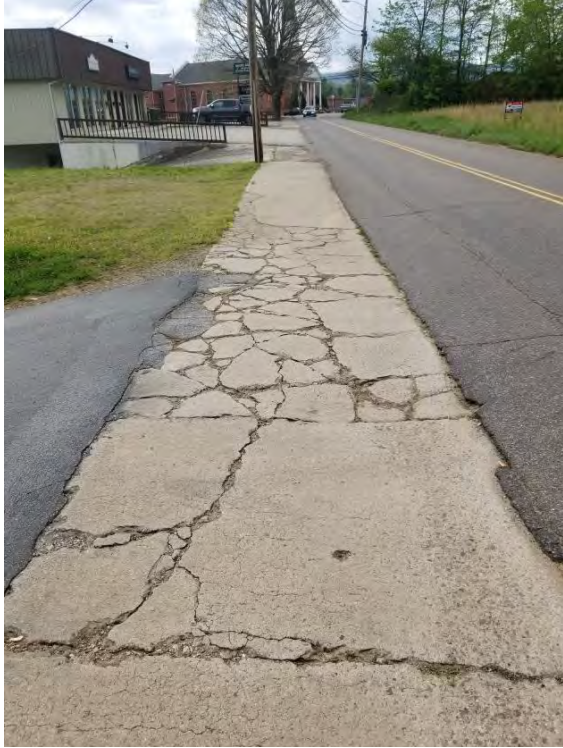
Cracking - Four or more surface cracks in the sidewalk panel.

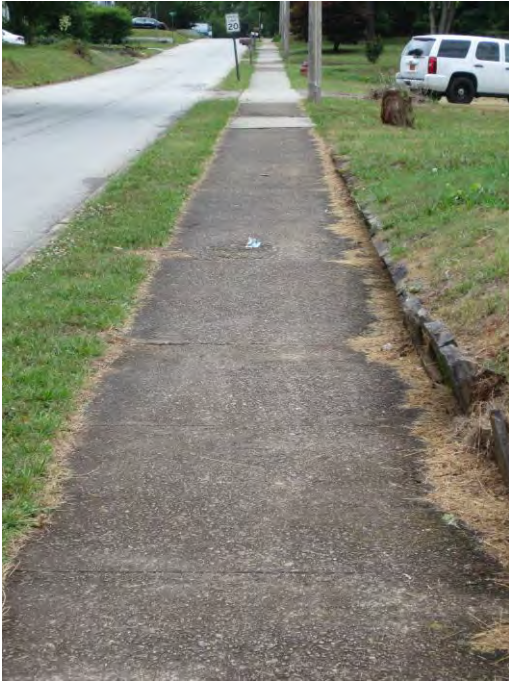
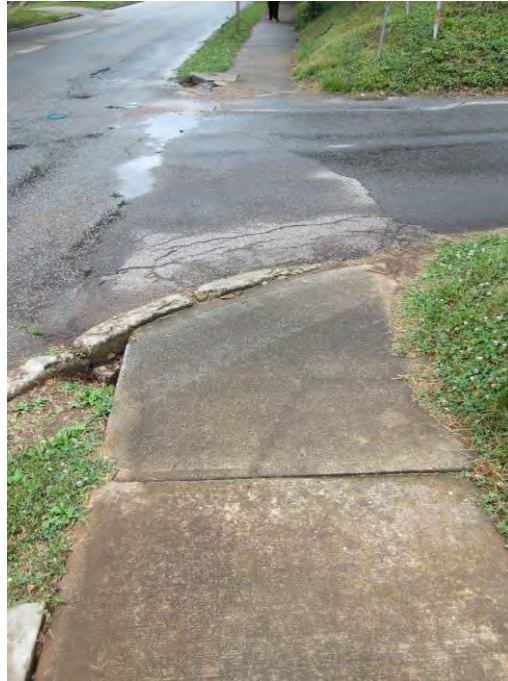
4.1 Bidwell Street

Bidwell Street sidewalk ranks **Fair**. There are six sections from West Main Street to Harrison Avenue:

- In these sections, the sidewalk starts at 5-foot in width and tapers to 4' 6" wide at Lyle Street intersection. Bidwell Street has a utility strip through the length of the street. Spalling is present in some locations along the first three sections. The sidewalk is flush with the road throughout and has standing water present in many locations.

- Three sections from Lyle St to Harrison Ave.
 - No ADA ramp or crosswalk is present at the Lyle St intersection.
 - The sidewalk has a few major toe trips and a major broken/sunken section.

- The width of the last sections varies from 5' to 4' 8".
 - The sidewalk ends at the stairs of a real estate office and does not have a crosswalk to the sidewalk on the north side of Harrison Avenue. *A crosswalk and ADA ramp is recommended for the end of Bidwell St to Harrison Avenue.*

- Three sections from W Main St to Lyle St intersections.
 - Bidwell Street starts with a non-ADA ramp with curb at West Main Street. *A new ramp and crosswalk are recommended for the West Main Street intersection.*

Recommendations: Upgrade to 5-foot standard; install ADA curb ramps.

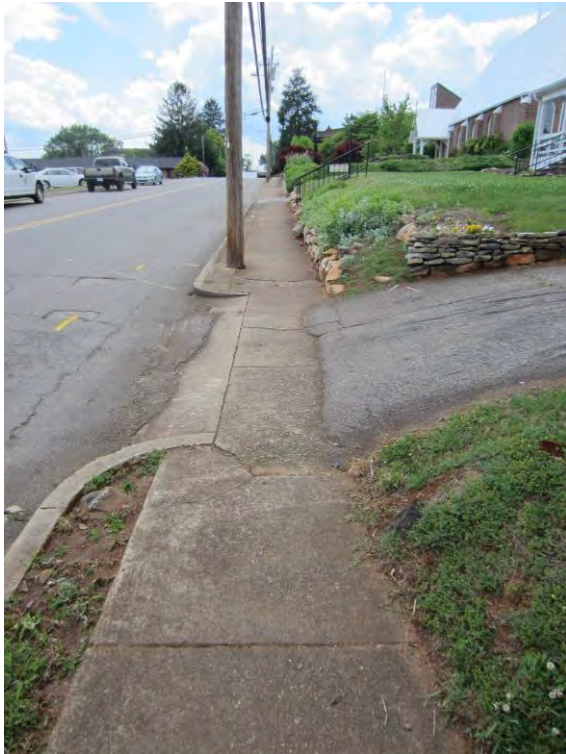
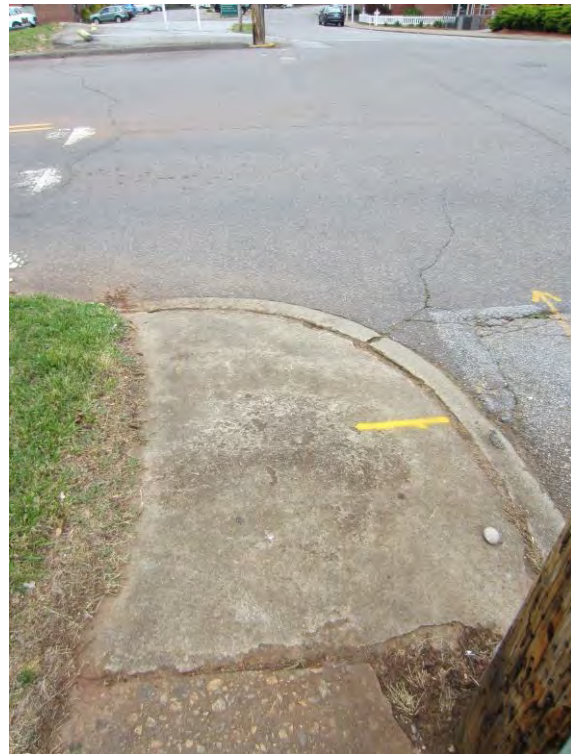
4.2 Church Street (North Side)

The north side of Church Street sidewalk ranks **Fair**; it has no ADA-curb ramps on either end of the street. Sidewalk width varies from 5-to-4 feet, and even to 3.5 feet and 2 feet at driveway entrances to the churches. There is a utility strip from Lotla St to the first church driveway entrance. Utility poles stand in the sidewalk along Church Street.

A ramp is recommended at the Harrison Avenue end to connect the Harrison Avenue sidewalk to the Church Street sidewalk.

Another crosswalk is recommended at the Lotla Street intersection to connect the north side to the east side of Lotla Street, by the Baptist Church.

Another crosswalk is recommended for Church Street, north side, to the south side at Lotla Street, heading south to Main Street.

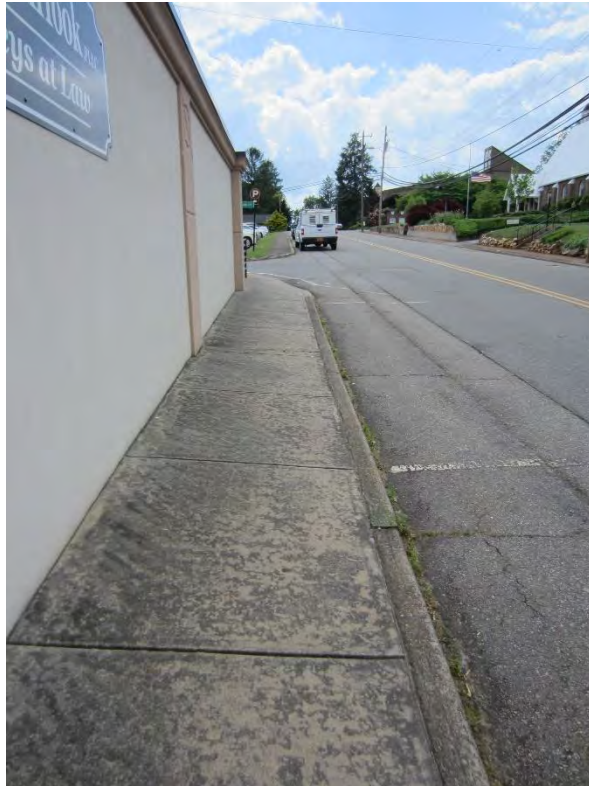
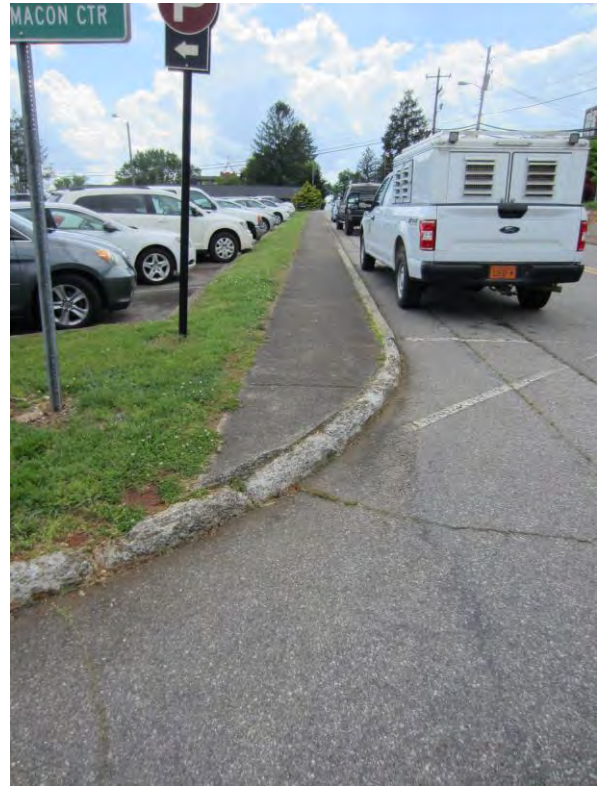
4.3 Church Street (South Side)

The South side of Church Street ranks **Good** in the section by the law office of Sloan & Vanhook, and **Fair** along the section on the courthouse property. The first section is 5-foot wide with no utility strip and a curb. There are no ADA-curb ramps at the courthouse entrance. As this is a very busy parking area, an ADA ramp is recommended at the entrance on both sides. The sidewalk along the courthouse property is 4-foot wide with no utility strip and a curb. This section could be increased to 5 feet very easily as the courthouse property has 4 feet of a flat grassy area to the parking lot. The south side walk ends at Macon Avenue, where there is no sidewalk to Harrison Avenue or down Macon Avenue.

Recommendations: Upgrade section ranked Fair to 5-foot-wide standard; install ADA curb ramps.

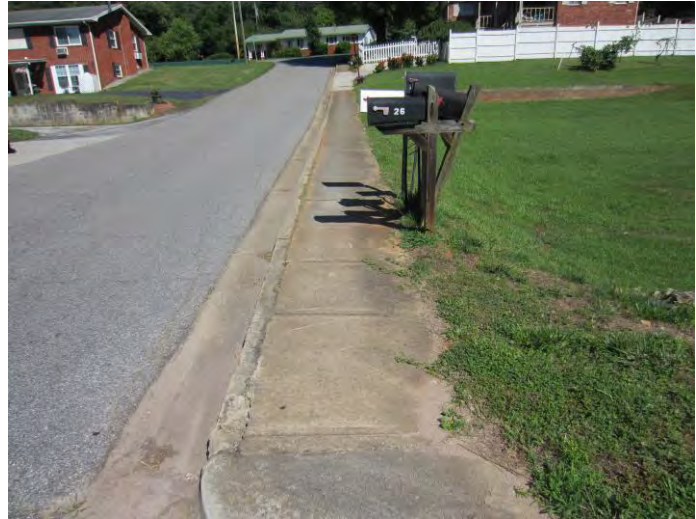
4.4 Dan Street

Dan Street sidewalk ranks **Fair**. It is 4-foot wide with a small gap at the East Main Street intersection ramp as shown above. The sidewalk has curbing but no utility strip. The sidewalk has an obstruction at the mailboxes located behind Wind River Construction. The obstruction restricts the sidewalk to 2.5-foot wide as shown. Dan Street ends at Watauga Street, where there is no ramp or crosswalk to Watauga Street sidewalk.

Recommendations: install ADA-compliant ramp; extend sidewalk to 5 feet wide; relocate mailboxes to remove obstacle.

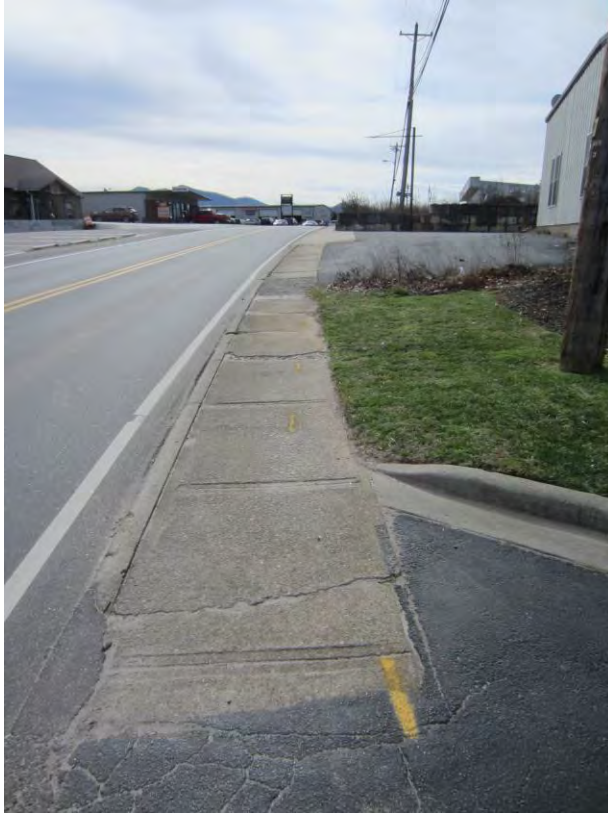
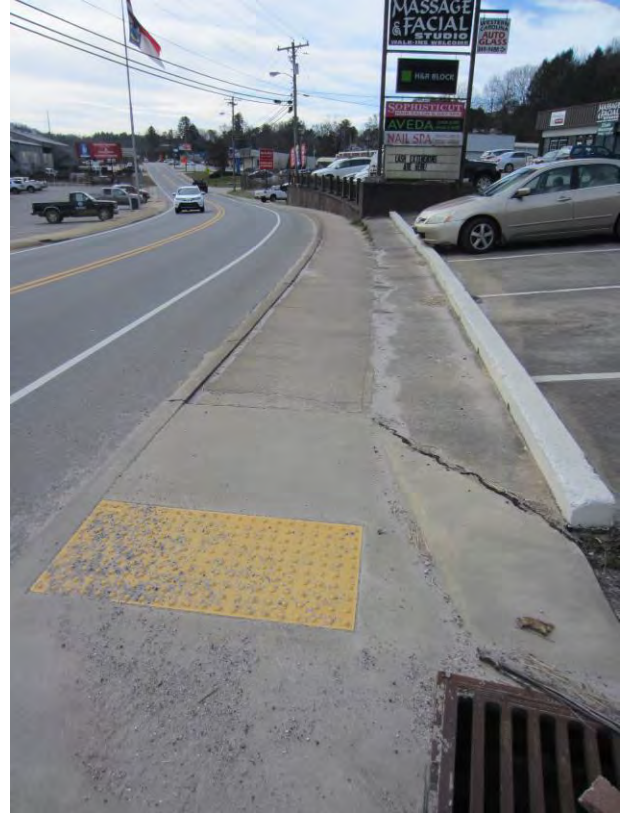
4.5 Depot Street Ranking Fair

Depot Street Sidewalk ranks **Fair**. It starts just past 560 Depot Street on the right (west) side of the street. The sidewalk has many large gaps. It is 5-foot wide with curb and guttering but no utility strips. There are many cracks throughout the concrete. It is also very dirty and needs to have debris cleaned from it. As NCDOT is in the development phase to upgrade Depot Street sidewalks to fill gaps, upgrade facilities along the right side of the street and add new sidewalk on the left side, there is no need for further recommendations.

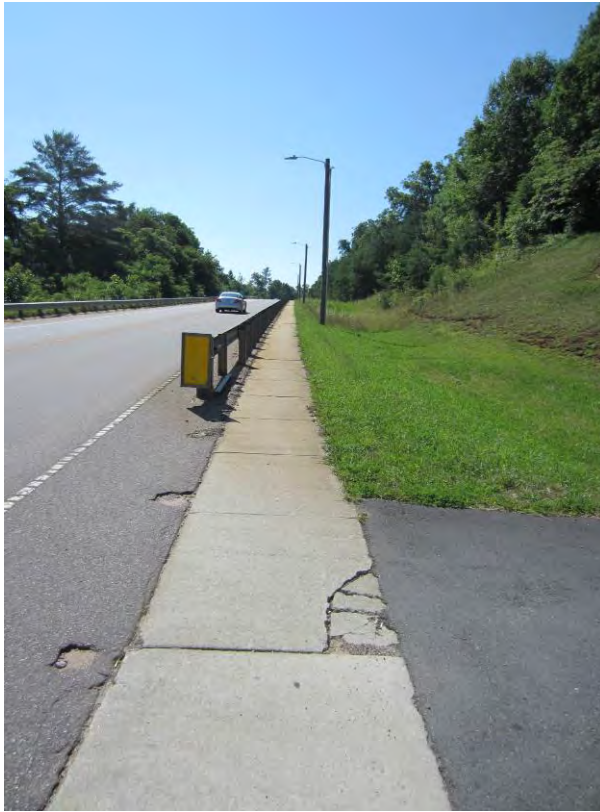
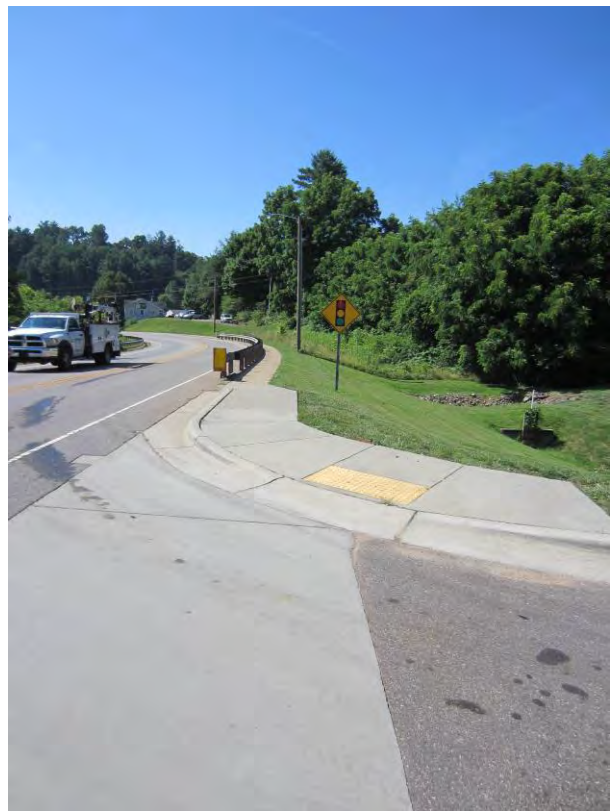
4.6 Depot St Extension Ranking Good & Fair

Depot St extension ranks **Good** from its beginning at NE Main Street to the Mission cancer center entrance. It is 5-foot wide in this section (Section 1), with curb and guttering but no utility strip. Section 2 starts at the cancer center and goes to Riverview Street; it ranks **Fair**. This section is 4-foot wide and has no curb and guttering. It is located behind a guardrail that is maintained by NCDOT. Some parts of Section 2 need cleaning and edging. The sidewalk ends at Riverview Street, with an ADA-compliant ramp and a crosswalk to Iotla Street.

Recommendation: Upgrade sidewalk to 5-foot standard; install curb and gutter.

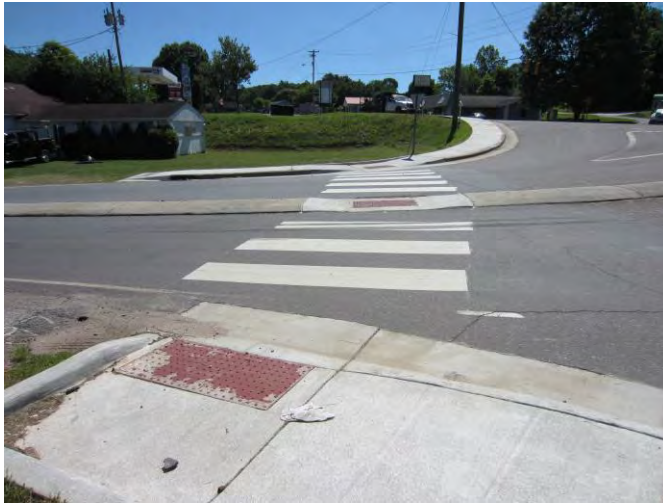
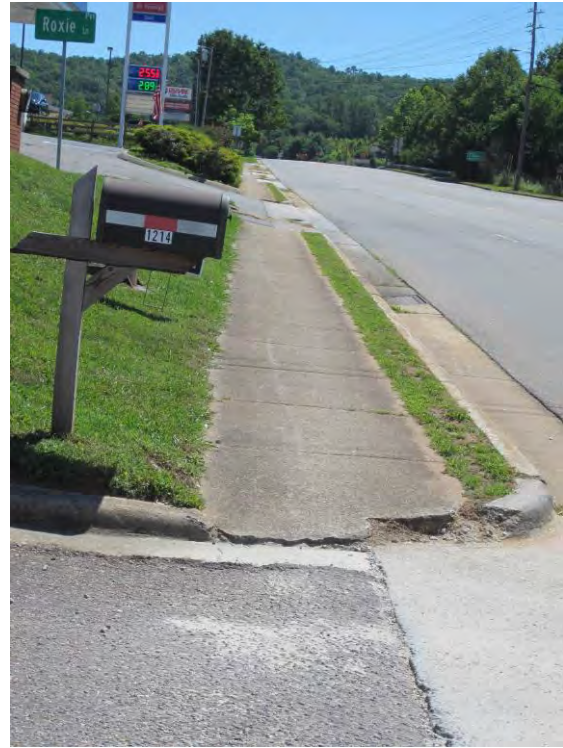
4.7 East Main Street (Lake Emory RD to 1320 E Main St) Ranking Fair

East Main Street sidewalks ends at 1320 E. Main. This section ranks **Fair**. The sidewalk is 4-foot wide. It is in good shape other than the driveway entrances, which have some toe trips. The oak tree at the church is pushing the sidewalk up. This section has a 1-foot utility strip and curb and guttering that is in good shape. It ends at Lake Emory Road, where NCDOT updated the curb ramps with ADA-compliant ramps and a pedestrian island with crosswalks. The section has multiple curb cuts for driveways.

Recommendation: Upgrade sidewalk to 5-foot standard.

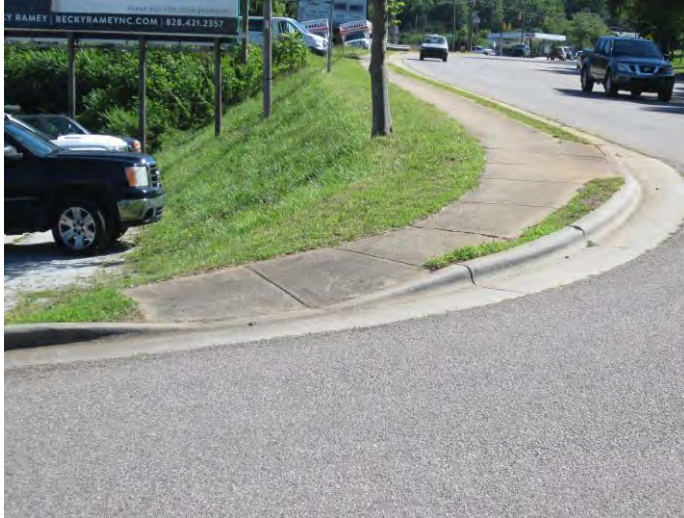
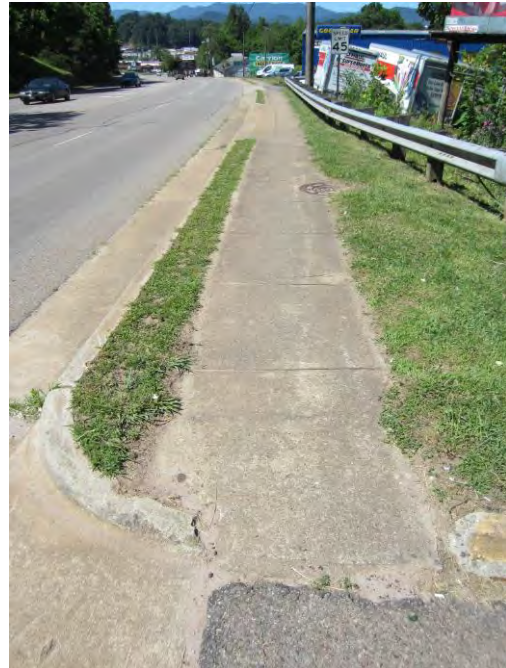
4.8 E Main Street (Lake Emory Road to Dan Street) Ranking Fair

This section ranks **Fair**, as it is 4-foot wide, but it is smooth and in good shape. There is a 1-foot utility strip and curb and guttering. A sewer manhole is located in this section of sidewalk. The section ends at Dan Street with a ramp without detectable domes that needs to be upgraded to ADA compliance.

Recommendations: Upgrade sidewalk to 5-foot standard; install ADA-compliant ramp; install crosswalk at Dan Street crossing.

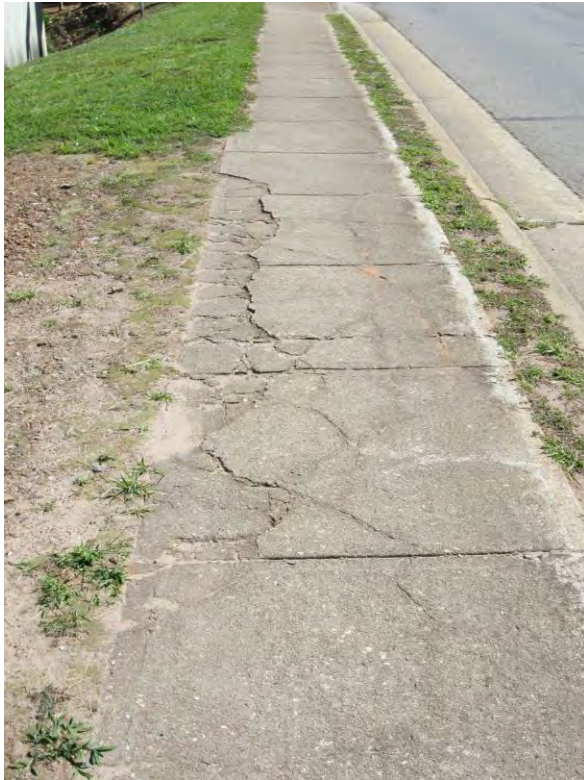
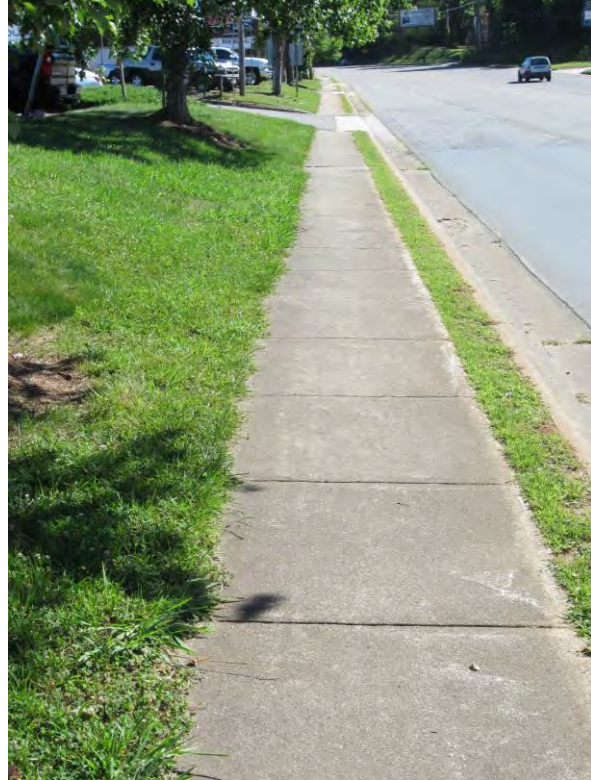
4.9 East Main Street (Dan Street to Lakeside Drive) Ranking Fair

This section of East Main Street sidewalk ranks **Fair**. It is 4-foot wide with a utility strip and curb and guttering. The ramp at Dan Street is without detectable domes and is not ADA-compliant. There is a pole obstruction at the Dan Street ramp. The sidewalk then becomes cracked and sunken at the furniture store as shown. This section ends at Lakeside Drive, with ADA-compliant curb ramps.

Recommendations: Upgrade sidewalk to 5-foot standard; install ADA-compliant ramp at Lakeside Drive.

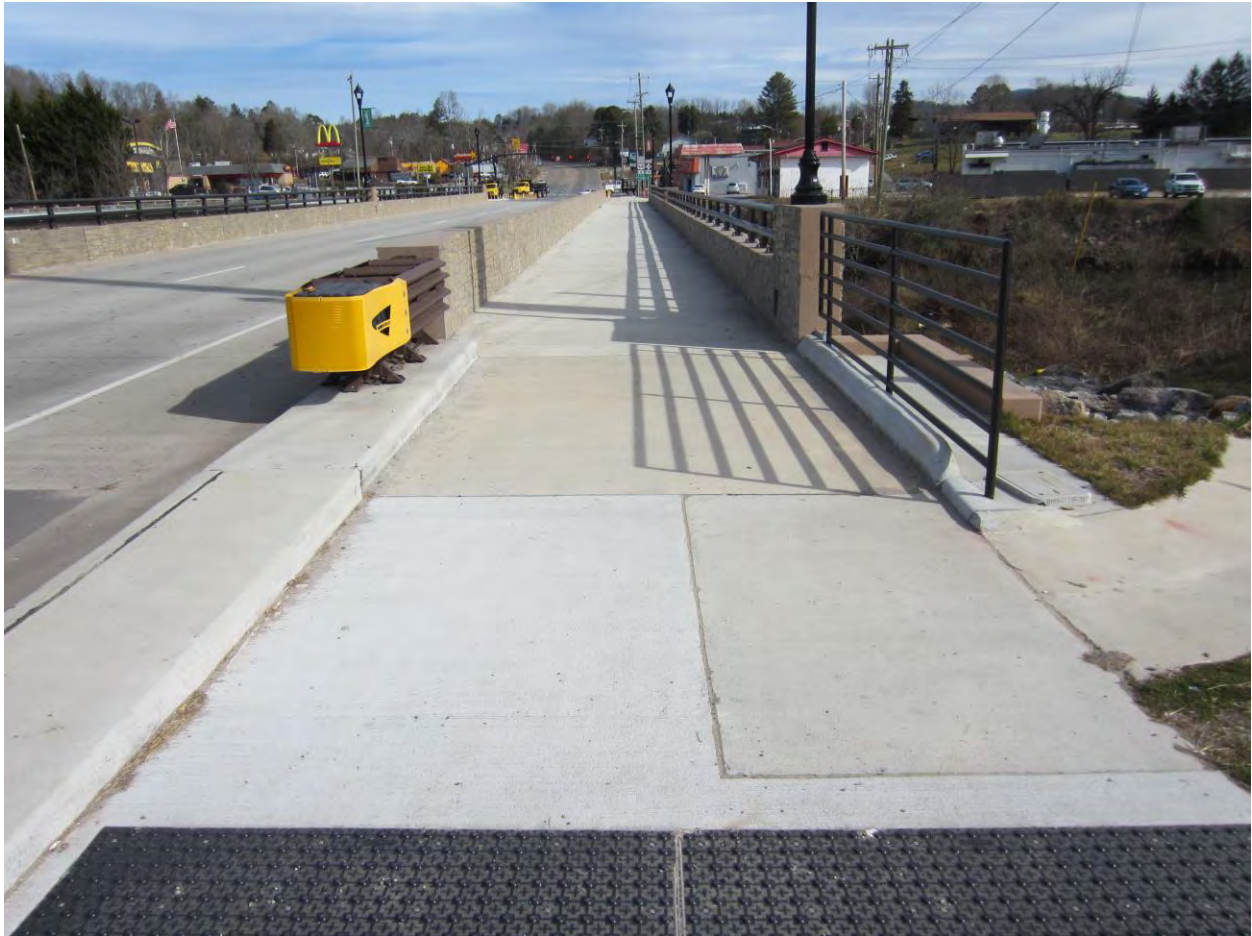
4.10 East Main Street (Highlands Road to Big Bear Lane) Ranking Good

The sidewalk on East Main Street, from Highlands Road intersection to Big Bear Lane, ranks **Good**. Most of the sidewalk was been replaced by NCDOT in 2018, in conjunction with the bridge replacement. The sidewalk is 5-foot wide along the road, and 9-foot wide on the bridge. The bridge sidewalk is planned for the future expansion of the Little Tennessee Greenway route. The sidewalk on the bridge has a protect wall to protect pedestrians from vehicle traffic. The sidewalk ends at Frog's Quarters' driveway.

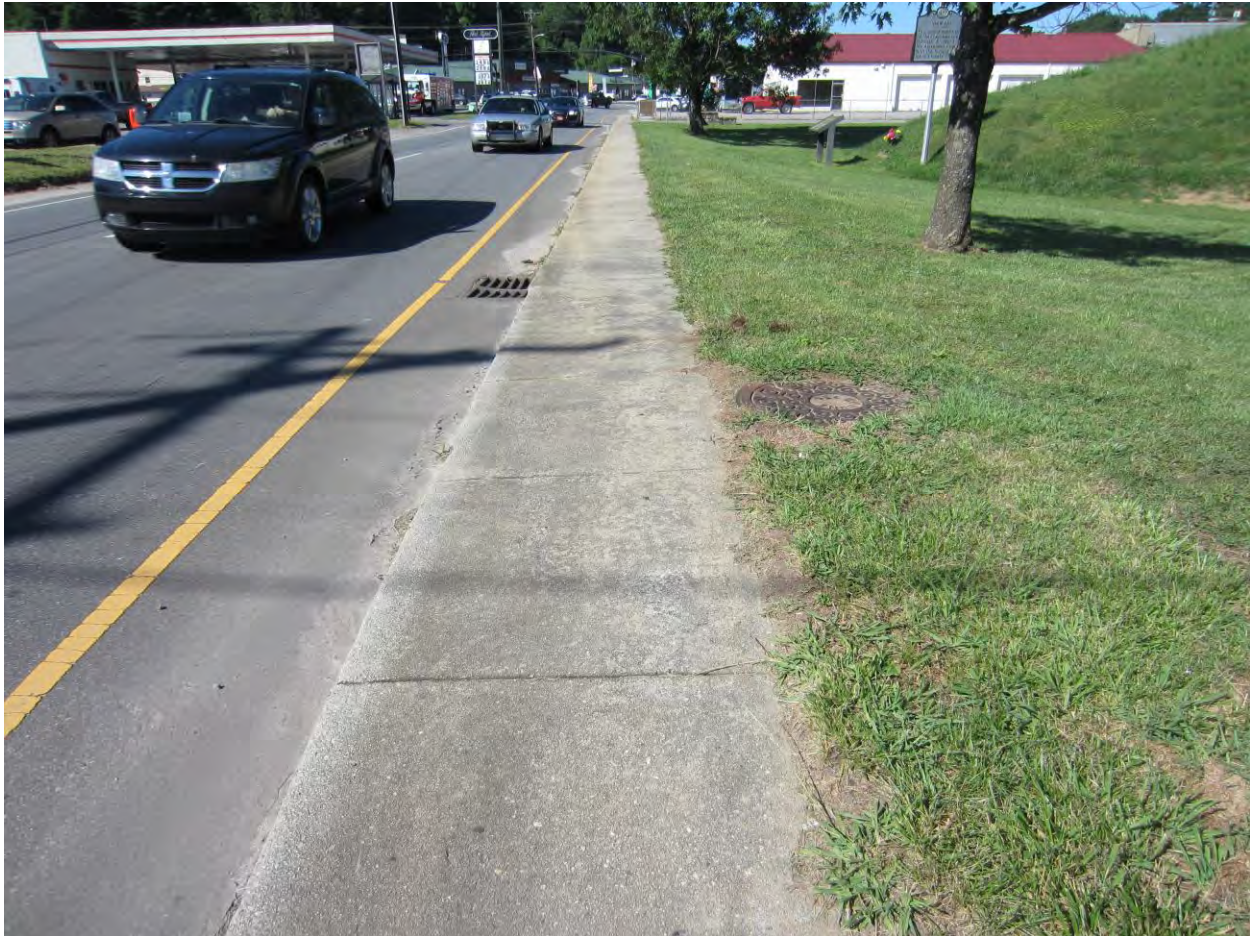
4.11 East Main Street (Flood Street to Depot Street) Ranking Fair

This section of East Main Street sidewalk ranks **Fair**. It is 4-foot wide with no curb or utility strip. The sidewalk itself is smooth and in good shape. There is no ADA-compliant ramp at Nikwasi Lane. The sidewalk then travels over the entrance to the building at 454 East Main Street, using the parking lot. The sidewalk ends at Depot Street, where there is a ramp without detectable domes to a crosswalk that is faded and in need of restriping.

Recommendations: add sidewalk in front of the 454 East Main Street location to help limit road access; upgrade sidewalk to 5' standard; install ADA-compliant ramps.

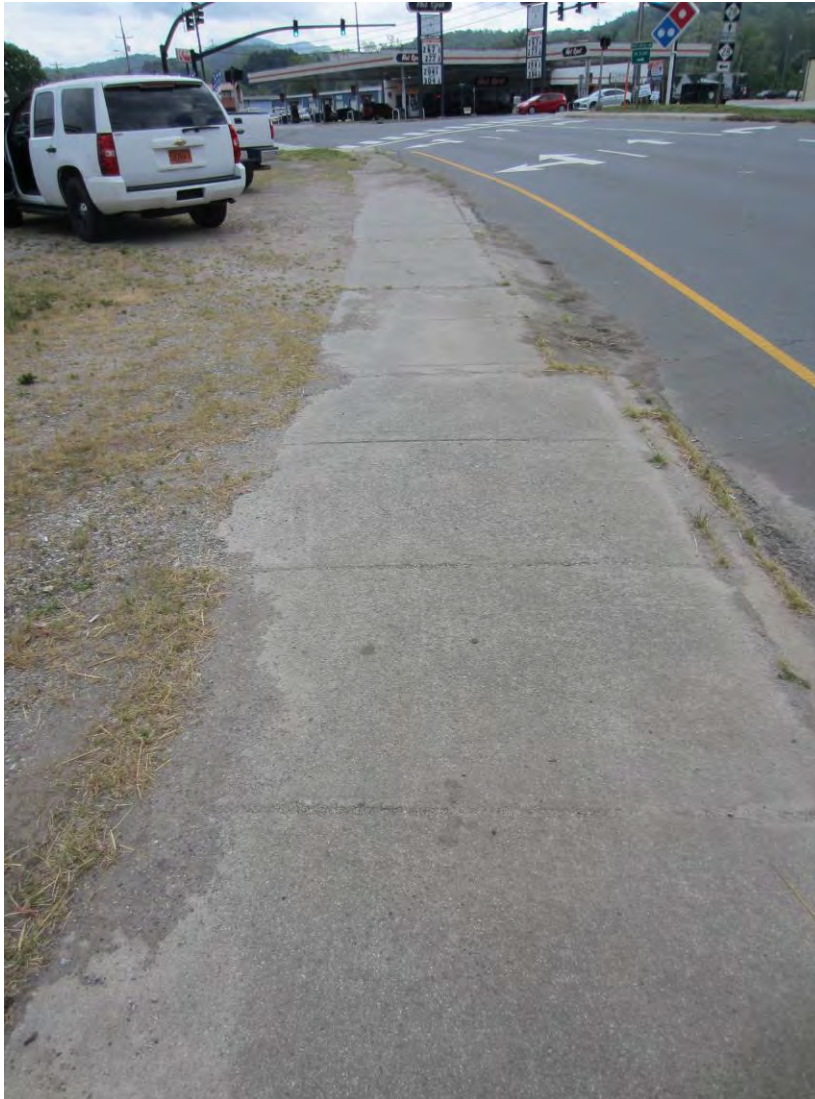
4.12 East Main Street (Depot Street to East Rogers Street) Ranking Poor

Sidewalk on this section of East Main Street ranks **Poor**. The section is 6-foot wide but has no curb or guttering as it is flush with the road. A large amount of debris has accumulated on the surface and needs to be cleaned off. It is also cracked and broken. The sidewalk starts with an ADA-compliant curb ramp at Depot Street, where a crosswalk crosses to Depot Street. It has a utility pole obstruction at 368 East Main Street. It ends at East Rogers Street where, in 2019, NCDOT upgraded the curb ramps to ADA compliance. A short gap at the address of 340 E Main Street should be built to help with walkability. *Recommendations: Upgrade to standard, clean, and repair; build sidewalk in gap.*

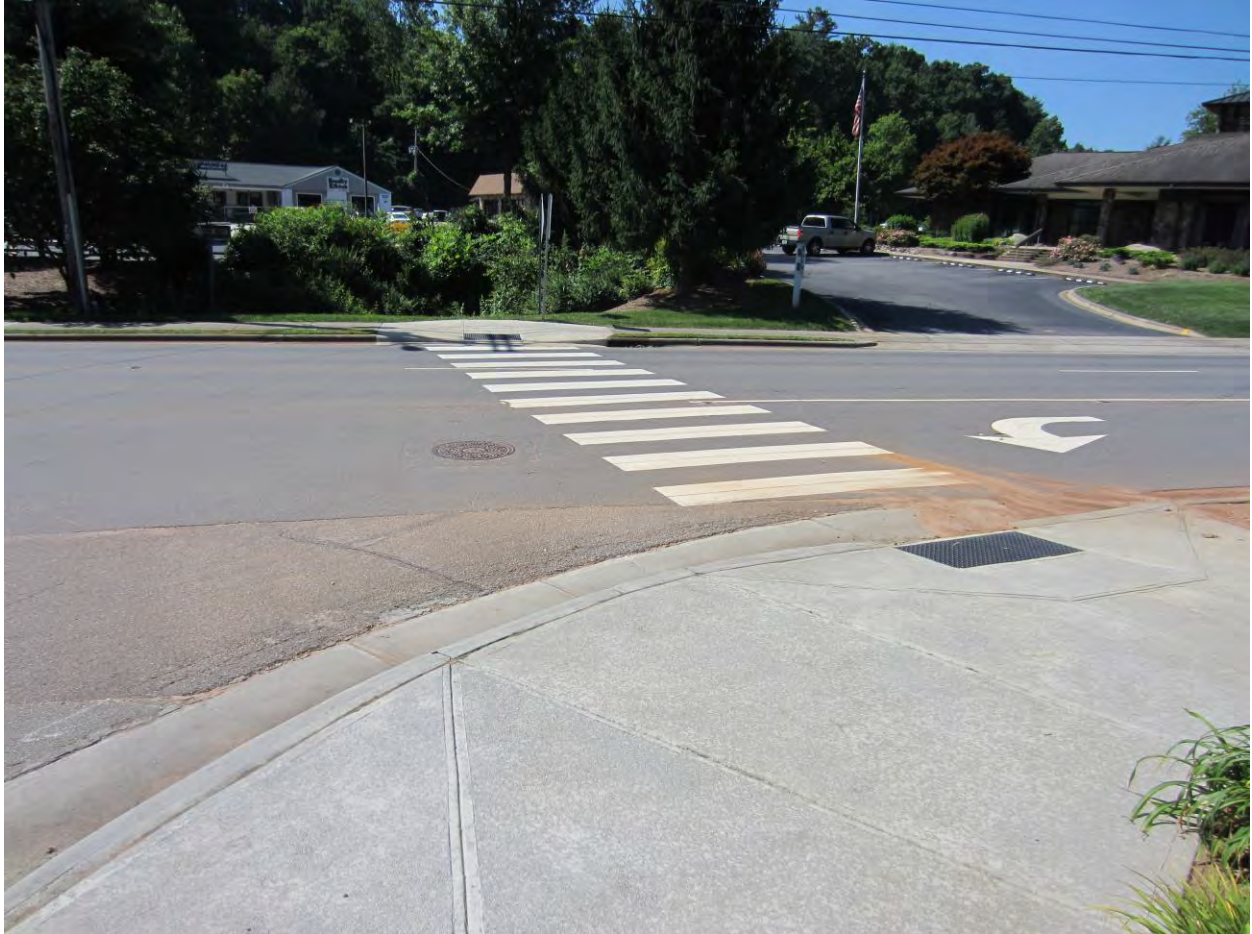
4.13 East Main Street (East Rogers St. to 473 Palmer St.) Ranking Good

The sidewalk on this section of East Main Street ranks **Good**. It is 5-foot wide with a utility strip and curb and guttering. It has a crosswalk from the north side of East Main Street to an ADA-compliant curb ramp. The sidewalk only needs annual maintenance performed.

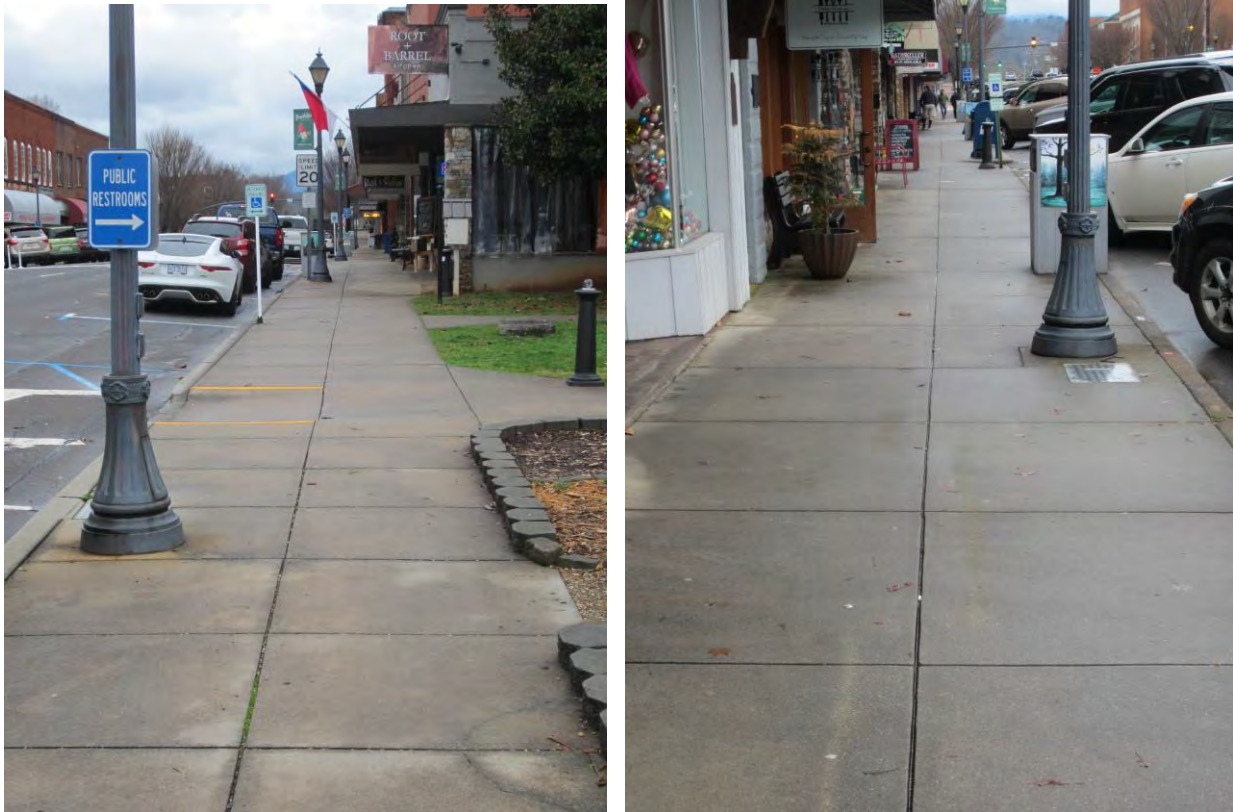
Ranking Good

East Main Street from Riverview Street to West Main Street Ranks **Good** on both sides of the street. The sidewalk starts at a curb ramp without detachable domes at Riverview Street on the north side. On the north side, the sidewalk is 5-foot wide with utility strip until it reaches Town Hall, where it becomes 9-foot wide. A 5-foot-wide sidewalk starts at Derby Street on the south side of East Main Street and becomes 9-feet wide at Patton Avenue. There are no ADA curb ramps at the intersections of Derby Street and Patton Avenue. From Patton Avenue and Town Hall heading west to West Main Street, sidewalk width varies from 9 feet to 8 feet at utility poles and trash cans. Farther down, width narrows to 5 feet and 4 feet at benches and signs. The sidewalk ends for this section at Iotla and Phillips Streets, where brick pavers at the curb ramps are signaled without detectable domes. Two mid-block crosswalks in this section cross East Main Street. NCDOT plans to upgrade these crosswalks soon with bulb-outs for pedestrian safety and new crosswalks.

Recommendations: Install ADA curb ramps where needed.

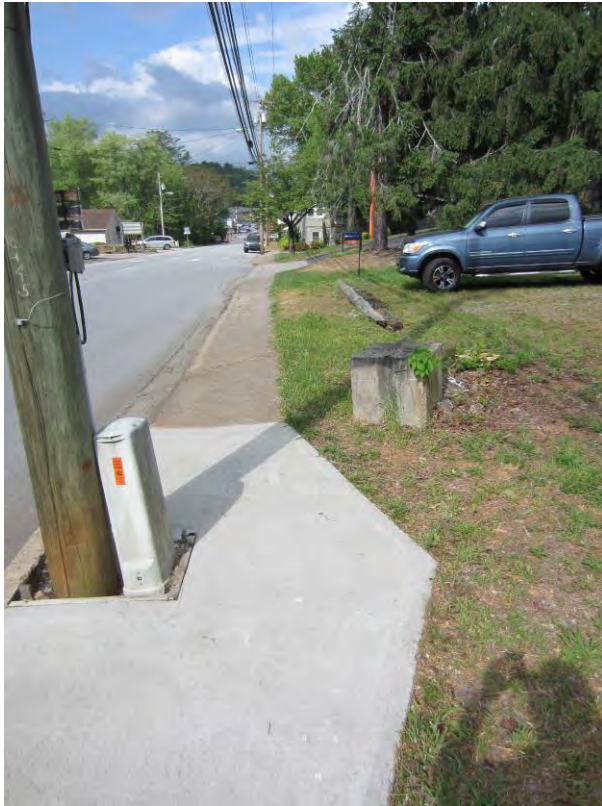
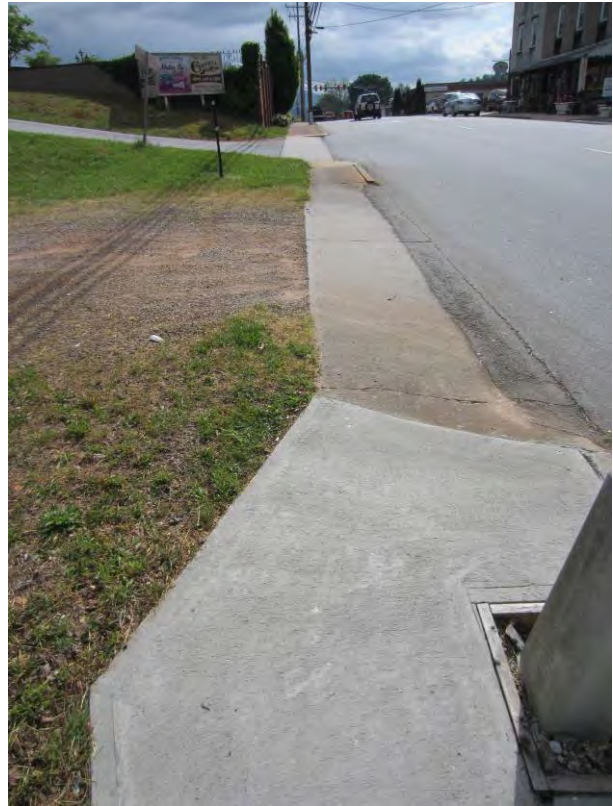
4.15 East Palmer St. (Porter St. to Phillips St.) Rankings Fair, Poor and Good

The rank of this section of East Palmer Street varies from **Fair** to **Poor** and back to **Fair** on the north side. Please refer to master map to see more details of location:

- The sidewalk starts at the 29 East Palmer Street driveway exit. This part has spalling and cracks and is 4-foot wide until it reaches an empty lot behind 88 West Main Street. Here the sidewalk is only 3.5-foot wide with a cross slope for driveway access as shown above. This is the section ranked **Poor**.
- Past that area, the sidewalk is 4' wide without a utility strip and ranks **Fair**. A wall along the sidewalk will make it difficult to widen. The section ends at an ADA-compliant curb ramp at the Phillips Street intersection.
- The sidewalk on the south side is 5-foot wide from Phillips Street back to 149 East Palmer Street, with an ADA curb ramp at Phillips Street. This area ranks **Good**.
- The final section, 4-foot wide, ranks **Fair**. A short gap separates it from the previous section, in front of 149 East Palmer Street.

Recommendations: Upgrade where possible to 5-foot wide standard.

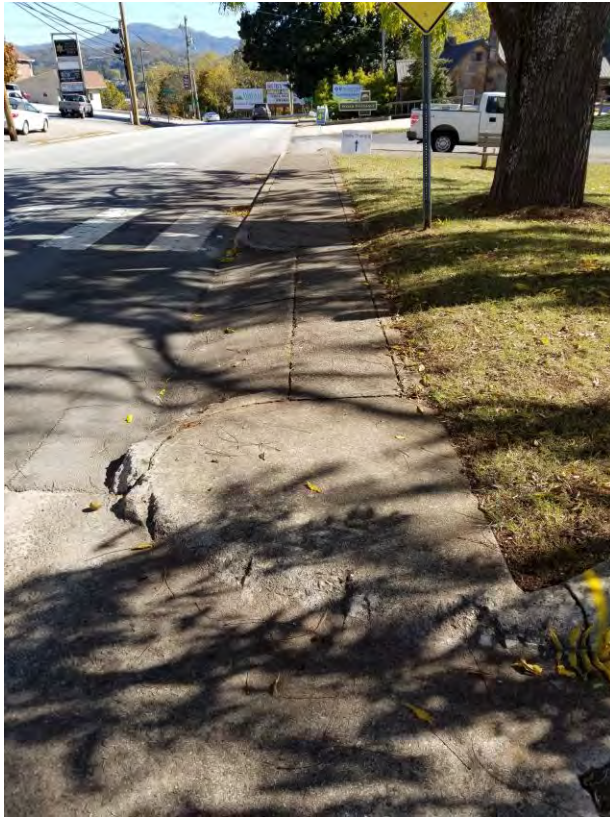
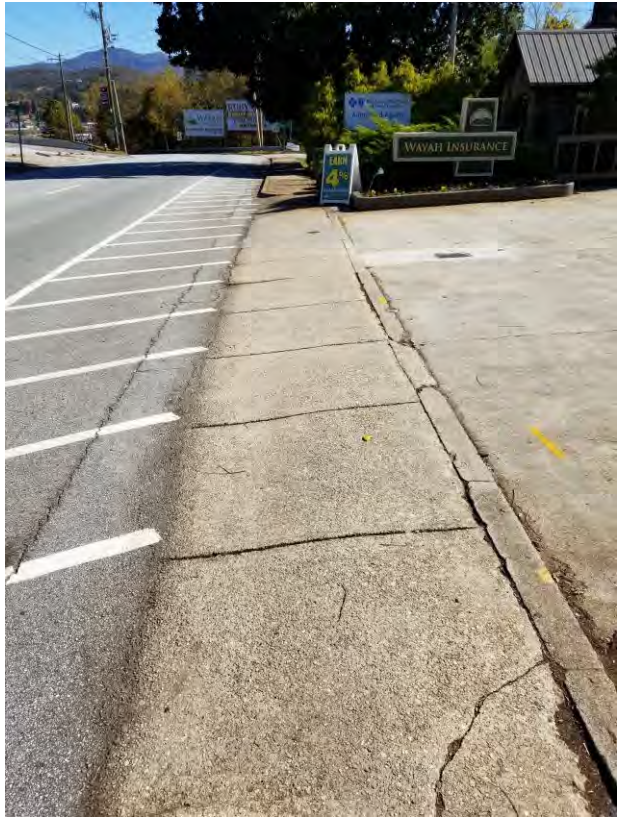
4.16 East Palmer Street (Phillips St. to South Patton Ave.) Ranking Fair and Good

This section of East Palmer Street ranks **Fair** along the section in front of 261 East Palmer Street. The sidewalk is 4-foot wide with curb and guttering and no utility strip. A crosswalk in this section crosses to no ramp, but NCDOT plans to replace this feature in 2020. There is a driveway entrance that is not needed, as shown in the above picture. This section ends at South Patton Avenue, where it is 5-foot wide, without a utility strip, and in good condition. There is no ADA ramp at South Patton Ave.

Recommendations: Upgrade sidewalk to 5-foot standard; install ADA curb ramps.

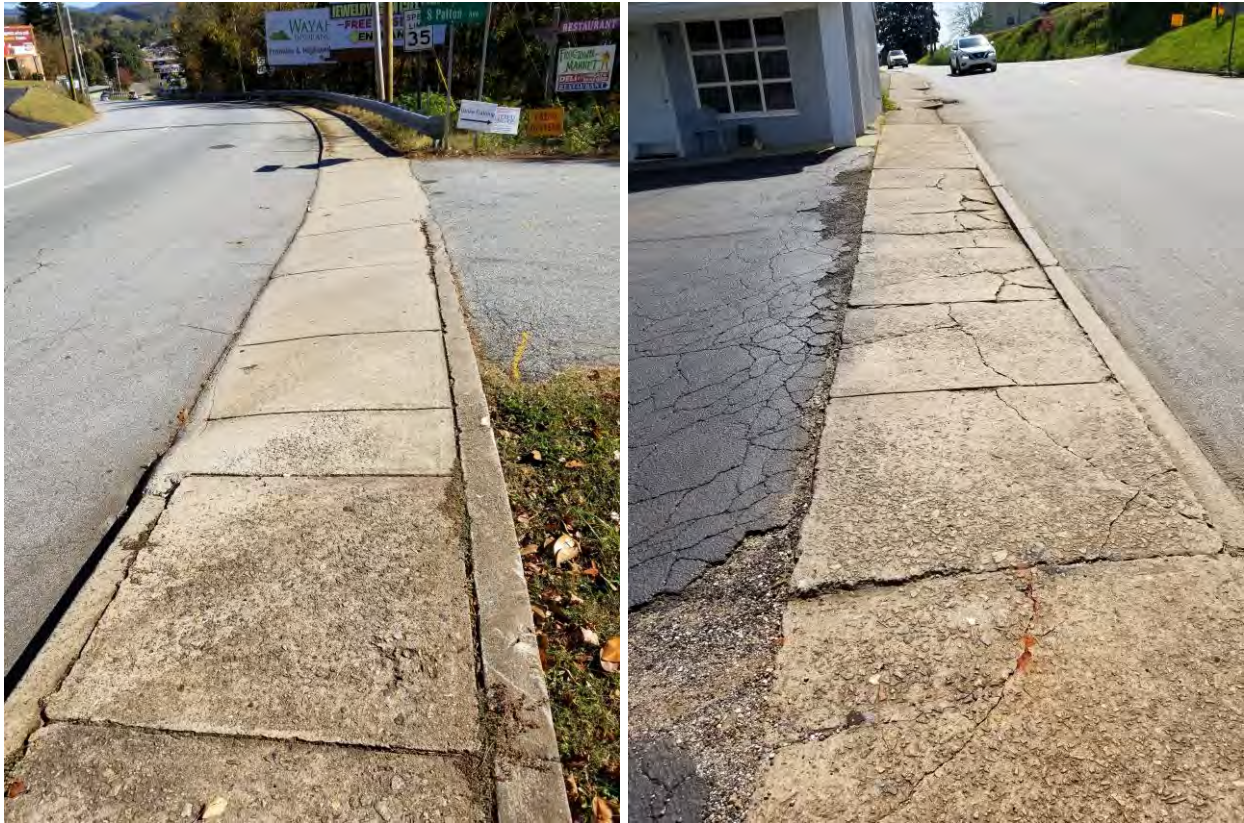
4.17 East Palmer Street (South Patton Avenue to East Main Street) Ranking Good and Poor

This sidewalk section starts at South Patton Avenue, where it ranks **Good**. There is no ADA ramp at South Patton, but the sidewalk here is 5-foot wide. It has curb and guttering but no utility strip. It has a guardrail that is maintained by NCDOT. This section turns to **Poor** condition at 399 East Palmer Street, where the sidewalk is 5-foot wide but has many broken areas, spalling, and many toe-trip hazards. Across from Derby Street, a storm drain in the sidewalk is in major need of repair.

Recommendations: Upgrade Poor section to standard; install ADA curb ramps.

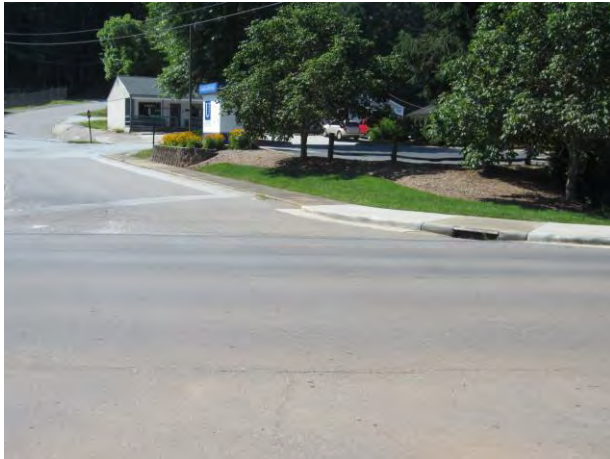
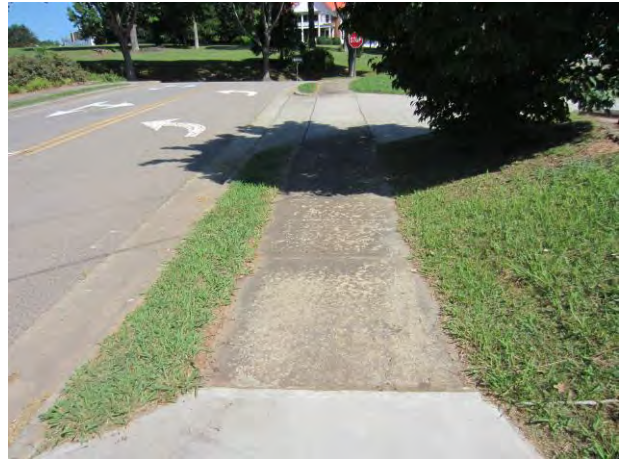
4.18 East Rogers Street

East Rogers Street sidewalk ranks **Good** on the section between NE Main Street and East Main Street. This section is 5-foot wide with curb and guttering and a utility strip. It has ramps, two of which are ADA-compliant. The ramp on NE Main Street is without detectable domes. This ramp goes to no mid-block crosswalk on NE Main Street.

The section along East Rogers Street, between East Main Street and Mill Street ranks **Fair**. It is 4-foot wide with no utility strip but with curb and guttering. It ends at Carolina Drive, where a ramp is present but without detectable domes.

Recommendations: Upgrade Fair section to 5-foot standard; install ADA curb ramps where needed.

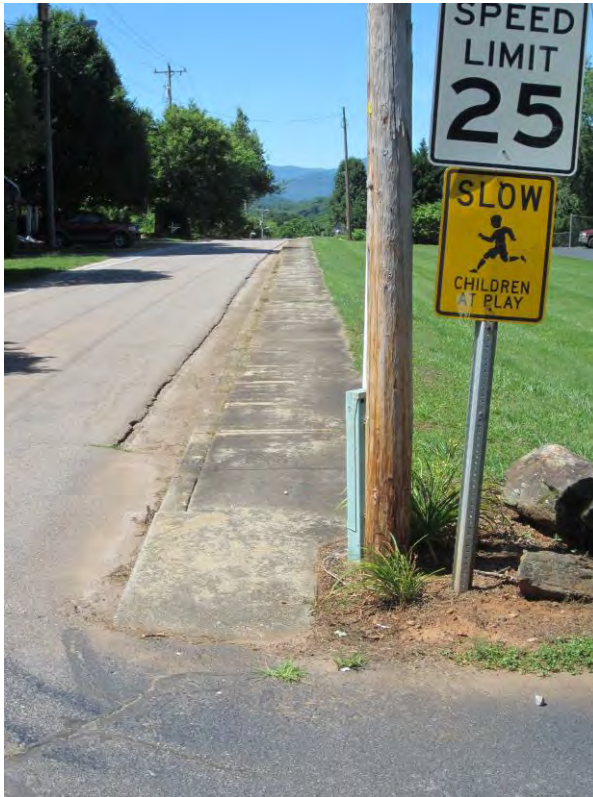
4.19 First Street

The First Street sidewalk ranks **Poor**. It starts with a pole obstruction at the driveway to Grace Presbyterian Church on the Old Cat Creek Road end, as shown. The sidewalk is 4-foot wide, with major toe trips, sunken places and no utility strip, but with curb and guttering. At 200 First Street driveway, the sidewalk has no ramps but a major step. The curb ends at this address, but sidewalk continues. At 154 First Street, a utility strip begins and continues to Highlands Road. This last section from 154 First Street to Highlands Road is in major need of edging to remove debris. Sidewalk is 3-foot wide because of overgrowth. Sidewalk is very dirty because it is almost flush with the road. Cars routinely park on the sidewalk at tire shop near Highlands Road intersection. Sidewalk is 5-foot wide past the tire shop to the intersection. NCDOT has a project in the planning phase to connect sidewalk from East Main Street up Old Cat Creek Road to First Street to complete a loop.

Recommendations: Upgrade sidewalk to 5-foot standard; remove one utility pole obstruction.
