Town of Franklin
Sidewalk Capital Improvement Plan
&
Condition Survey

Adopted May 4, 2020

Prepared by the Town of Franklin Planning Department
Town Planner Justin Setser

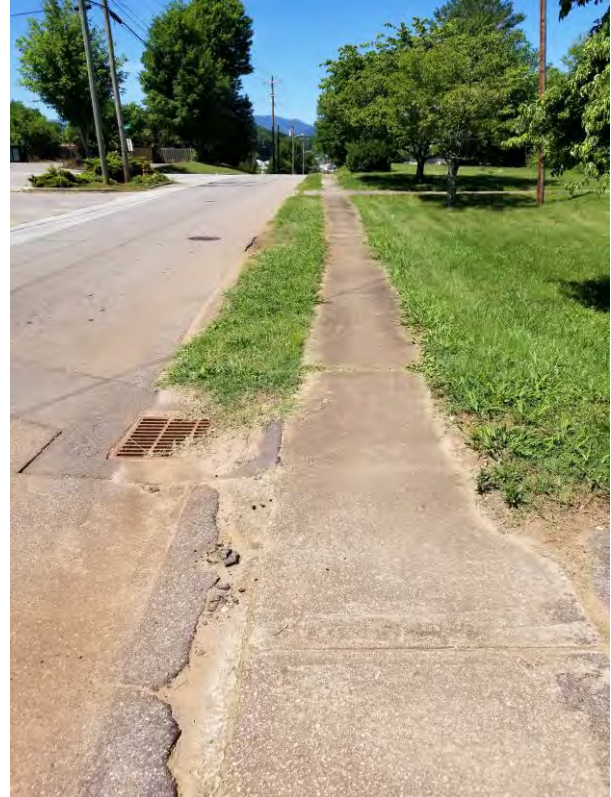
Ranking Poor

The First Street sidewalk ranks **Poor**. It starts with a pole obstruction at the driveway to Grace Presbyterian Church on the Old Cat Creek Road end, as shown. The sidewalk is 4-foot wide, with major toe trips, sunken places and no utility strip, but with curb and guttering. At 200 First Street driveway, the sidewalk has no ramps but a major step. The curb ends at this address, but sidewalk continues. At 154 First Street, a utility strip begins and continues to Highlands Road. This last section from 154 First Street to Highlands Road is in major need of edging to remove debris. Sidewalk is 3-foot wide because of overgrowth. Sidewalk is very dirty because it is almost flush with the road. Cars routinely park on the sidewalk at tire shop near Highlands Road intersection. Sidewalk is 5-foot wide past the tire shop to the intersection. NCDOT has a project in the planning phase to connect sidewalk from East Main Street up Old Cat Creek Road to First Street to complete a loop.

Recommendations: Upgrade sidewalk to 5-foot standard; remove one utility pole obstruction.

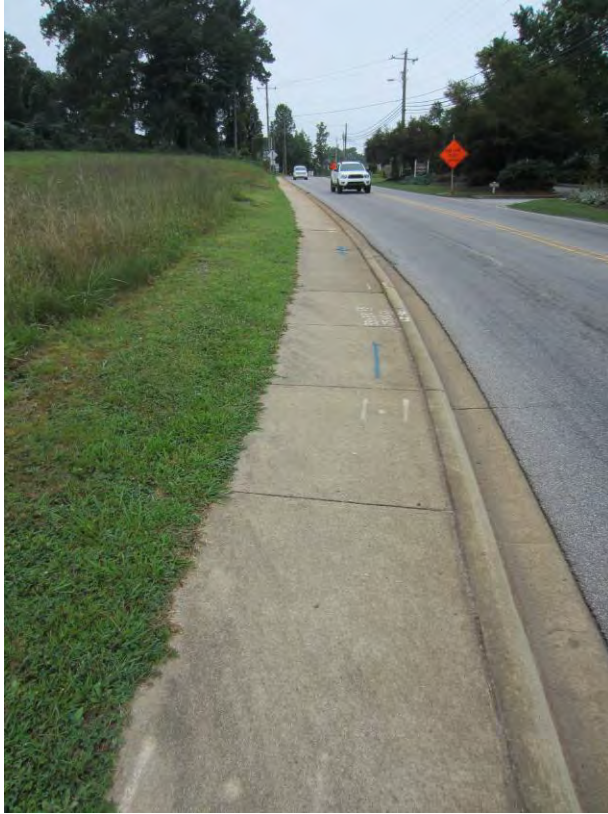
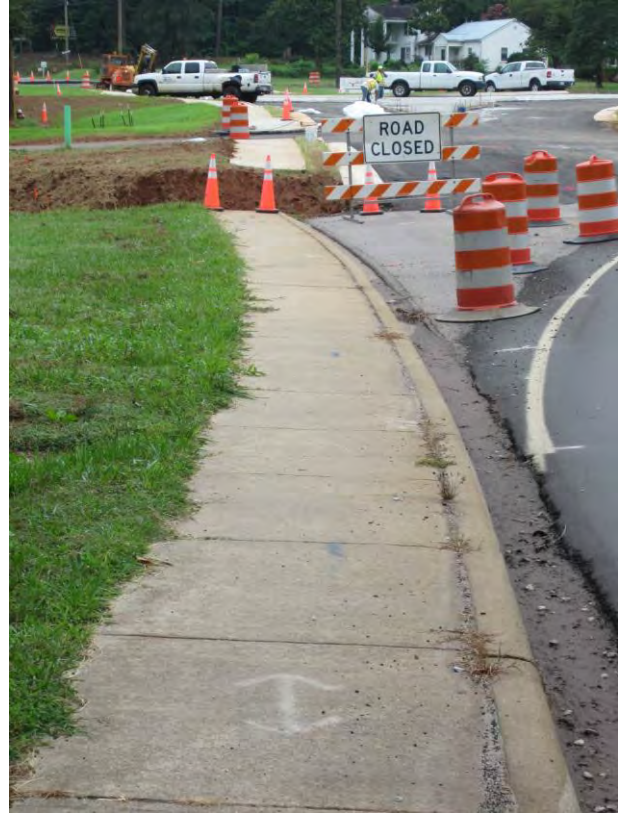
Ranking Fair and Good

Sidewalks on Georgia Road are evolving as NCDOT makes road upgrades. Currently, the sidewalks rank **Fair** from Maple Street to the new roundabout at Womack Street, then **Good** from the roundabout to Golfview Drive. The section from Maple Street to the new roundabout ranks **Fair**; it is 4-foot wide with no utility strip but with curb and guttering. The concrete condition is good. Curb ramps at Edgewood Avenue are present but are without detectable domes and not ADA-compliant. A plant obstruction at 220 Georgia Road requires trimming or removal. At the roundabout, much new 5-foot-wide sidewalk has been built with utility strips and curb and guttering.

Recommendations: Upgrade narrow sidewalk to 5-foot standard; install ADA curb ramps.

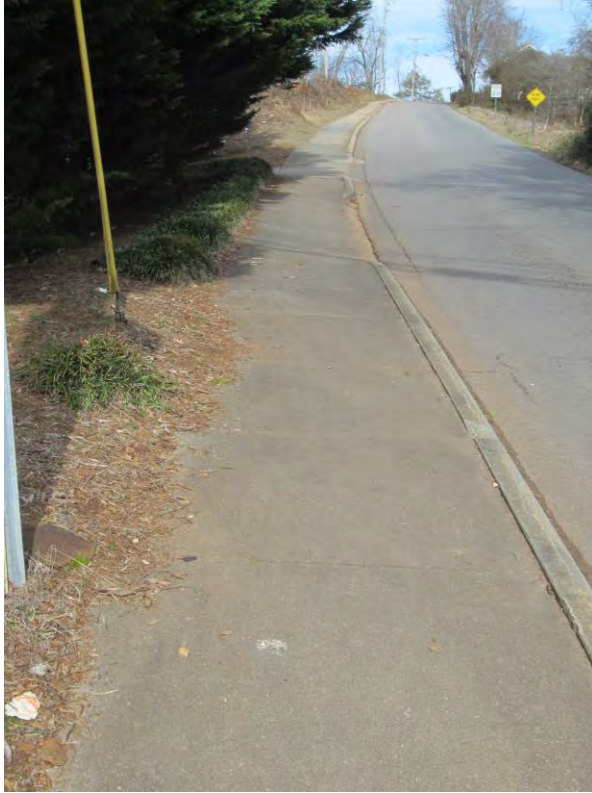
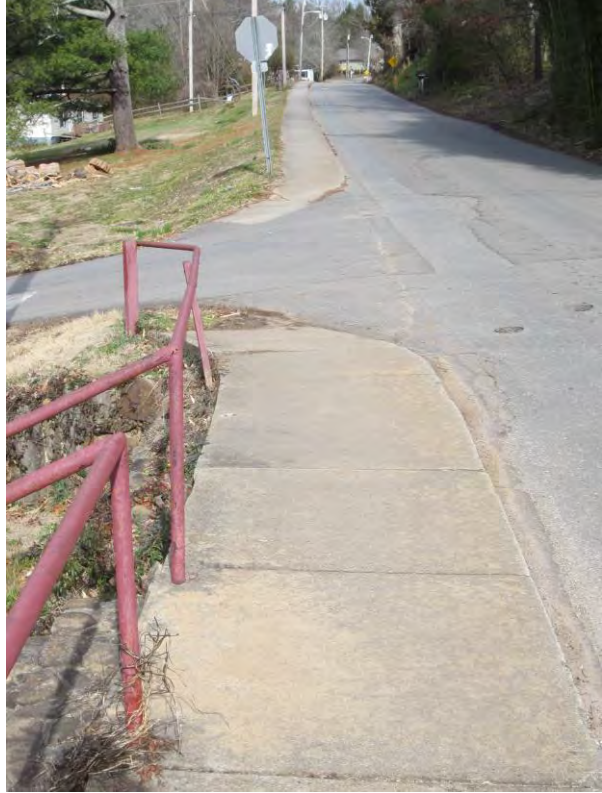
4.21 Green Street

Green Street ranks **Good** from its start at the intersection of West Main Street to 142 Green Street. There is no ADA-compliant curb ramp at West Main Street but, in this section, the sidewalk is 5-foot wide with curb and guttering but no utility strip.

After 142 Green Street, the sidewalk is 4-foot wide, with no curb, and ranks **Fair**. There is a handrail along the sidewalk from 152 Green Street to the intersection of Lyle Street, as seen pictured above. The intersection with Lyle Street does not have a crosswalk or ADA-compliant curb ramps. The sidewalk continues along the left side of Green Street, to where it ends at Wild Mint Road. There is no ADA-compliant curb ramp at this location.

Recommendations: Upgrade sidewalk to 5-foot standard; install ADA-compliant ramps.

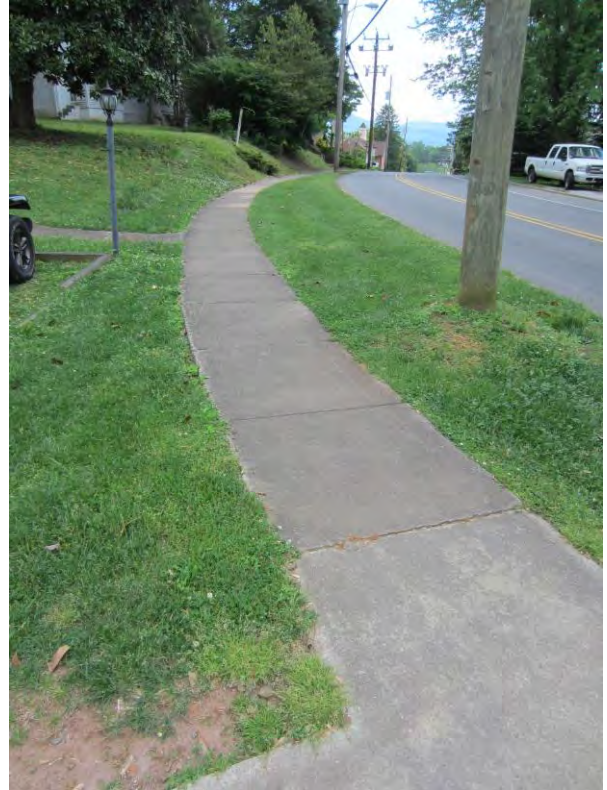
4.22 Harrison Avenue (West Main St. to Callahan St.)

This section of Harrison Avenue ranks **Fair**. It starts at West Main Street with steps down to the crosswalk. No ADA ramp is present. The sidewalk is elevated a couple feet above the roadway and is 4-foot wide with 3-foot utility strip, curb and guttering. This section ends at Church Street, with no ADA curb ramps or crosswalk. The sidewalk continues from Church Street, still 4-foot wide with some minor sunken places and cracks, ending at Callahan Street. As shown, there is room to easily accommodate a 5-foot wide sidewalk.

Recommendations: Upgrade to 5' foot standard, install ADA curb ramps.

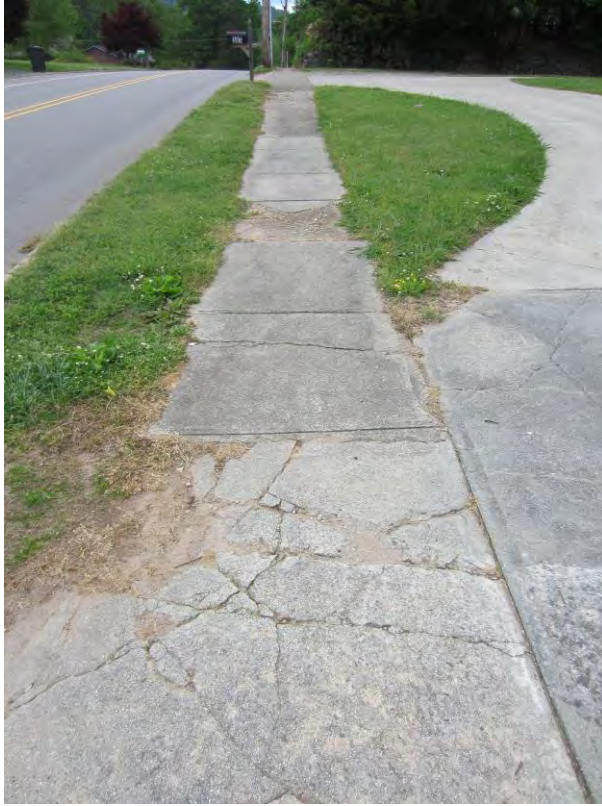
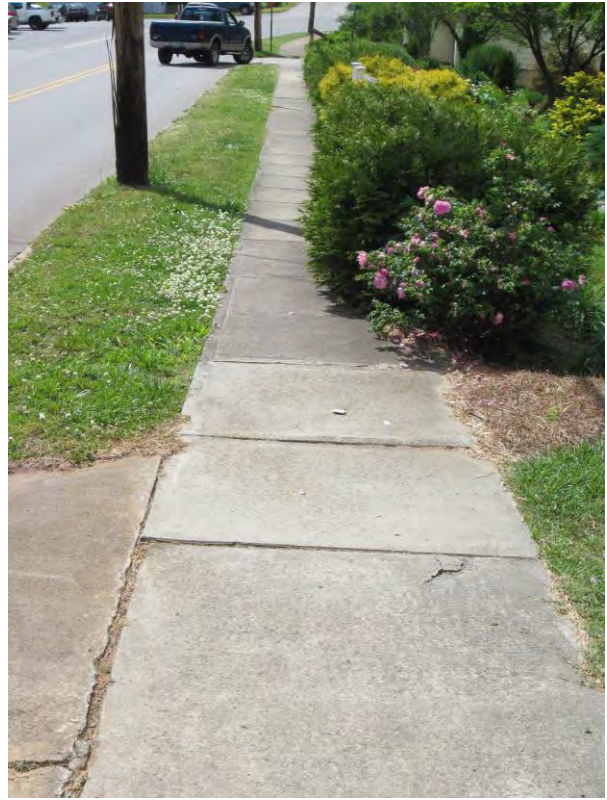
4.23 Harrison Avenue (Callahan St. to 587 Harrison Ave.) Ranking Poor

This section of Harrison Avenue sidewalk ranks **Poor**. It is 4-foot wide with a utility strip that varies in width. Curbing is almost non-existent, and sidewalk is flush with the road. The sidewalk has many toe trips, cracks, broken places, and obstructions from poles and plants. At some places, it is only 3.5-foot wide and even narrower at obstructions. The intersection with Love Street doesn't have ADA-compliant curb ramps.

Recommendations: Upgrade sidewalk to 5-foot standard, install ADA curb ramps.

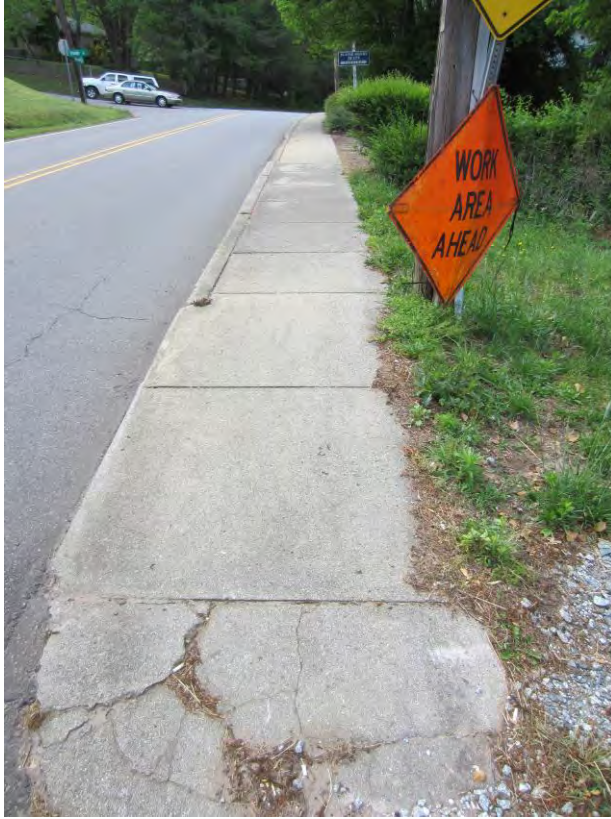
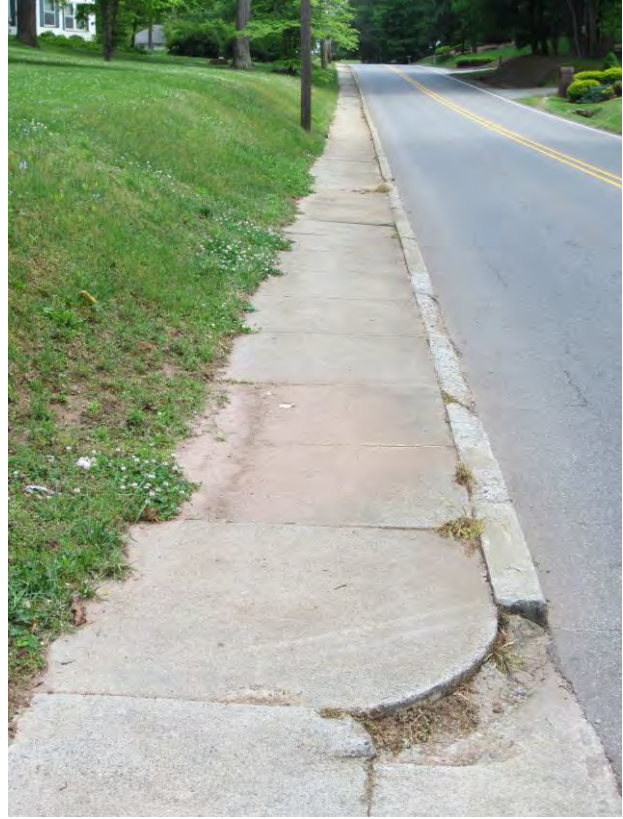
4.24 Harrison Avenue (587 Harrison Ave. to Mashburn St.) Ranking Fair

This section of Harrison Avenue sidewalk ranks **Fair**. It is 4-foot wide with curb and guttering but no utility strips. The curb is broken and cracked in many places. The sidewalk has a few cracked and sunken places. Debris has built up in the stretch near Mashburn Street. The sidewalk ends at Mashburn Street with no ADA-compliant curb ramp. Sidewalk needs cleaning and edging.

Recommendations: Upgrade to 5-foot standard; install ADA curb ramp; clean.

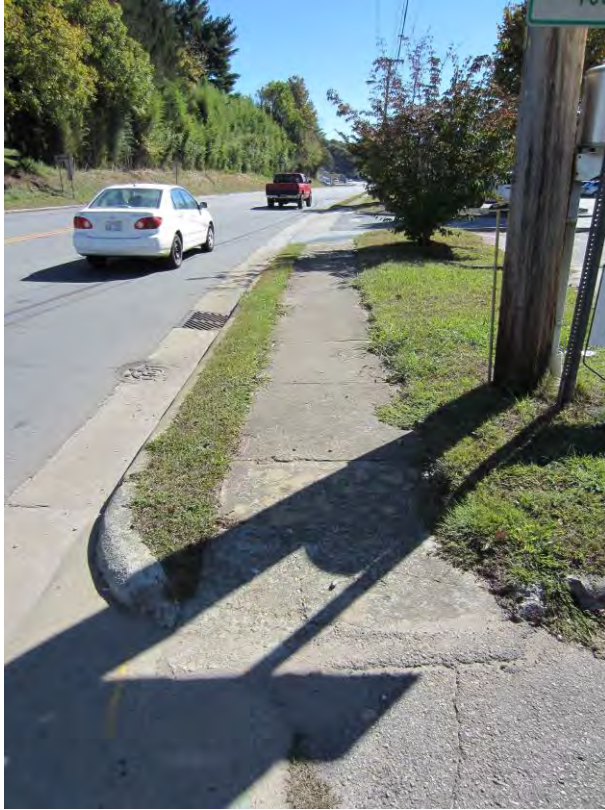
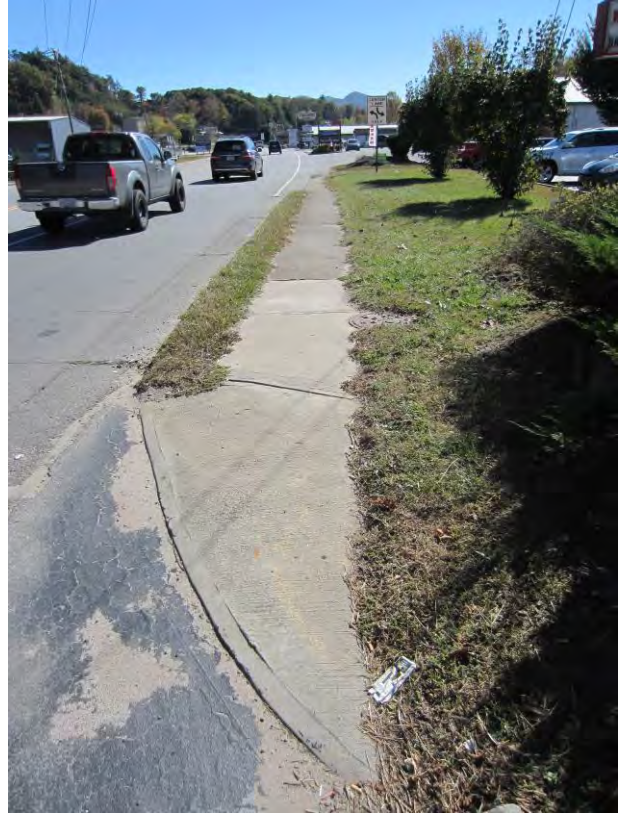
4.25 Highlands Road (East Main Street to Crane Circle) Ranking Fair

Sidewalk on this section of Highlands Road ranks **Fair**. It is 4-foot wide and in need of edging and cleaning. Overgrowth in some areas reduces effective width to 3 feet, but edging can resolve that. This section has a utility strip and curb and guttering. The last 40 feet are flush with the road before the sidewalk ends at Crane Circle. There is no mid-block crosswalk to continue on the sidewalk on the opposite side of Highlands Road.

Recommendations: Upgrade to 5-foot standard; install ADA curb ramp; install crosswalk; clean and trim.

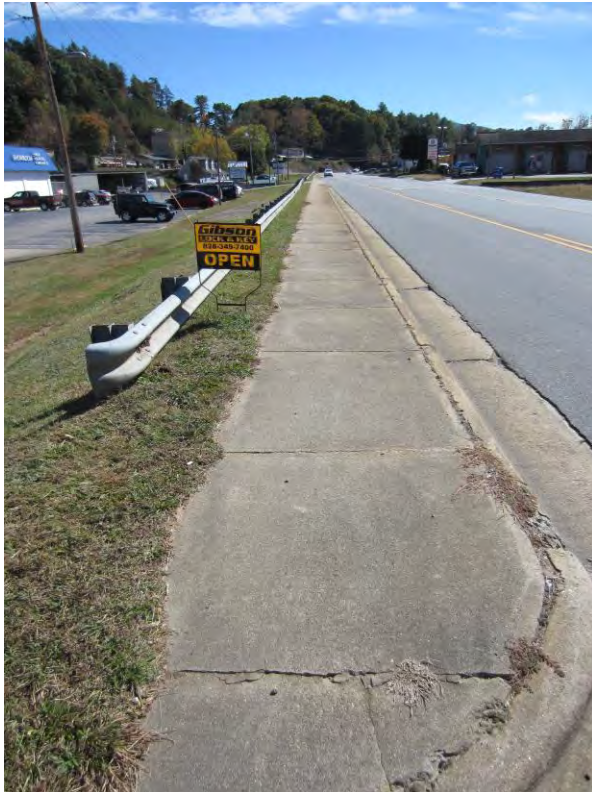
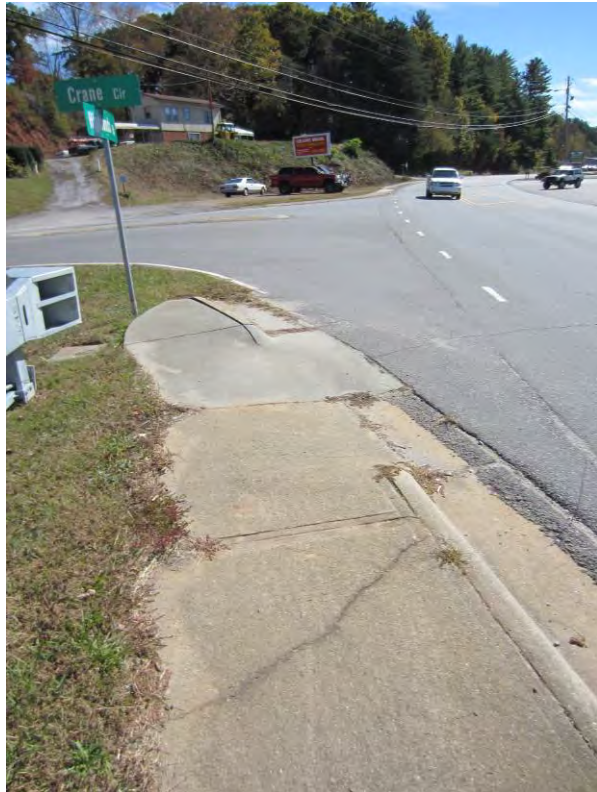
4.26 Highlands Road (Crane Circle to Crane Circle)

This section of Highlands Road sidewalk ranks **Good**. It is 5-foot wide without a utility strip but with curb and guttering and guardrail. The concrete is smooth and in good condition. It starts with no ADA-compliant curb ramp at the north end of Crane Circle. It ends at the south end of Crane Circle where there is a curb ramp without detectable domes. This ramp is also angled to the Highlands Road travel lane and not towards the sidewalk on the opposite side of Crane Circle. Some minor edging needs to be performed along this section.

Recommendations: Install ADA curb ramps.

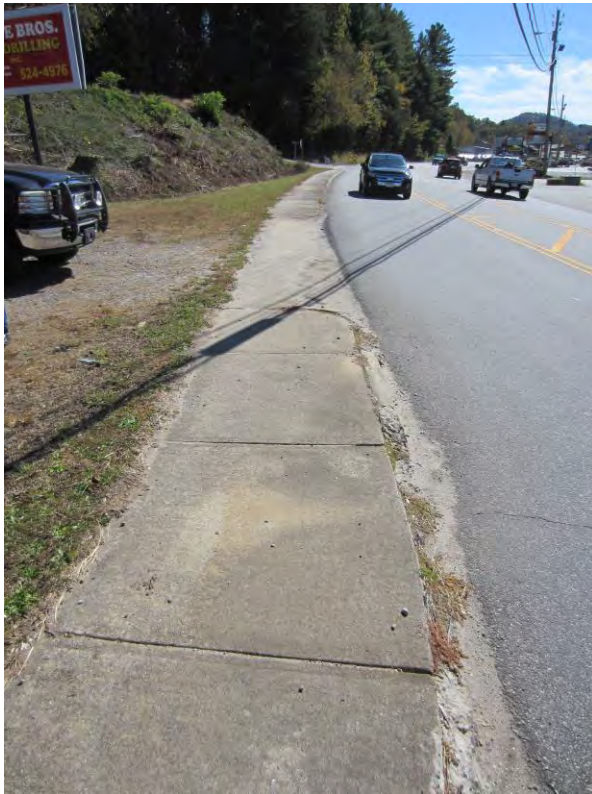
4.27 Highlands Road (Crane Circle to Thomas Heights Rd) Ranking Fair and Poor

This section of Highlands Road ranks **Fair** and **Poor**. The sidewalk is 5-foot wide without a utility strip but with curb and guttering. The curb is in poor shape in many places. The sidewalk has many broken and sunken places. It begins at Crane Circle with no crosswalk across Crane Circle and no ADA-compliant curb ramp at the Circle or at either side of Tennessee View Street. There is also no crosswalk at Tennessee View Street. Edging and debris cleaning need to be performed on this section of sidewalk. The sidewalk ends at Thomas Heights Road, where there is a curb ramp but without detectable domes.

Recommendations: Replace inferior sidewalk and install ADA curb ramps and crosswalks.

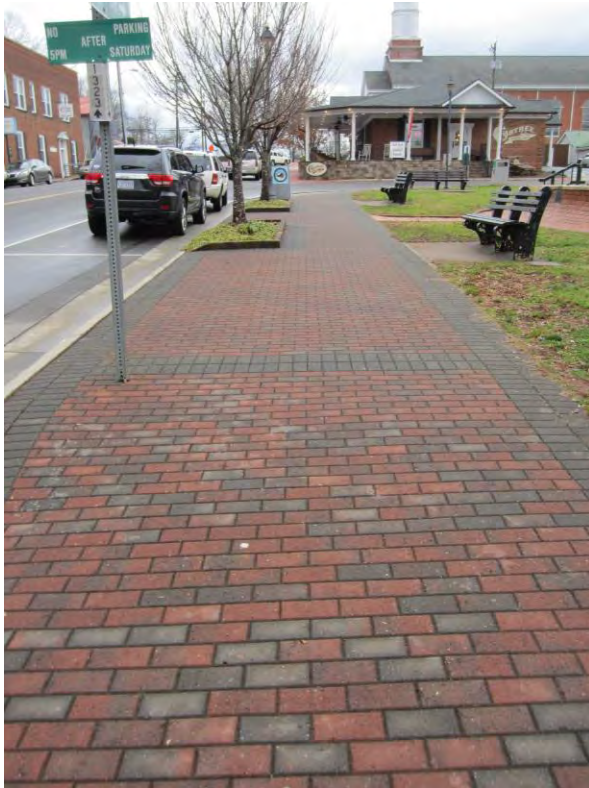
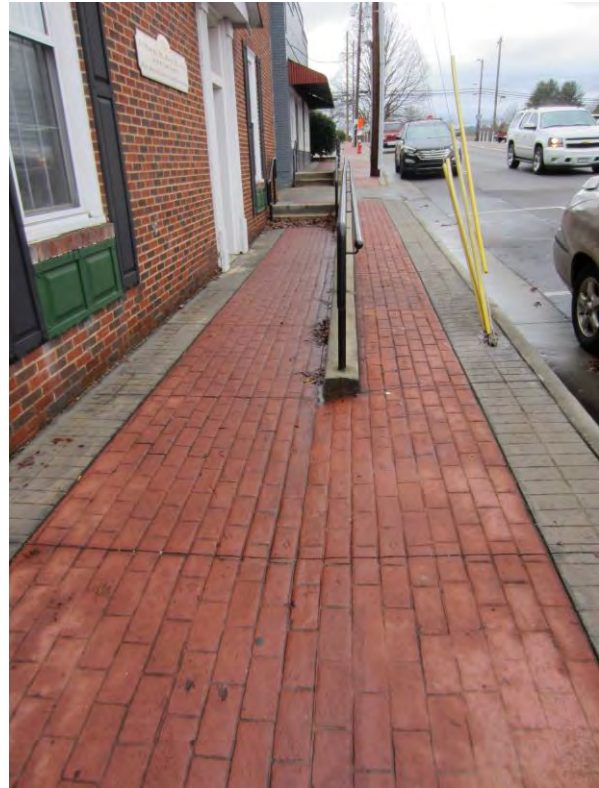
4.28 Iotla Street (East Main Street to Church Street)

Iotla Street sidewalk from East Main Street to Church Street ranks **Good**. Width varies from 5-foot to 9-foot. There is sidewalk on both sides of the street with curb and guttering. Some utility-pole obstructions occur within the sidewalks, but these have 5-foot sidewalk around them. An area with steps also has ADA-compliant sidewalk, as shown. Two curb ramps at the intersection on East Main and Iotla Streets are present but without detectable domes. This is also the case at the intersection of Iotla and Church Streets. Sidewalk is built with concrete pavers and stamped, colored concrete in this area, as shown.

Recommendations: Install ADA curb ramps.

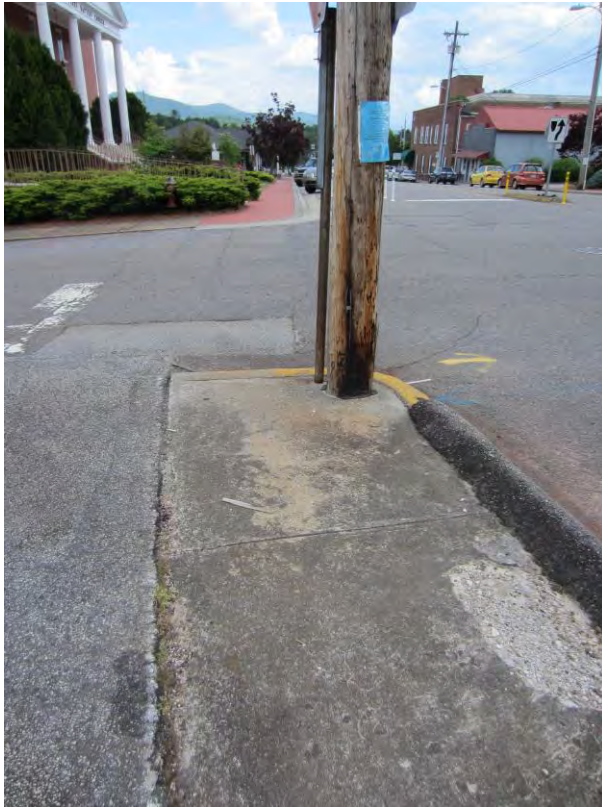
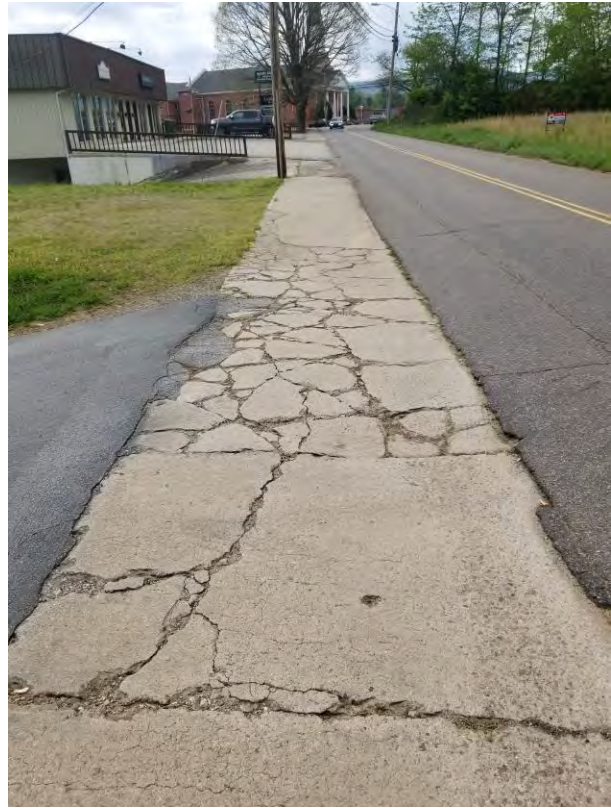
4.29 Iotla Street (Church Street to 261 Iotla Street) Ranking Poor and Good

Iotla Street from Church Street to the funeral home entrance at 261 Iotla Street ranks **Poor** and **Good**. Starting at Church Street on the right side of the road, there is no ADA-compliant curb ramp or crosswalk. A utility pole obstruction occurs where an ADA-compliant ramp should be installed, as shown. The sidewalk is 4-foot wide and flush with the road, with no curb or guttering; it is broken and cracked until it reaches to the point where Town of Franklin public works has been replacing the sidewalk. At that point, the sidewalk turns to good condition: 5-foot wide, with curb and guttering, and elevated above the road for proper drainage.

Recommendations: Upgrade remaining Poor section to 5-foot standard; install ADA ramp and crosswalk.

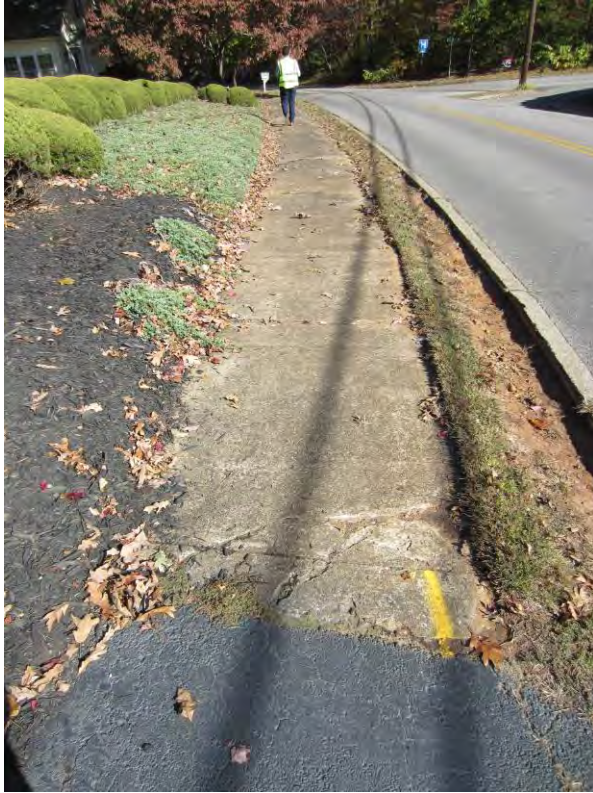
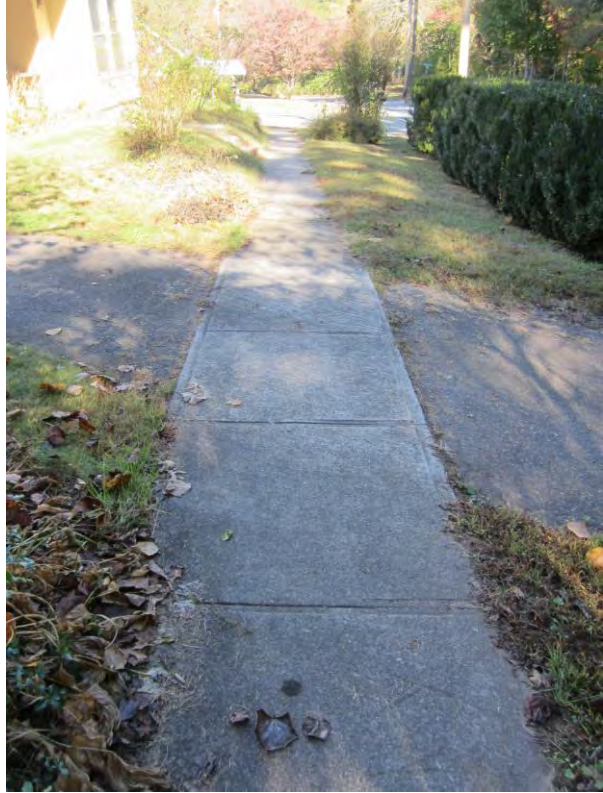
4.30 Iotla Street (White Oak Street to Doraul Street) Ranking Fair

The Iotla Street sidewalk in this section ranks **Fair**. It crosses Iotla Street at 261 Iotla Street without a mid-block crosswalk. The sidewalk then continues on the left side of the street. It is 5-foot wide with a utility strip that varies in width. It starts flush with the road, with a curb in poor condition. Once to the intersection of White Oak Street, the sidewalk becomes 4-foot wide. The sidewalk then travels through residential yards and is 6-to-10 feet from the road. It encounters a limb obstruction at 318 Iotla Street, then comes back to the road and is flush with the road with no curb. Sidewalk ends at Doraul Street, with no ADA-compliant curb ramp. This section is also in need of edging in parts.

Recommendations: Upgrade to 5' sidewalk standard; install ADA curb ramps; install crosswalk.

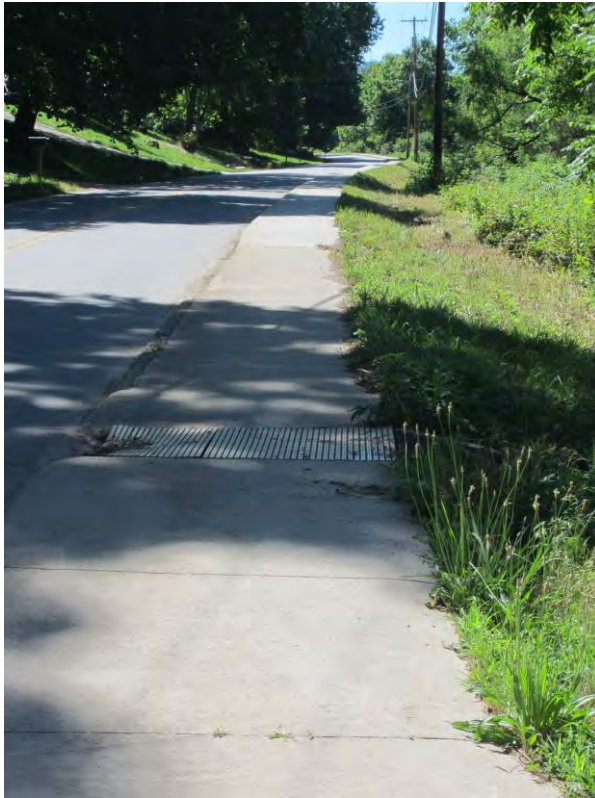
4.32 Lakeside Drive (Town Mountain Dr. to NE Main St.) Ranking Good

Lakeside Drive sidewalk, was replaced in 2016 by the Town of Franklin, ranks **Good**. It is 5-foot wide with curb and guttering. The sidewalk has an ADA-compliant curb ramp at 100 Lakeside Drive, across to the east side or right side of Lakeside Drive, with a crosswalk. No repairs are needed now other than regular maintenance such as edging and weed eating. The sidewalk ends at NE Main Street with an ADA-compliant curb ramp to cross NE Main Street and East Main Street to Highlands Road.

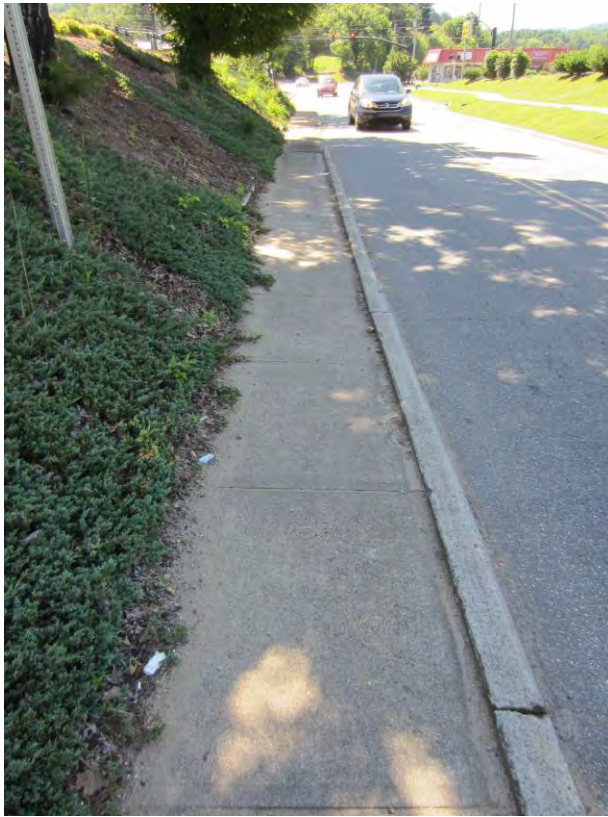
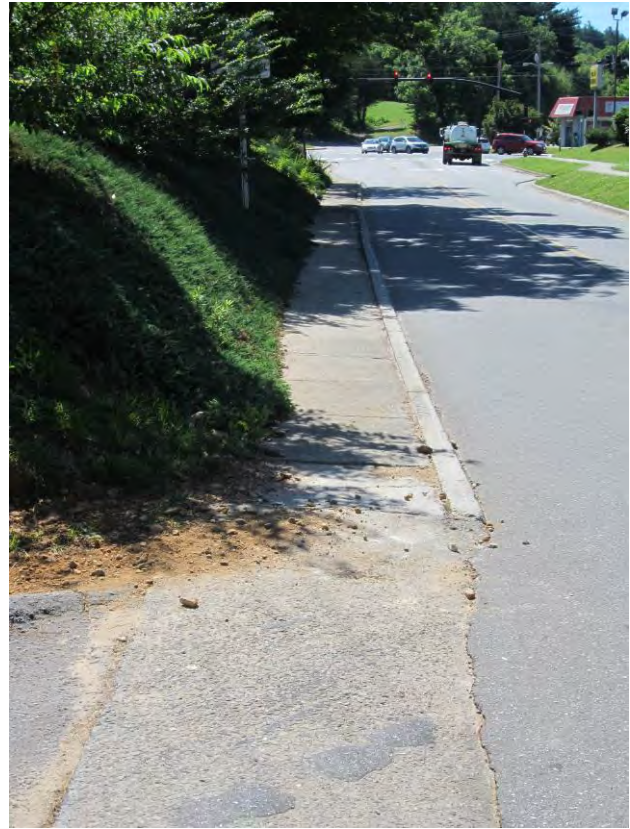
4.33 Lakeside Drive (East Main St. to Watauga St.) Ranking Poor and Fair

The section of Lakeside Drive on the right side of the street ranks **Poor** and **Fair**. It starts with an ADA-compliant curb ramp at the East Main Street intersection. Here, the ranking is **Poor**. The sidewalk has curb and guttering but is broken and sinking in places with toe trips. This section also needs edging as its 4-foot width is reduced to 3.5-foot wide from overgrowth from the bank and plants. After the crosswalk, it ends with a short section ranked **Fair** at Watauga Street. There is no ADA-compliant curb ramp here.

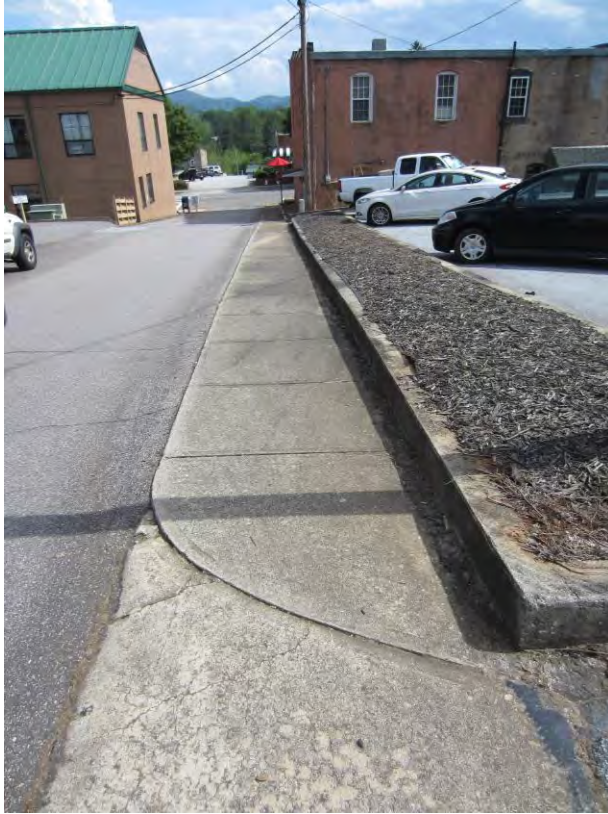
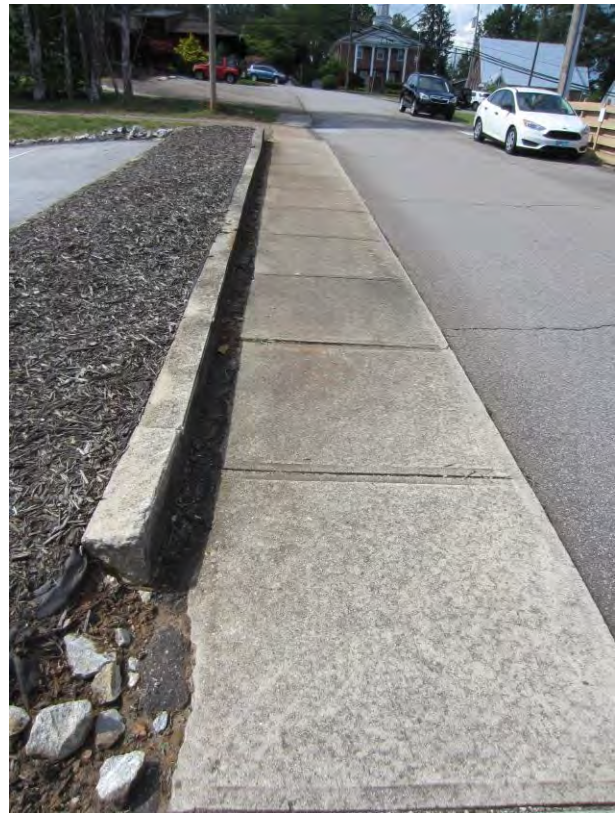
4.34 Macon Avenue Ranking Fair

Macon Avenue sidewalk ranks **Fair**. This is a 4-foot wide sidewalk, starting at 68 Macon Avenue. It does not connect to the Church Street sidewalk. Concrete is in good condition, but there is no curbing. The sidewalk ends at West Main Street, with steps to the Russell Bowling law office. Widening of this sidewalk could be tricky, as it abuts a building and a raised mulch bed, as shown above.

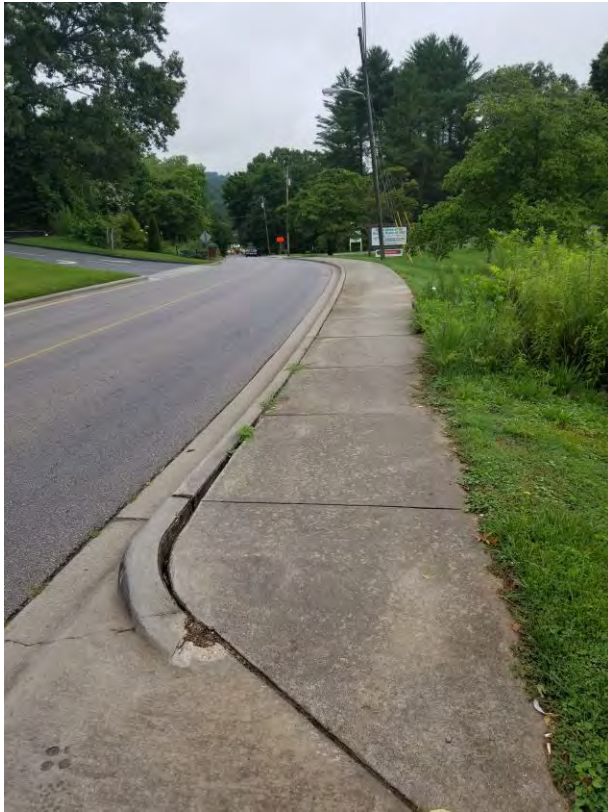
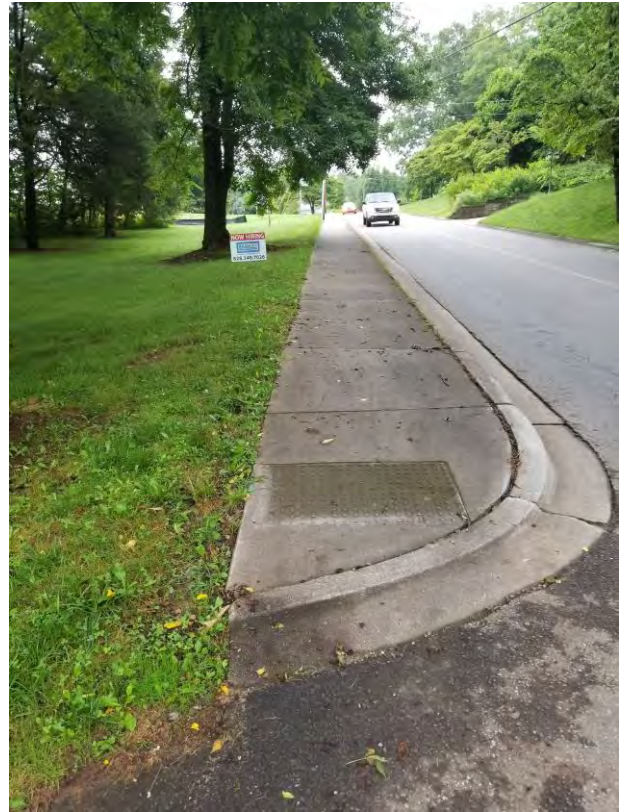
4.35 Maple Street (Georgia Road to East Dogwood Road) Ranking Good

This section of Maple Street ranks **Good**. A roundabout with new sidewalks and ADA-compliant curb ramps is in construction at the intersection of Maple Street and Georgia Road, with completion planned for 2020. The sidewalk is 5-foot wide with curb and guttering. This section ends at East Dogwood Drive with an ADA-compliant curb ramp.

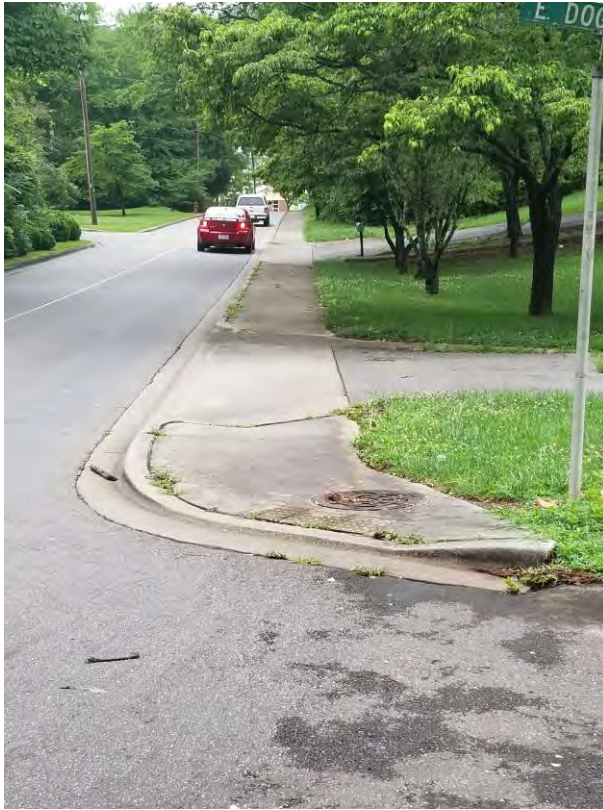
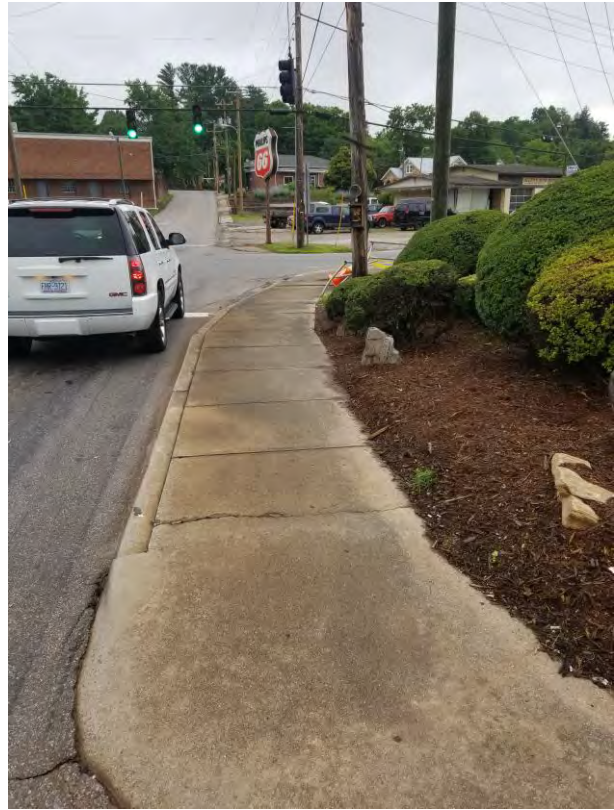
4.36 Maple Street (East Dogwood Drive to West Palmer St.) Ranking Good

This section of Maple Street ranks **Good**. It begins at the other side of East Dogwood Drive, with an ADA-compliant curb ramp but no crosswalk to East Dogwood. It continues down the hill, with some minor cracks in the sidewalk curb at the entrance of the Ingles driveway. The sidewalk is 5-foot wide along this section, with curb and guttering. It ends at West Palmer Street, with no ADA-compliant curb ramp to cross West Palmer, and no crosswalk for safe crossing to continue walking on Maple Street.

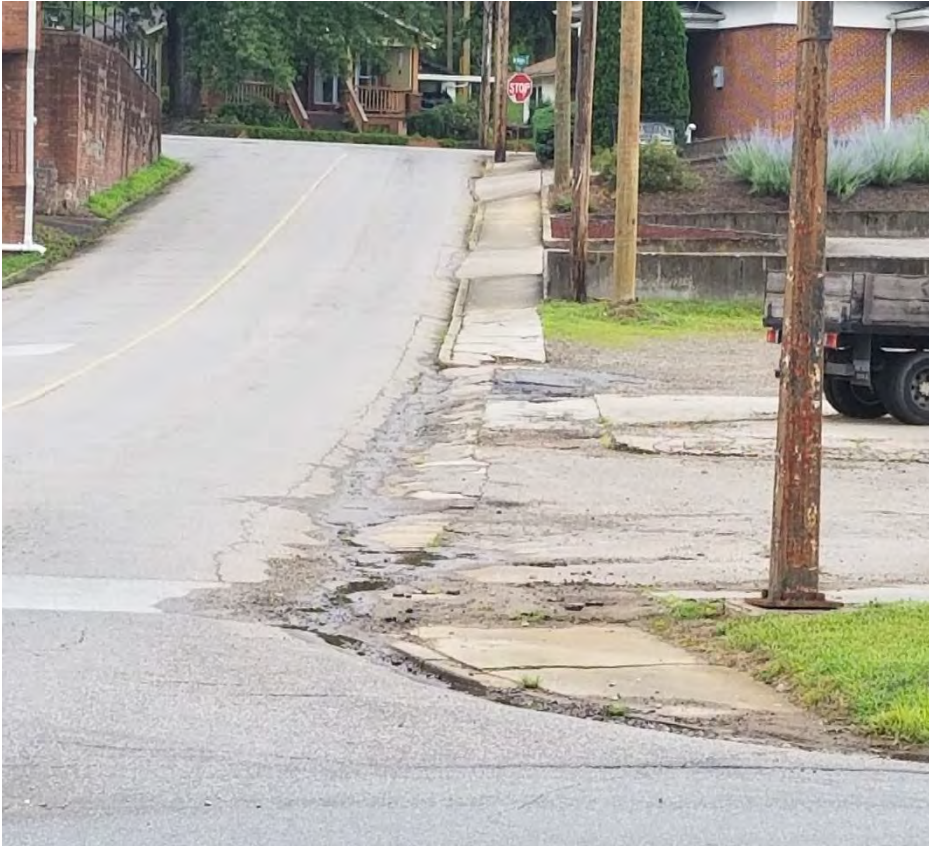
Ranking Poor

Maple Street from West Palmer to West Main Street ranks **Poor**. The sidewalk at West Palmer Street has no ADA-compliant curb ramp. It is 4-foot wide, very broken and cracked. It has curb and guttering but no utility strip. A large portion is a driveway entrance to a mechanic shop. The sidewalk continues up Maple Street to West Main Street, with a pole obstruction at the intersection. It ends at West Main Street with no crosswalk or ADA curb ramp to cross West Main Street.

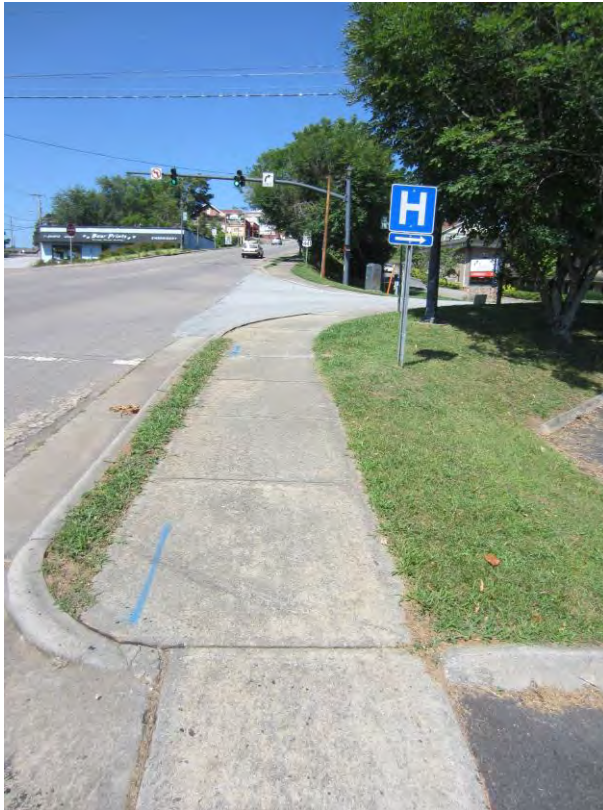
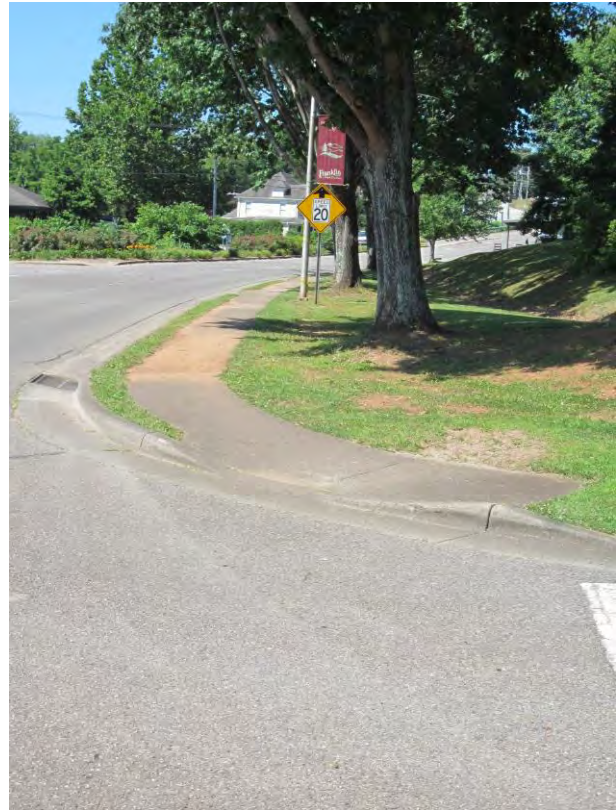
Ranking Good

The Northeast Main Street sidewalk ranks **Good**. It starts at Riverview Street and travels along the north side of the street. It is 5-foot wide with curb and guttering and a 2-foot utility strip. The sidewalk has two curb ramps without detectable domes at Riverview Street and Depot Street. The East Rogers Street sidewalk does not cross to a ramp.

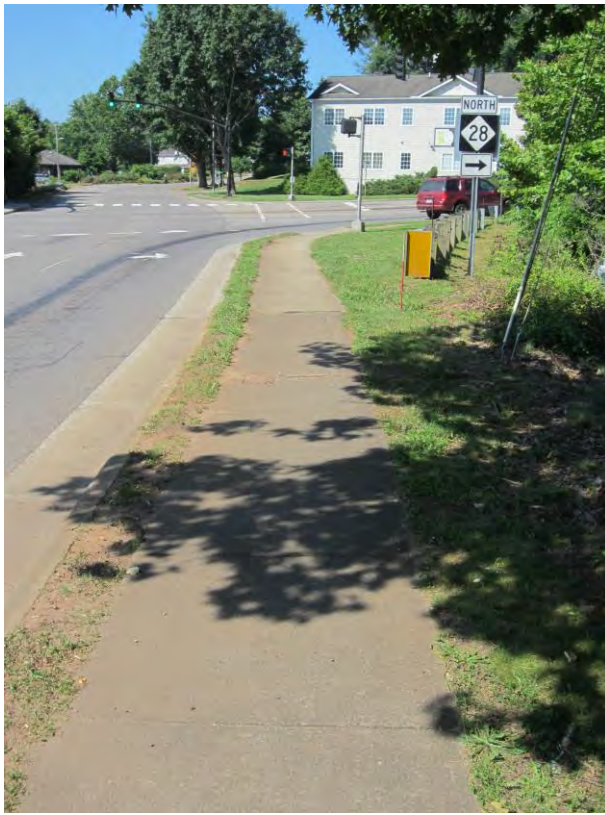
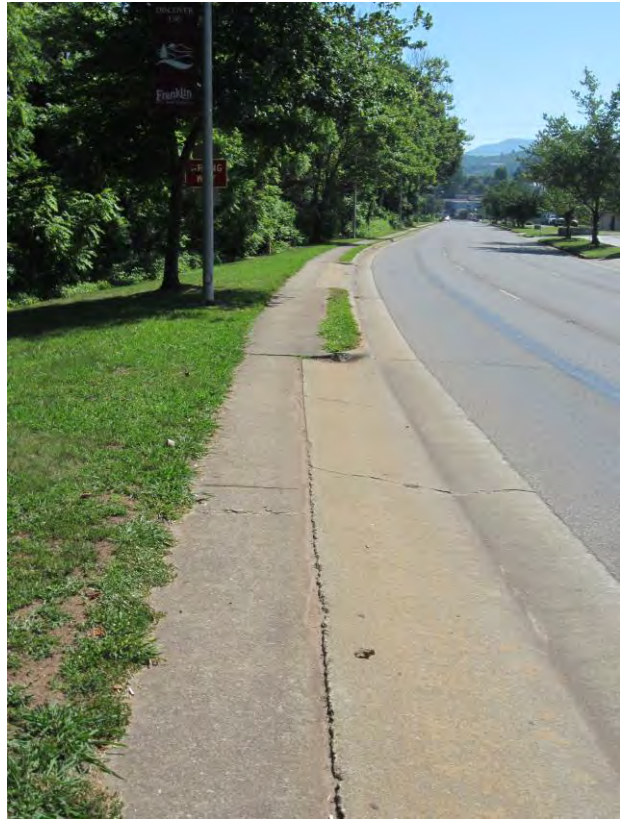
Ranking Good

The Northeast Main Street sidewalk ranks **Good**. It crosses Depot Street with a crosswalk to a curb ramp without detectable domes. The sidewalk continues along the north side of the street only. The sidewalk is 5-foot wide with curb and guttering and a utility strip. A few driveway cuts could be replaced with curb and guttering. These cuts are unlikely to ever be used as the area is a wetland and owned by Macon County. Only a few squares at the first entrance to Big Bear Park that are cracked and broken need to be replaced. The sidewalk then crosses Ed Henson Bridge and ends at Lakeside Drive.

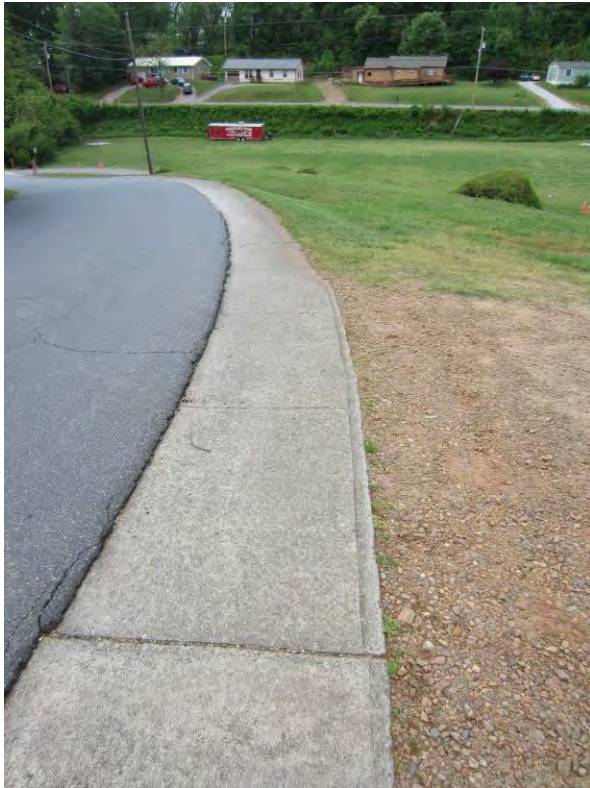
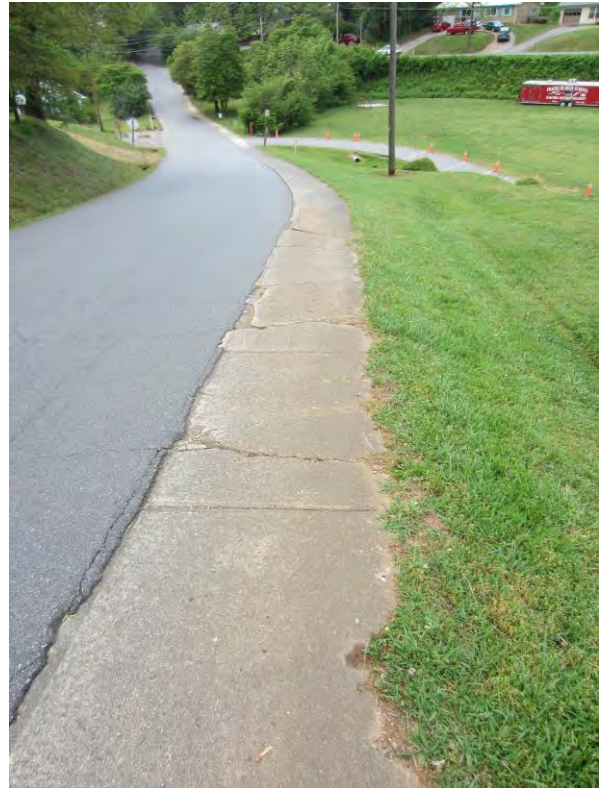
4.40 Phillips Street (Panther Drive to Wayah Street)

Phillips Street, from Panther Drive to Wayah Street, ranks **Poor**. The sidewalk starts at Panther Drive with no ADA-compliant curb ramp and continues down Phillips Street on the right (east) side of the street. It is 4-foot wide with no curb and guttering and is flush with the street. The concrete of the sidewalk is cracked and broken in places. At the bottom of the hill, at the lowest point, considerable rock and sand stands on the sidewalk. The sidewalk ends on the hill at Wayah Street, with no ADA-compliant curb ramp. Because of the angle and steepness of the intersection at Wayah Street, an ADA-compliant curb ramp might be very difficult to achieve.

Recommendations: Upgrade sidewalk to 5-foot standard; install ADA curb ramps where possible.

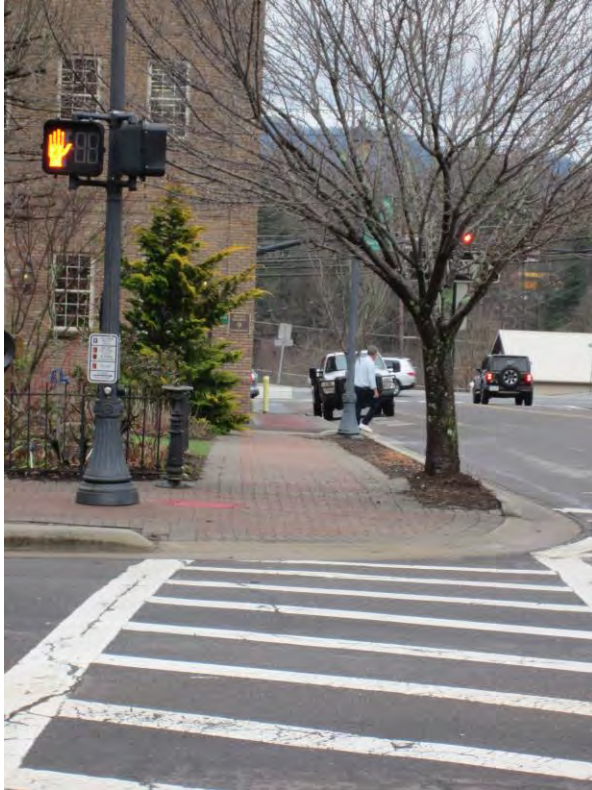
4.41 Phillips Street (East Main St. to East Palmer St.)

This section of Phillips Street ranks **Good**. It has sidewalks on both sides of the street, varying in width from 6-foot to 5-foot wide. It is paved with brick pavers and dyed concrete. The Intersections are marked with crosswalks, and ADA-compliant curb ramps are present at East Palmer Street intersection. East and West Main Street intersection curb ramps are present but without detectable domes. The street has curb and guttering on both sides. Utility poles and streetlights are present on both sides, which causes the width to vary. There is a short section of utility strip along the Clock Tower parcel on the east of the street. The intersections are signalized for pedestrians.

Recommendations: Install ADA-compliant ramps.
