Town of Franklin
Sidewalk Capital Improvement Plan
&
Condition Survey

Adopted May 4, 2020

Prepared by the Town of Franklin Planning Department
Town Planner Justin Setser

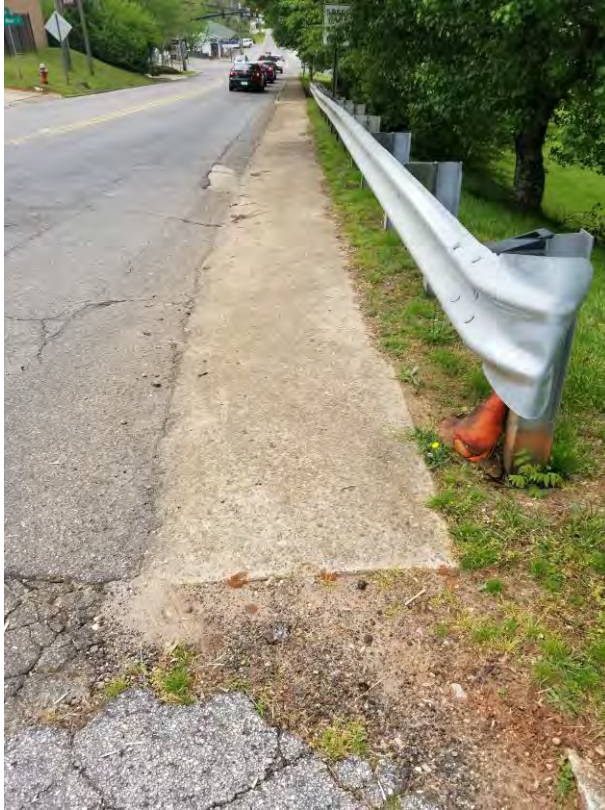
Ranking Poor

This section of Porter Street ranks **Poor**. It starts with a crosswalk across West Main Street to no ADA-Compliant curb ramp on either side and continues down Porter Street on the west side with guttering for only a short distance. The sidewalk is 4-foot wide with curb and guttering and a guardrail maintained by NCDOT. The guardrail would have to be moved to upgrade to 5-foot width. The sidewalk ends with another short section of guttering only and no sidewalk at West Palmer Street. There is no ADA-compliant curb ramp at the intersection of West Palmer Street.

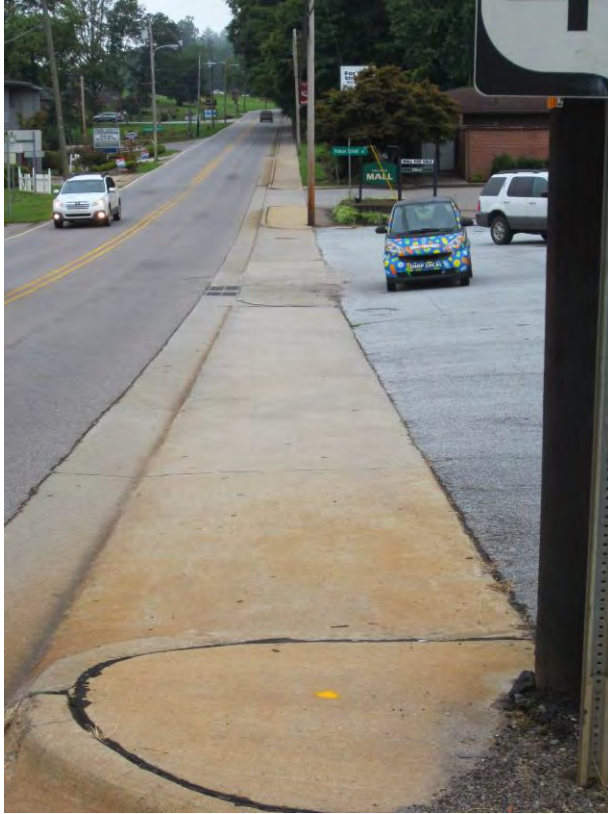
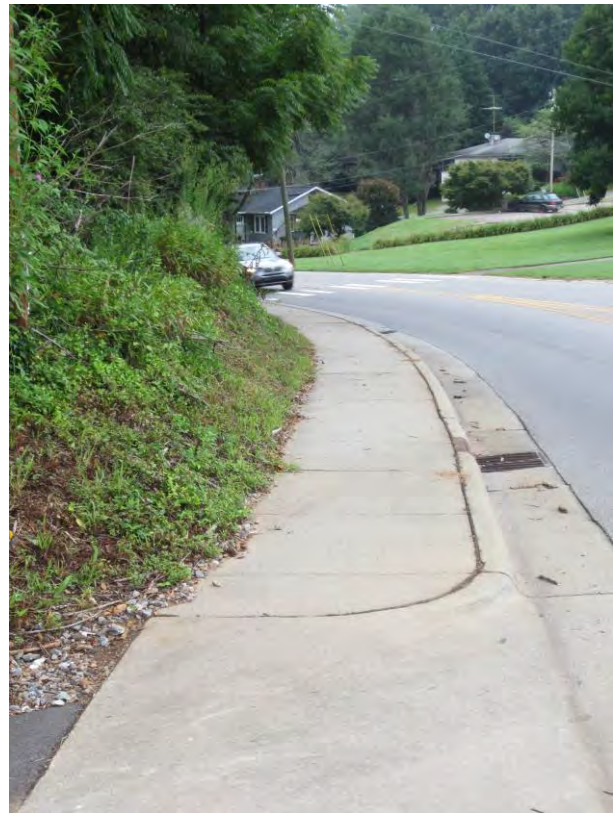
4.43 Porter Street (West Palmer St. to Panther Dr.) Ranking Good and Fair

This section of West Palmer Street sidewalk ranks **Good** and **Fair**.

When pedestrians cross West Palmer, they do not cross to a curb ramp or with a crosswalk. The sidewalk starts after the intersection and is 5-foot wide with curb and guttering but no utility strip. The sidewalk ranks **Good** in this section; it has no flaws, but it does from time become covered with pine needles that need to be monitored and removed. There is a utility pole obstruction at Panther Drive, which is also where the sidewalk becomes 6-foot wide. There is a mid-block crosswalk just after Panther Drive that crosses to the east side of the street, to the sidewalk on the Franklin High School parking lot side. The sidewalk on this side ranks **Fair**; it has some toe trips but is 5-foot wide. There is no curb or guttering, but there is a 6-foot-wide utility strip. This side ends at Panther Drive with no ADA-compliant curb ramps at the crosswalk or the end at Panther Drive.

Recommendations: Upgrade Fair portion to 5-foot standards; install ADA curb ramps.

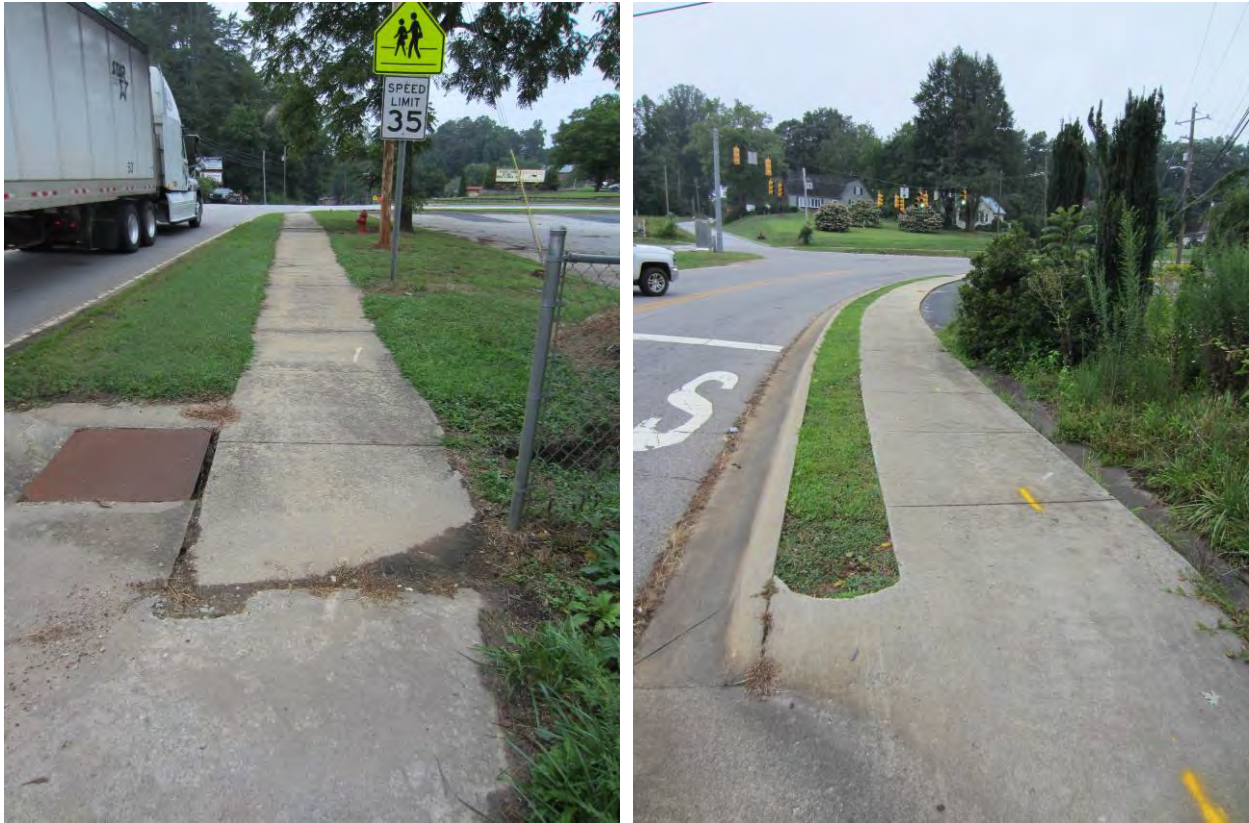
4.44 Porter Street (Panther Dr. to Wayah St.) Ranking Good and Poor

Shown on left above is the section of Porter Street sidewalk along the Franklin High School Parking lot, which is described in section 4.43. The second picture shows Porter Street sidewalk after Panther Drive to Wayah Street. This side of the street sidewalk ranks **Good**. The opposite side of the street has a short section that intersects with Wayah Street. It ranks **Poor**. NCDOT plans to remove and replace both sections in the summer of 2020, during construction of a new roundabout at this intersection. There are no further recommendations at this time.

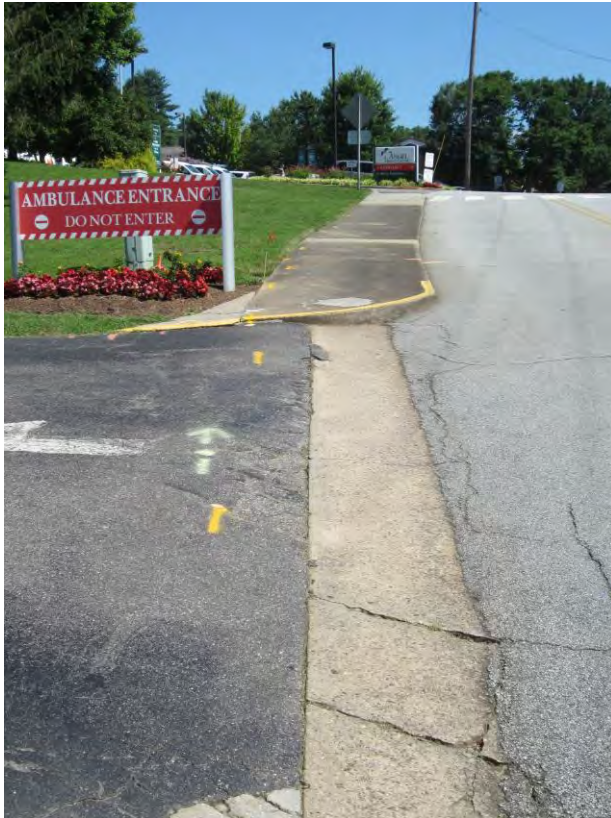
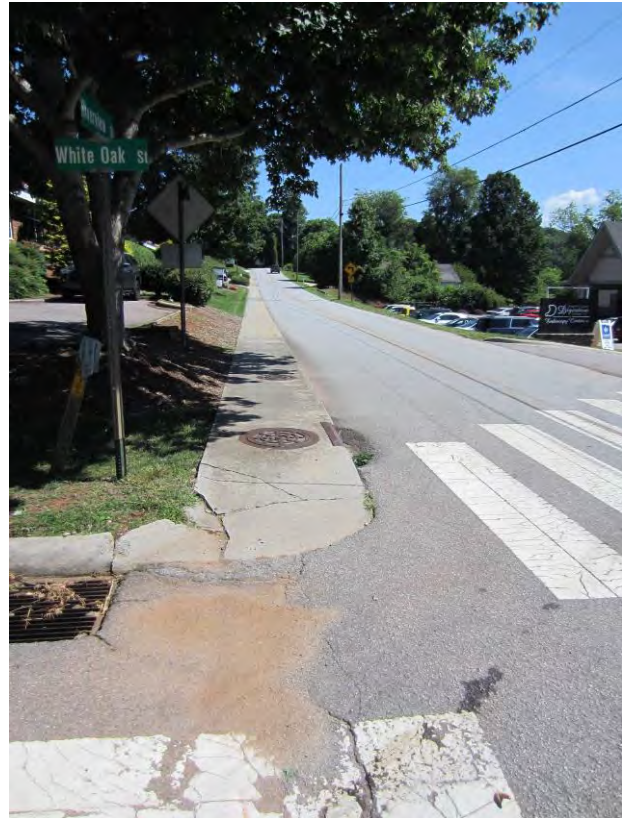
4.45 Riverview Street (East Main St. to White Oak St.) Ranking Good & Fair

The first section of the Riverview Street sidewalk ranks **Good**: it is 5-foot wide at the intersection of East Main Street, with curb and guttering and a utility strip. The sidewalk widens to 6-foot at the entrance to Angel Medical Center. It ranks **Fair** where it narrows to 4-foot wide, past White Oak Street. There are multiple steps at curb cuts for driveway entrances to the hospital that are not ADA-compliant. A mid-block crosswalk is marked at the hospital entrance. A ramp for the crosswalk is present, but without detectable domes. The crosswalk goes to the parking lot across the street, and there is no ADA-compliant curb ramp in the parking lot. At the intersection of White Oak Street, ramps are present for the crosswalks but no detectable domes. After White Oak Street, the sidewalk doesn't have curbing. The concrete as a whole is in good condition.

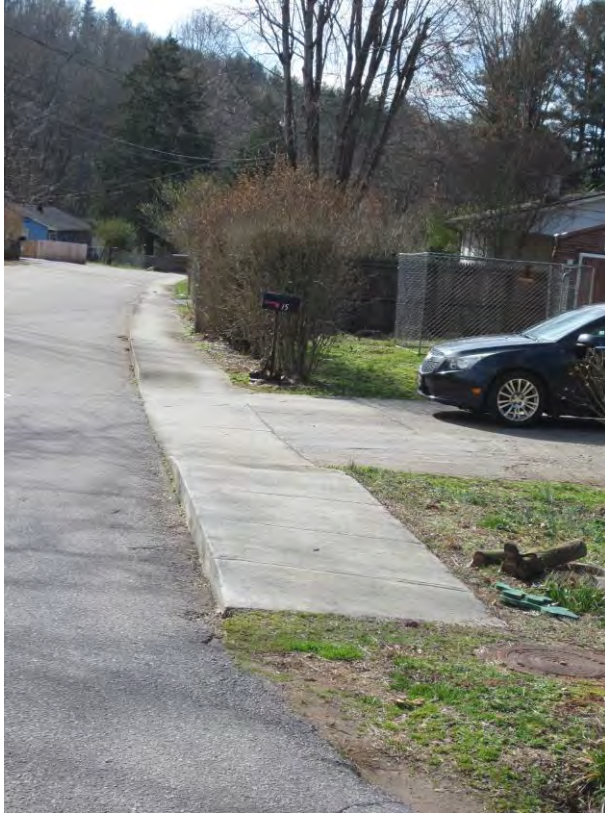
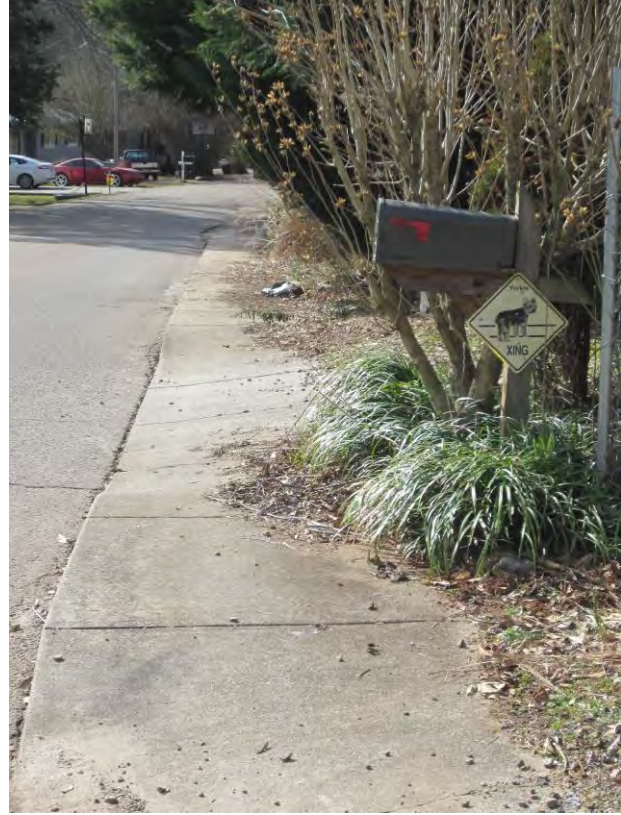
Ranking Fair

The sidewalk along Rolling Hills Drive ranks **Fair**. It is 4-foot wide; there are no curbs and no utility strips. The sidewalk is very dirty in many places and covered with debris. Multiple locations along the 900-foot sidewalk have obstructions from mailboxes, plants, and trees. These obstructions choke the sidewalk down to 2-foot and less in width. The concrete is in good condition. Neither end of the street has ADA-compliant curb ramps. Edging and cleaning of the sidewalk would be a major help to the residents of Rolling Hills Drive.

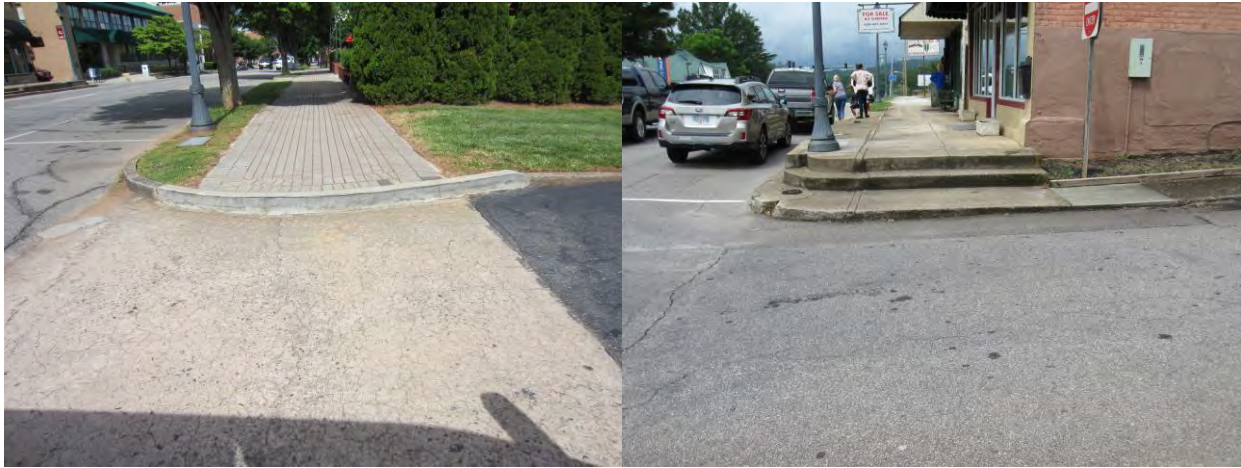
West Main Street, from Iotla Street to Harrison Avenue, has sidewalk on both sides. It ranks **Good** on the left (south) side and is also **Good** on the right side, until the Macon Avenue to Harrison Avenue portion, which ranks **Fair**. Much of the sidewalk is paved with concrete and brick pavers. There are utility strips, curb and guttering throughout. Width varies from 8-to 5 feet. A mid-block crosswalk at Macon Avenue has no ADA-compliant curb ramps. At Macon Avenue, you must take steps to continue on sidewalk (shown). Concrete on the Fair section is spalled and cracked. The sidewalk ends at Harrison Avenue with steps to the crosswalk.

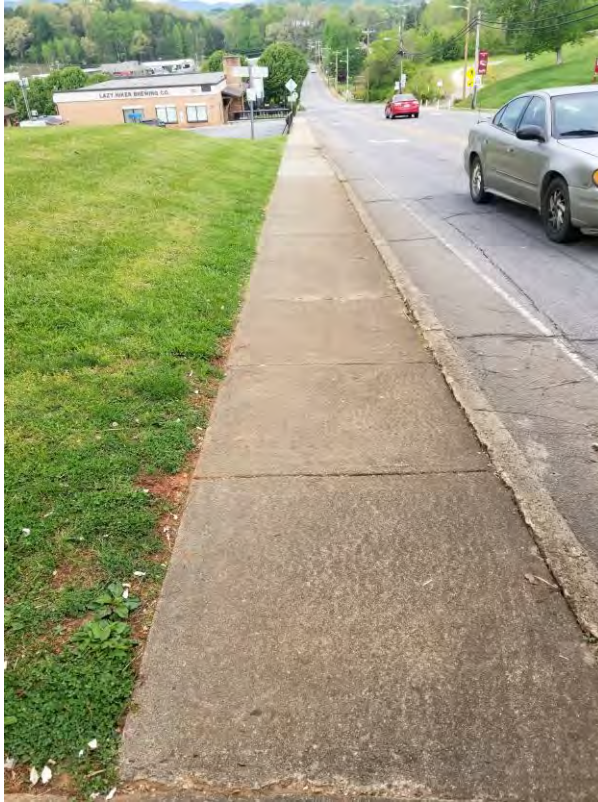
4.48 West Main Street (Harrison Ave. to Porter St.) Ranking Poor and Fair

West Main Street in this section has sidewalks on both sides. The left (south) side ranks **Poor** for the first 50 feet. From that point, the sidewalk ranks **Fair** to Porter Street. This side has a utility strip and curb and guttering. Spalling is starting to occur and the sidewalk is 4-foot wide. There are no ADA-compliant curb ramps at the Harrison Avenue intersection.

The right side of the street is 4-foot wide and ranks **Fair**. There are stairs in the sidewalk path at 124 West Main Street. This side has curb and guttering but no utility strip. There is a wall with a handrail at the 188 West Main Street parking lot. The sidewalk ends at 188 West Main Street, at the mid-block crosswalk, which does not have an ADA-compliant curb ramp. There is also no ADA-compliant curb ramp at the West Main Street crossing to the north side of the street.

Recommendations: Upgrade sidewalks to 5-foot standard; install ADA-compliant ramps.

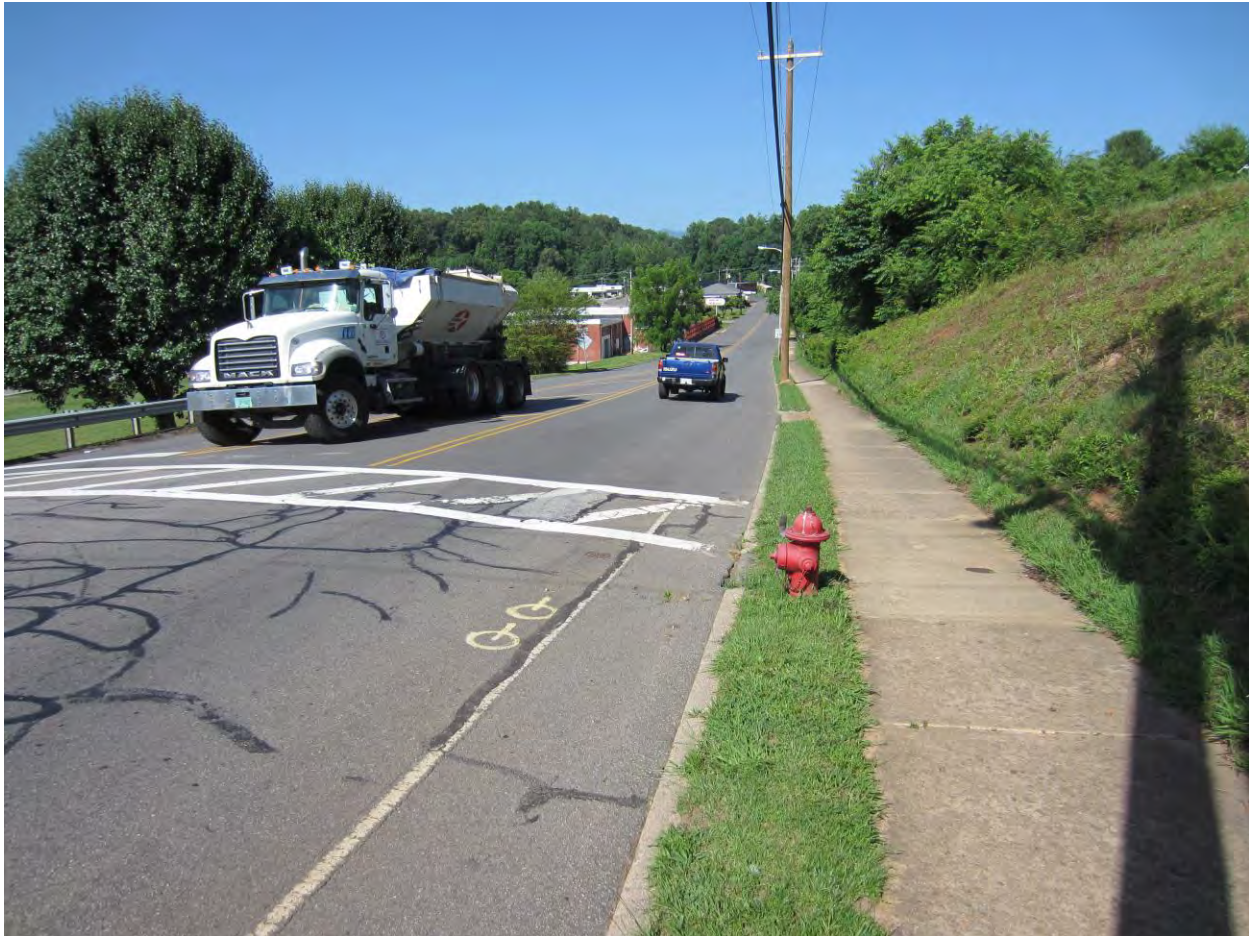
Ranking Fair

The sidewalk on this section of West Main Street ranks **Fair**. It has curb and guttering and a 2-foot utility strip, but is 4-foot wide, with some cracking and spalling. Water running down the sidewalk is an issue about halfway down the hill. A storm-drain outlet from the First United Methodist Church parking lot dumps water onto the sidewalk. No crosswalk or curb ramp is present mid-block, at Maple Street. The sidewalk ends at Bidwell Street with no ADA-compliant curb ramp.

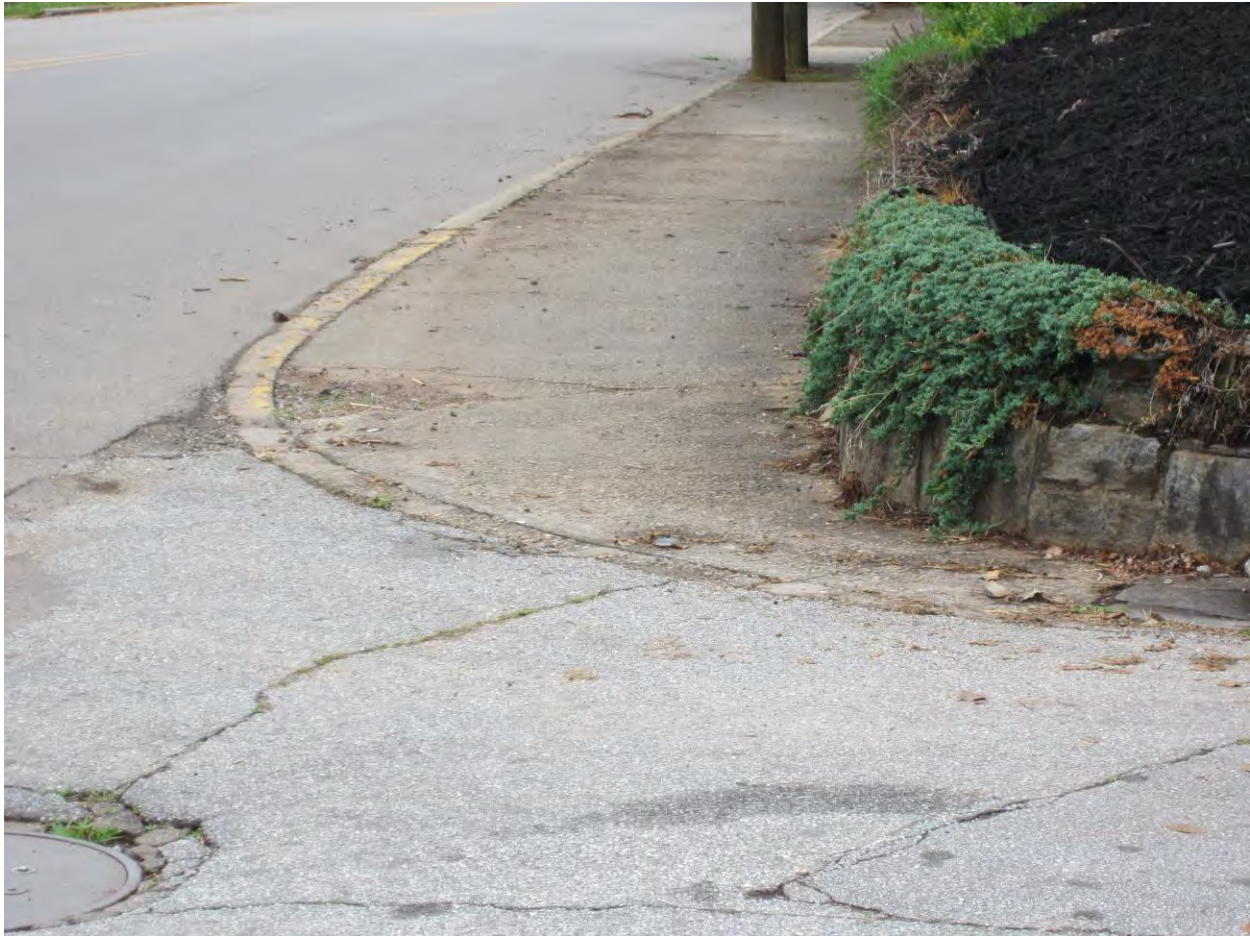
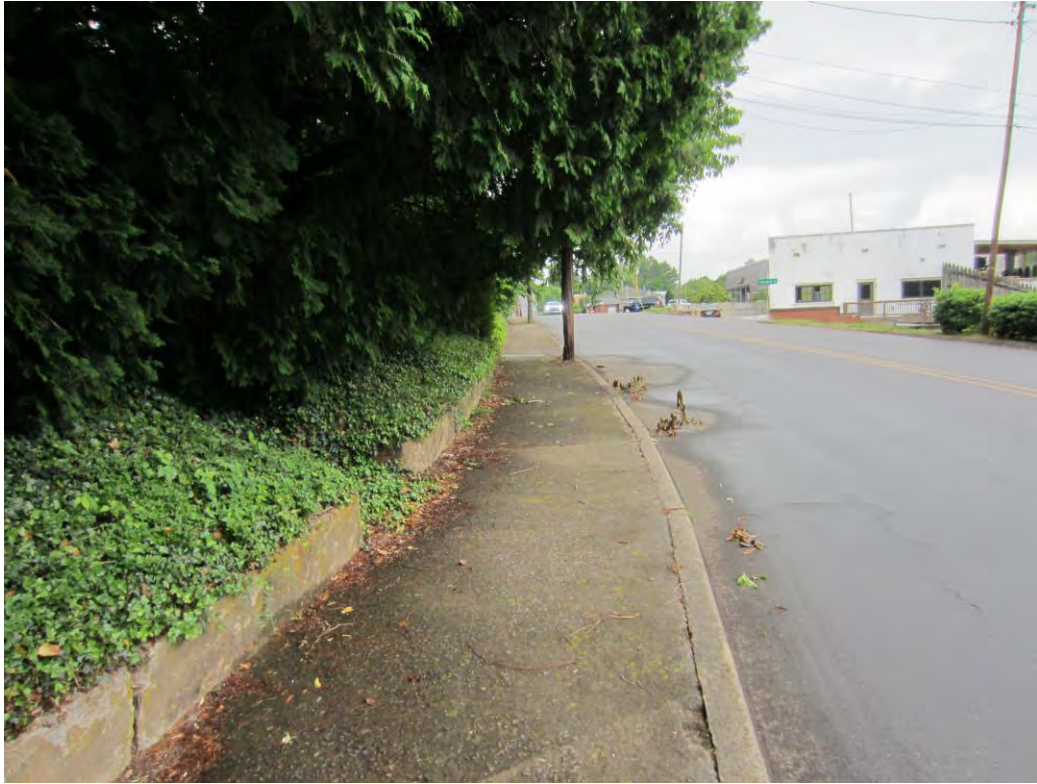
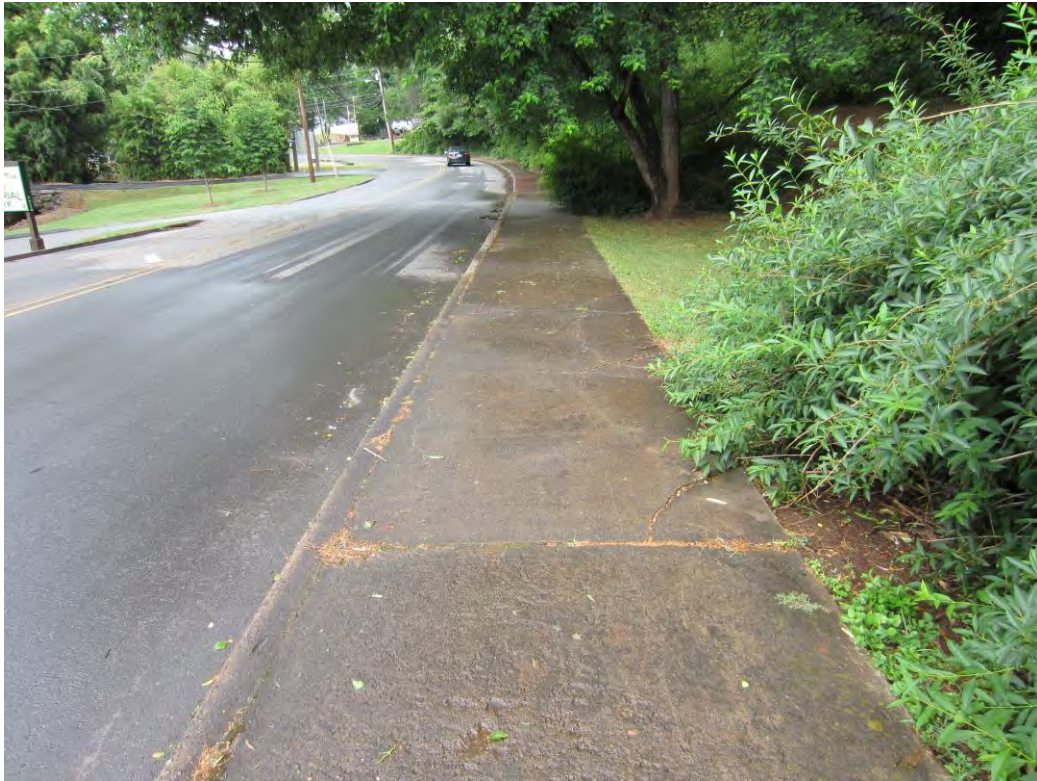
Ranking Fair

The West Main Street sidewalk in this section ranks **Fair**. The sidewalk continues along the right side of the street after Bidwell Street, starting with no ADA-compliant curb ramp, as shown. The sidewalk is 6-foot wide with some utility pole obstructions along the way. It has curb and guttering but no utility strips. Some tree-limb obstructions hang below 6 feet in height. The sidewalk is covered with plant debris, restricting width to an effective 4 feet in places. The sidewalk crosses West Boulevard and Green Street with no ADA-compliant curb ramps or marked crosswalks. (More photos on next pages)

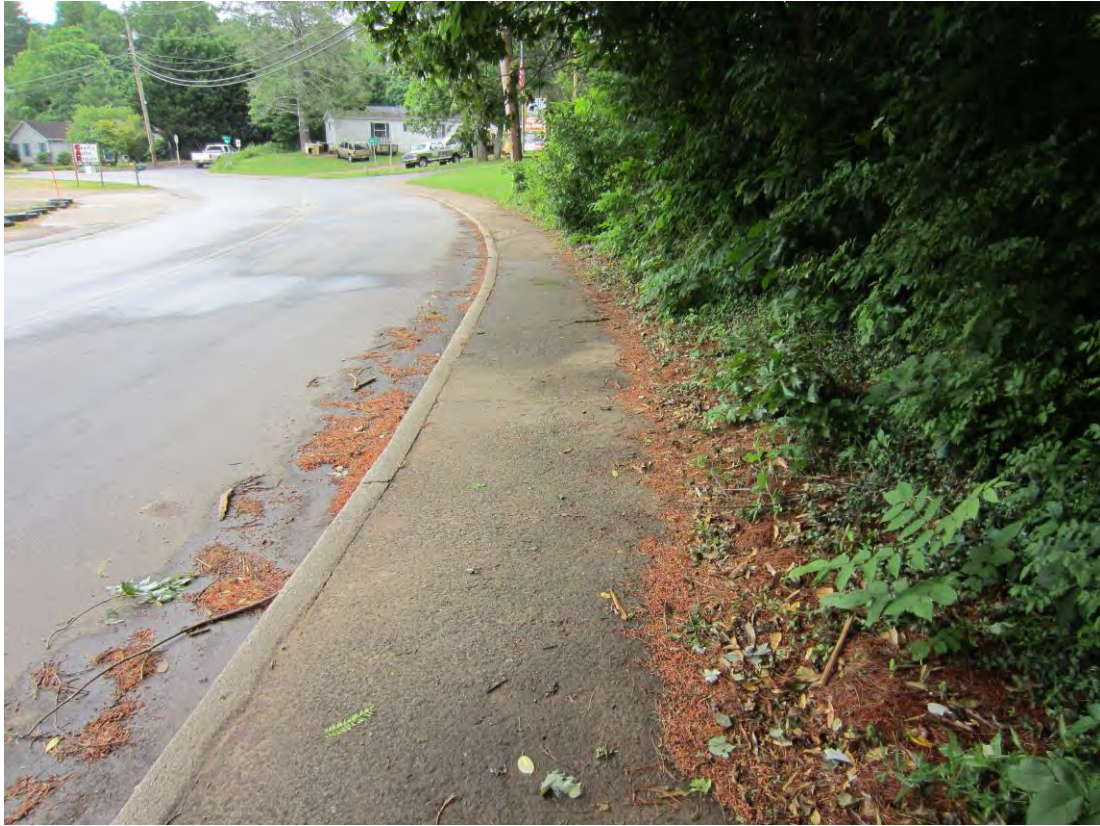
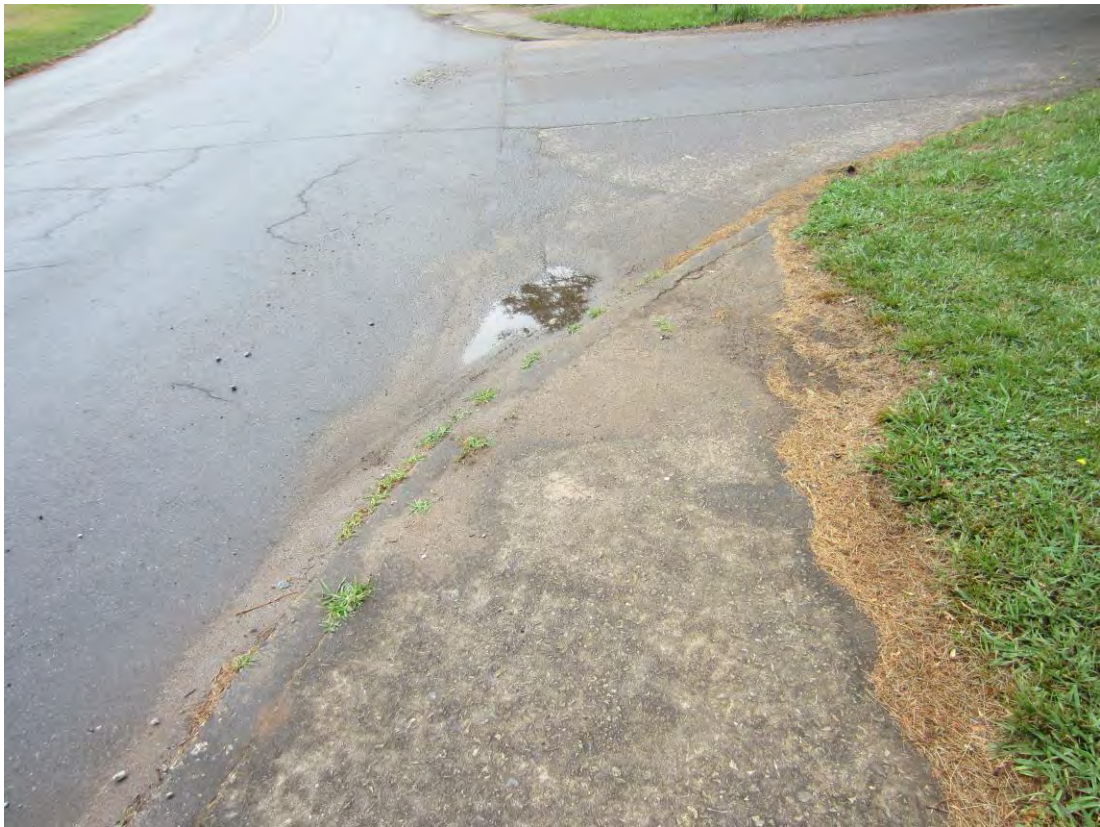
4.51 West Main Street (Green St. to West Palmer St.)

This last section of West Main Street sidewalk ranks **Fair**. It starts at Green Street with no ADA-compliant curb ramp. It is 5-foot wide with curb and guttering but no utility strip. The sidewalk has cracks where patching has been performed. A utility pole obstruction at 587 West Main Street (shown) restricts the sidewalk to 2'6"-wide. There are no ADA-compliant curb ramps at any of the street intersections on this section. The sidewalk continues onto West Palmer Street after West Main Street comes to an end. (More photos on next pages)

Recommendations: Upgrade sidewalk to 5-foot standard; install ADA curb ramps.

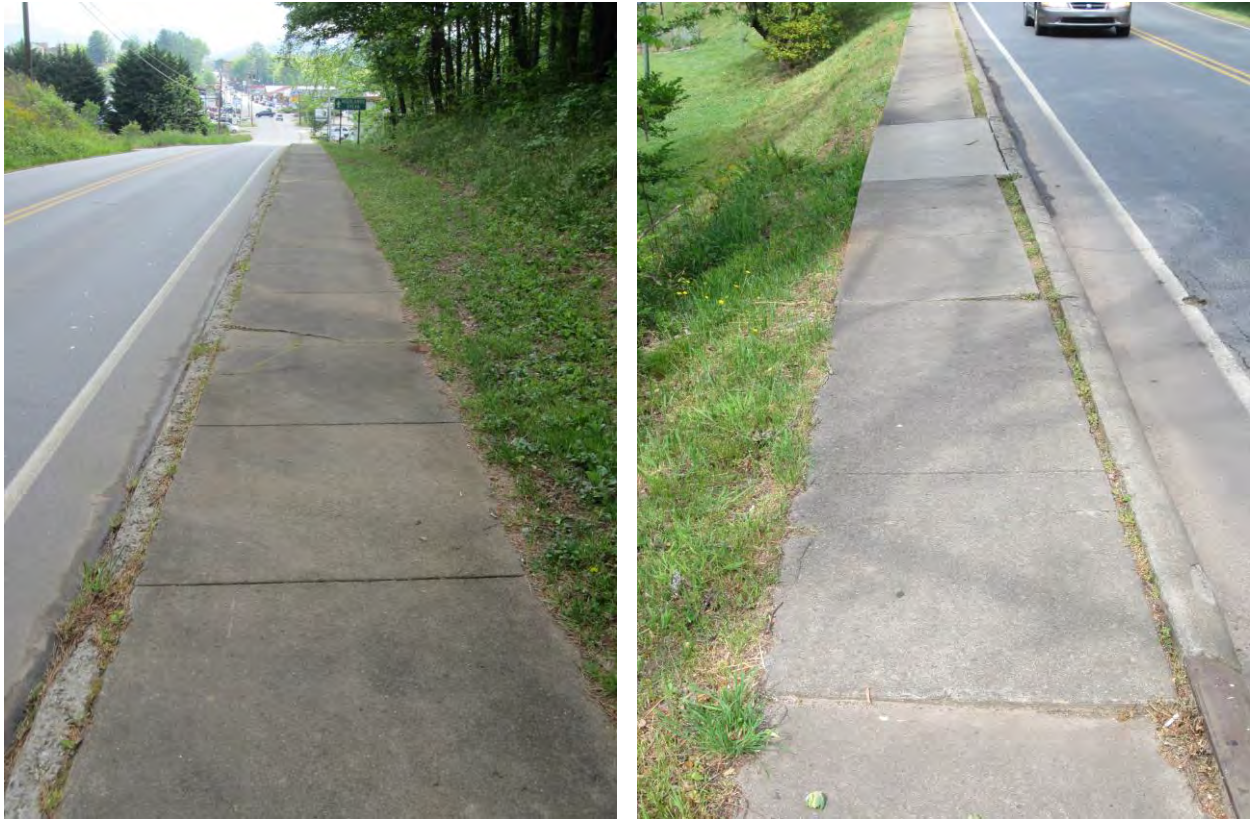
This section of West Palmer Street sidewalk ranks **Poor**. It is 5-foot wide at the beginning, at the Franklin Police Department, with curb and guttering but no utility strip. The curb and guttering is much deteriorated and almost non-existent. In the 5-foot section, the sidewalk itself has some cracks. After the driveway for 368 West Palmer Street, the sidewalk becomes 4-foot wide and ranks **Poor** condition. This section runs over an embankment that is starting fall off the bank. Horizontal gaps are forming where it is separating from the curb, as shown. For this section to be widened to 5-foot, a wall would have to be engineered and constructed. This section of sidewalk crosses over Crawford Branch. There are three ADA-compliant curb ramps on this section of sidewalk.

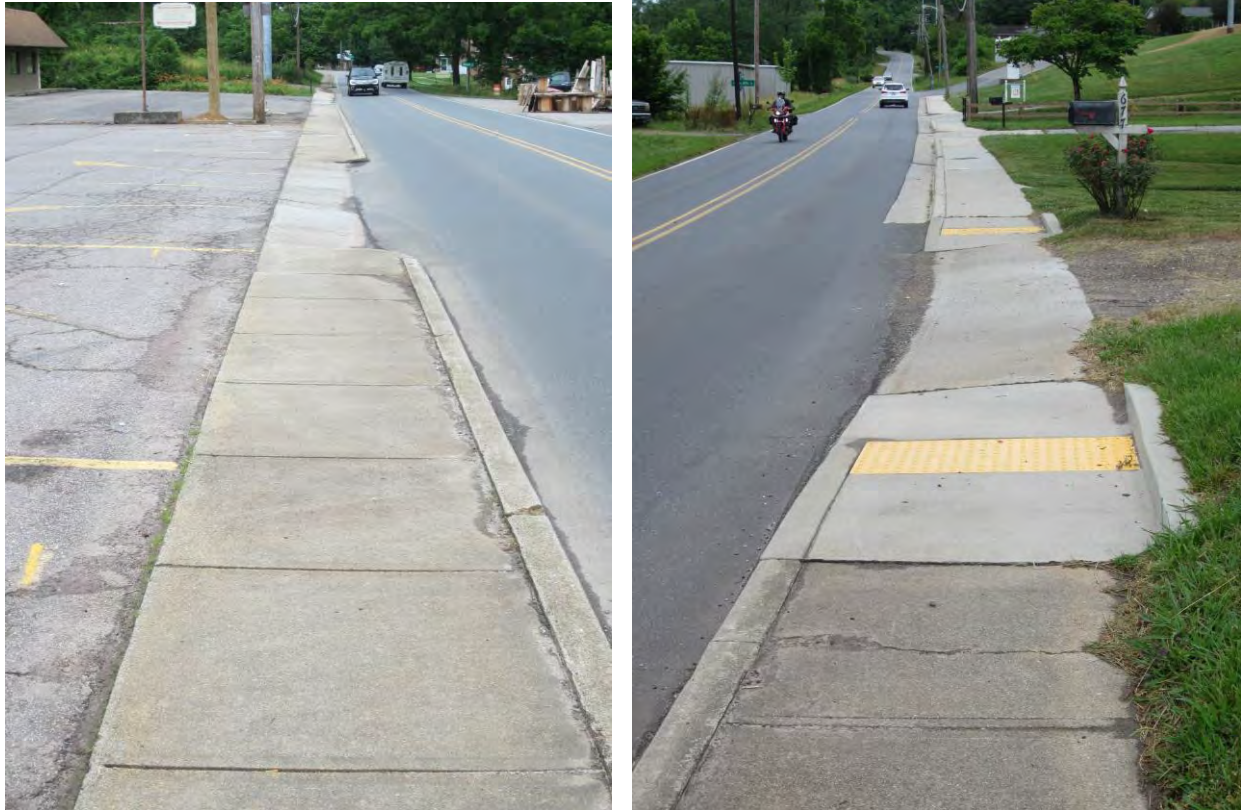
West Palmer Street sidewalk in this section ranks **Fair**. The sidewalk is 4-foot wide with curb and guttering but no utility strip. In 2017, NCDOT updated multiple intersections and driveway entrances with ADA-compliant curb ramps as shown. The sidewalk has debris on it in various places and needs edging in places. The concrete has some cracks throughout. The driveway to the Duke Power transmission lines is broken and needs replacement. There is a utility pole obstruction the intersection of West Main Street and West Palmer Street. No crosswalk is marked at the intersection with Wilkie Street.

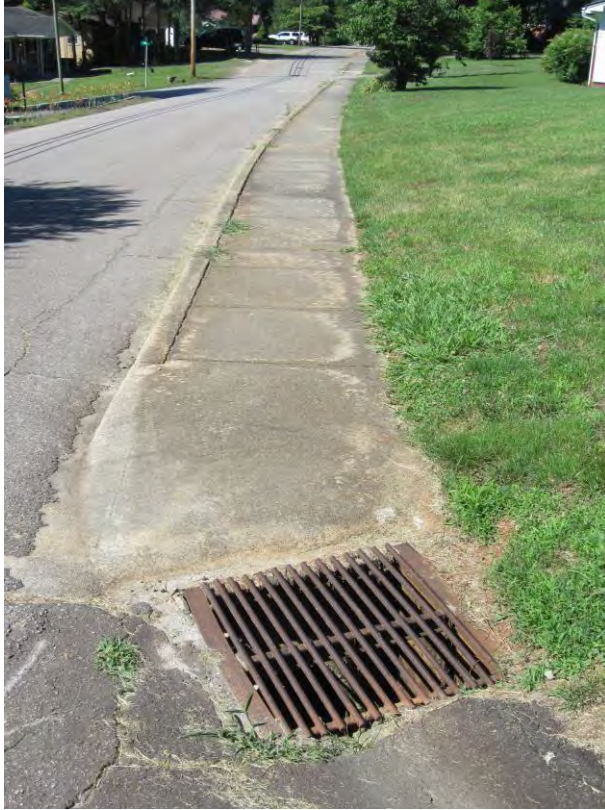
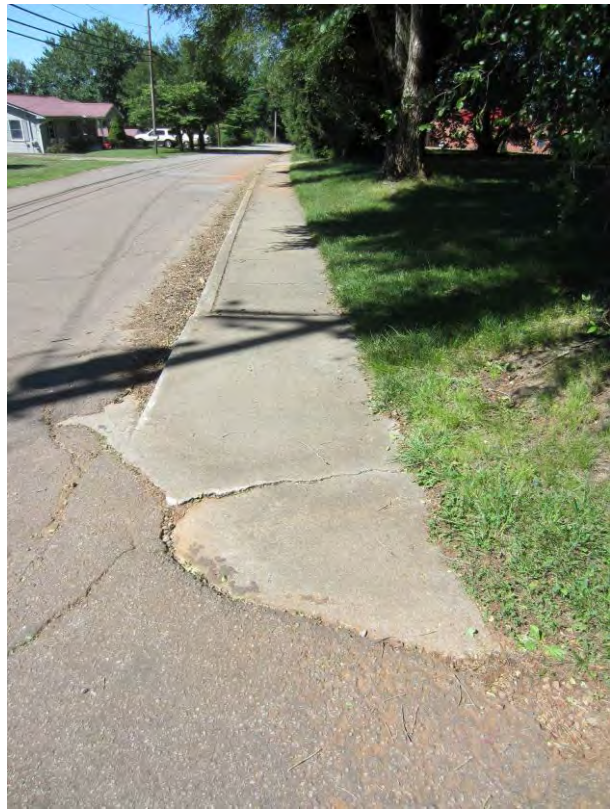
Watauga Street sidewalk from Clyde Street to Randolph Street ranks **Fair**. It is 4-foot wide, with curb and guttering but no utility strip. The sidewalk starts at Clyde Street with a curb ramp, but it doesn't have detectable domes. There is a storm drain at the entrance of to the ramp, as shown. The concrete has very few defects or cracks in this section. There is no ADA-compliant curb ramp at Randolph Street on either side, nor is there a marked crosswalk. After Randolph Street, the sidewalk is still 4-foot wide but becomes poor in condition until it reaches East Franklin Elementary School. A tree obstructs the sidewalk at Randolph Street and concrete is broken in many places. Also, Watauga Street is not designated a school zone.

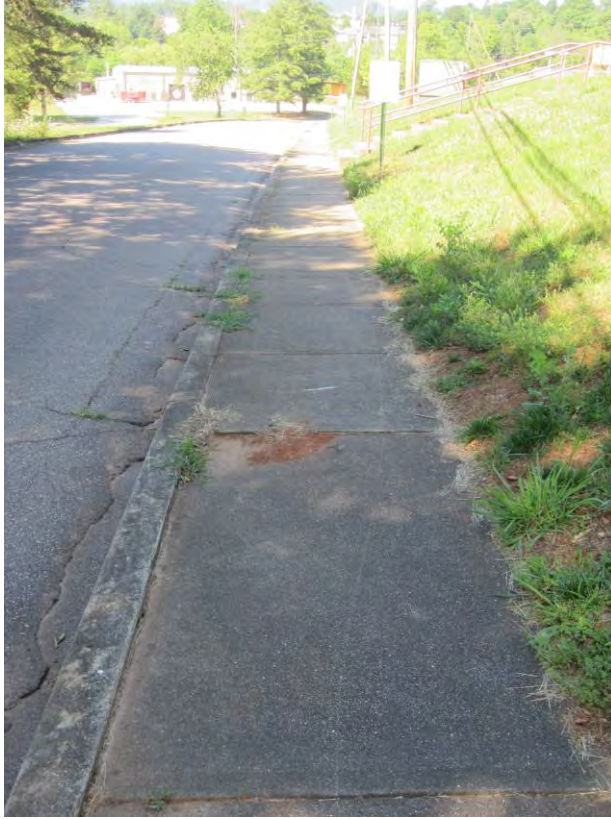
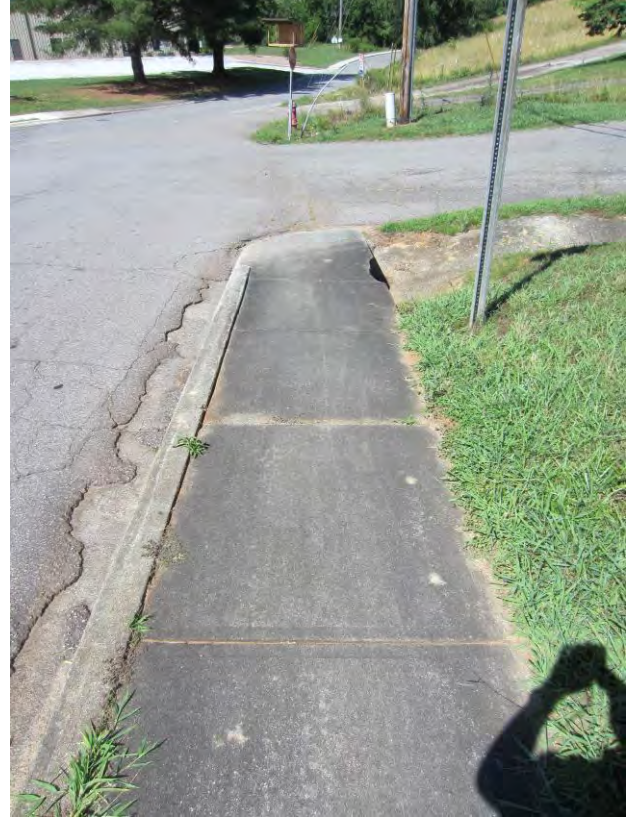
This section of Watauga Street sidewalk ranks **Fair**. It is 4-foot wide with curb and guttering but no utility strip. The sidewalk has multiple toe trips and is sinking below the curb. The sidewalk ends at the stop sign for Watauga Street, with no ADA-compliant curb ramps to cross Watauga Street to the south side, to continue on the sidewalk on Lakeside Drive. A crosswalk is needed at the stop sign for Watauga Street as well. A handrail is also recommended at the stop sign for the sidewalk, as there is a culvert entrance under the road with a 3-foot drop to the culvert. See picture of this issue on the following page.

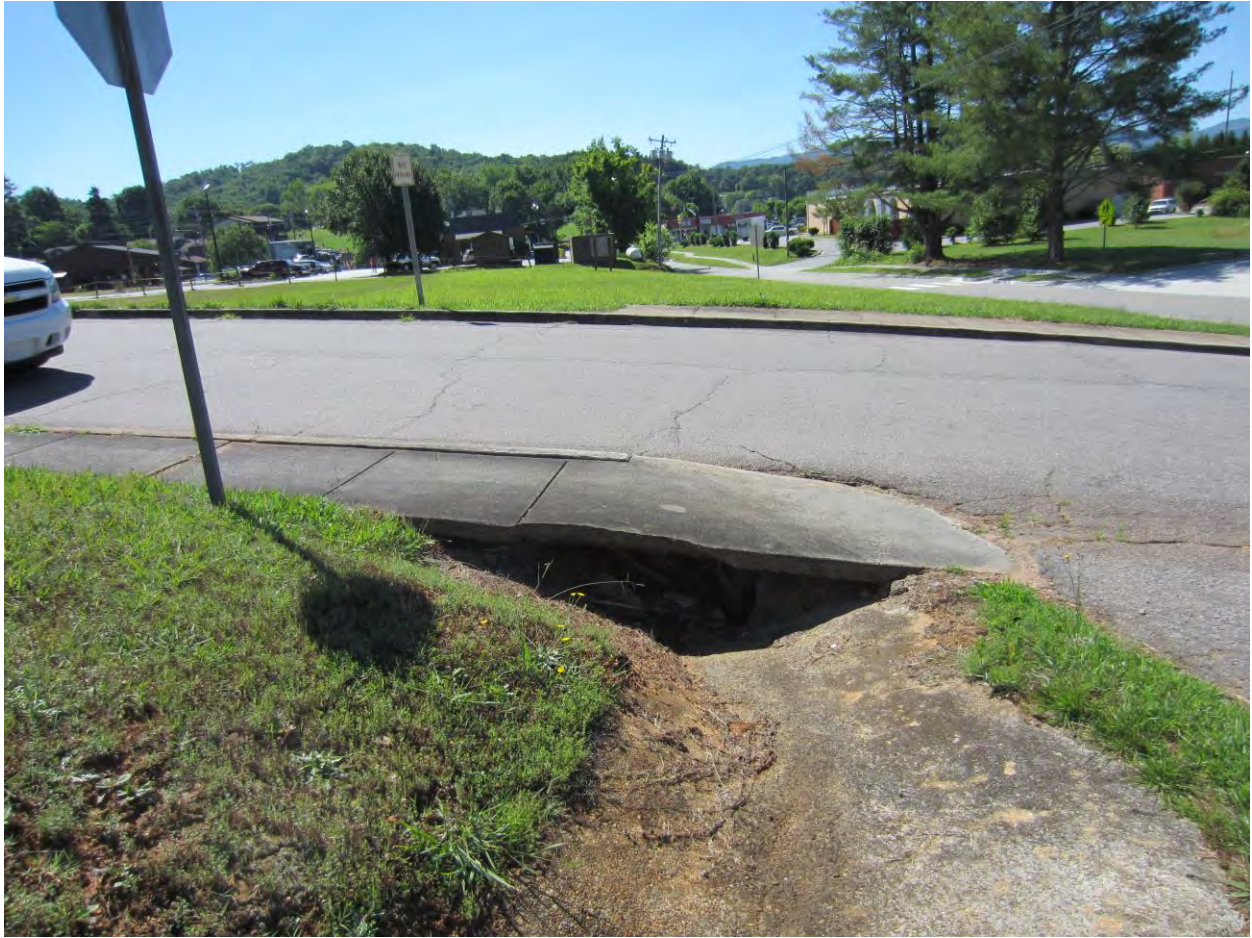
Photo showing the need for ADA-compliant curb ramps, handrail and marked crosswalk in front of stop bar for stop sign on Watauga St.

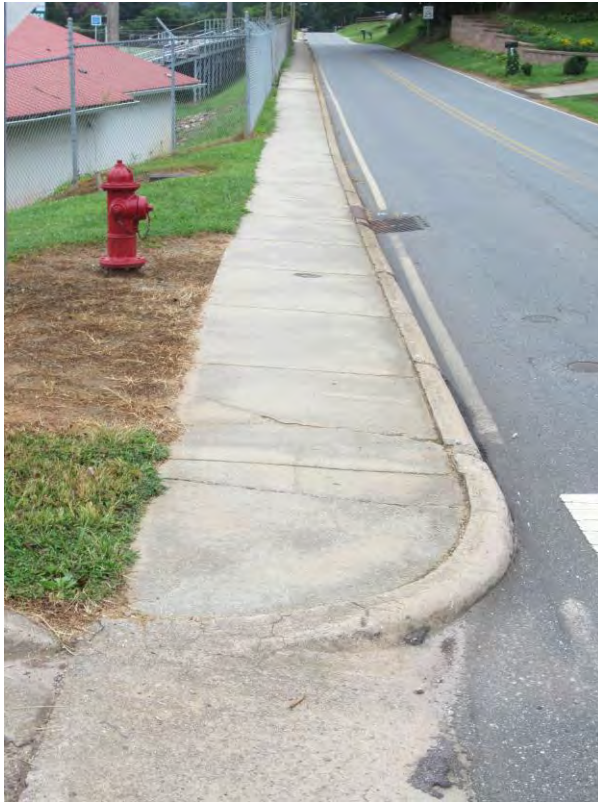
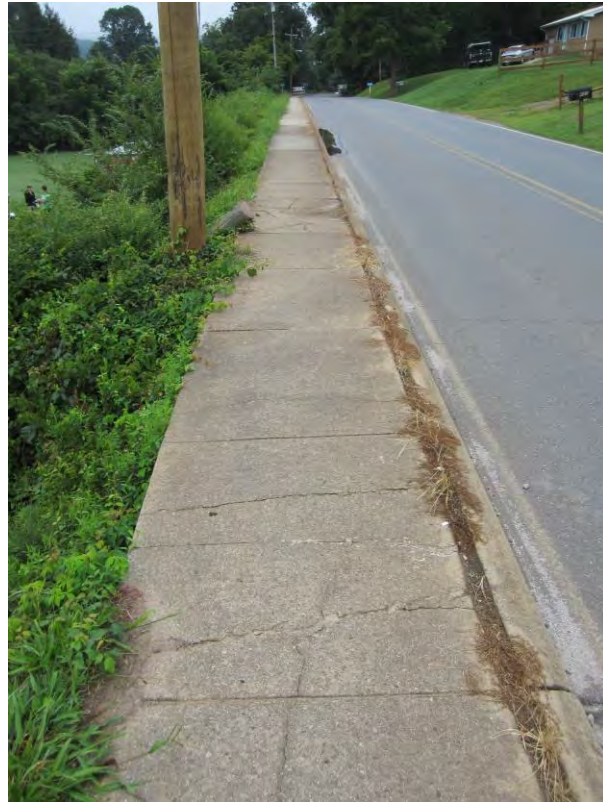
4.56 Wayah Street (244 Wayah St. to Phillips St.)

Wayah Street sidewalk ranks **Fair** where it starts at 244 Wayah Street. The sidewalk is 4-foot wide with curb and guttering but no utility strip. It sits on top of a bank above the student parking lot for Franklin High School. There is no guardrail above the parking lot. A curb ramp at the entrance to the student parking lot does not have detectable domes. A crosswalk to Ulco Drive does not have ADA-compliant curb ramps.

The sidewalk stays in fair condition until it reaches the gated entrance to the football field. After that point the sidewalk ranks **Poor**. Here, the sidewalk is above the bank for the band practice field and is very broken and cracked. At the location of the utility pole shown above, the ground is eroding away from under the sidewalk. Horizontal gaps are starting to show in the section as well. Wayah Street is a designated school zone.

Recommendations: Upgrade sidewalk to 5-foot standard; install ADA curb ramps.

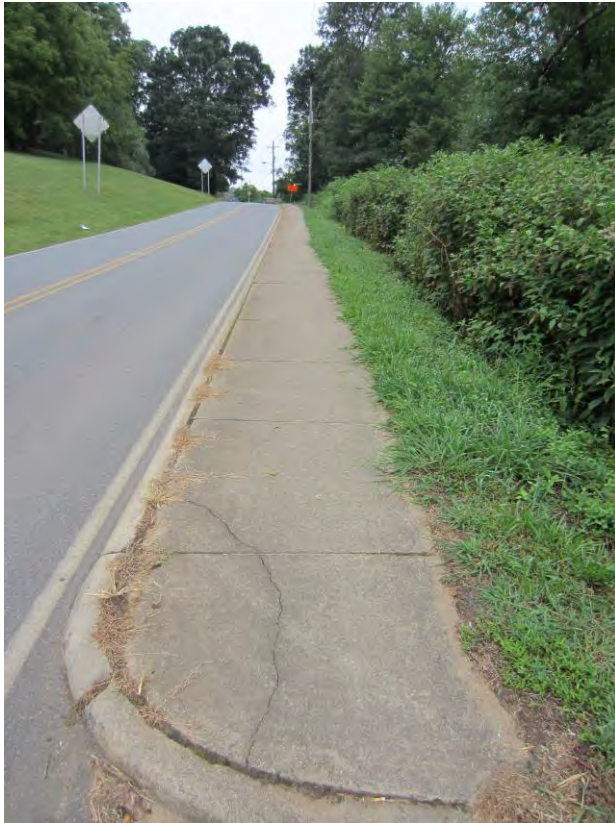
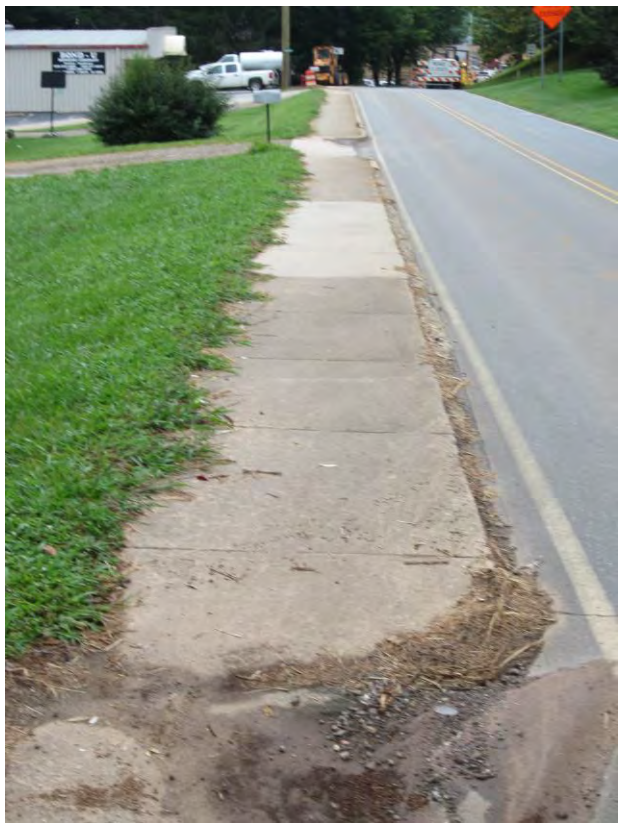
This section of Wayah Street sidewalk ranks **Poor**. It is 5-foot wide with curb and guttering but no utility strip. The sidewalk has many broken and sunken sections and the curb is starting to deteriorate in this section. Edging needs to be done on this section and debris should be cleaned from the sidewalk. There are no ADA-compliant curb ramps at Phillips Street or Winston Avenue. The sidewalk ends where it currently connects to Depot Street at the new roundabout, where new sidewalk facilities have been built by NCDOT.

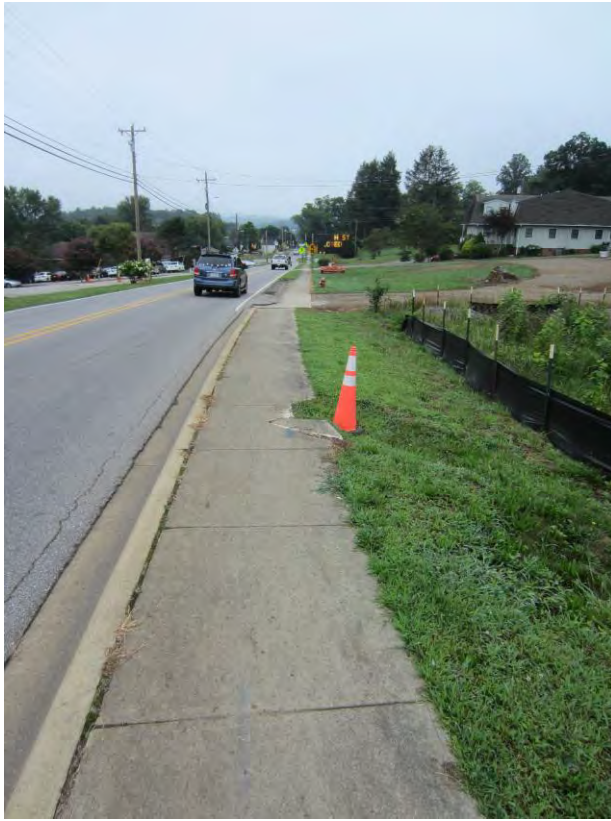
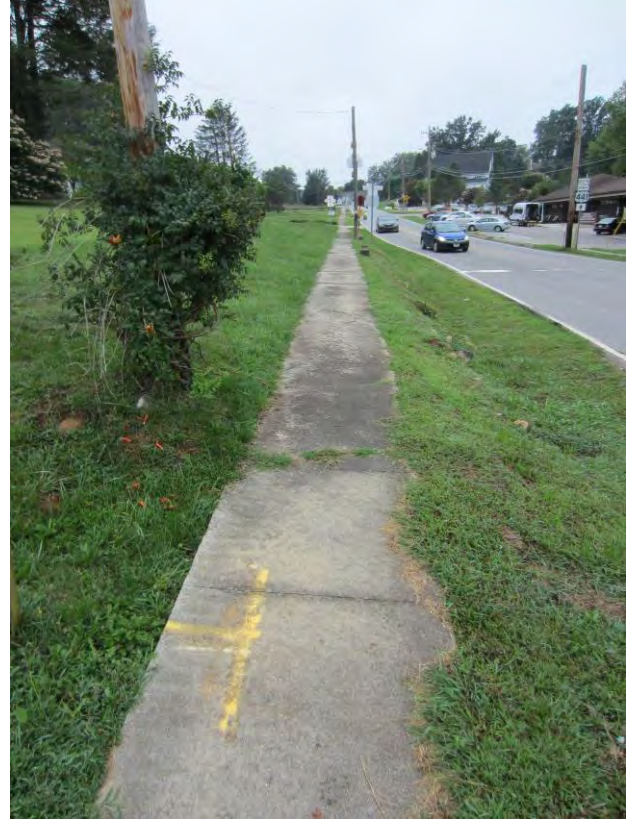
This section of Wayah Street sidewalk ranks **Poor**. It is 3'10"-wide and elevated above the road. It is very broken and has sunken places along the sidewalk. It has curb and guttering on the Maple Street end, but no curb and guttering on the Porter Street end. The entire section is slated to be replaced by NCDOT in 2020 with the construction of two new roundabouts at the intersections of Porter Street and Wayah Street, and Maple Street and Georgia Road. The sidewalk is currently only on the south side of the street but will be on both sides of the street after NCDOT finishes construction on this section of Wayah St.
