Town of Franklin
Sidewalk Capital Improvement Plan
&
Condition Survey

Adopted May 4, 2020

Prepared by the Town of Franklin Planning Department
Town Planner Justin Setser

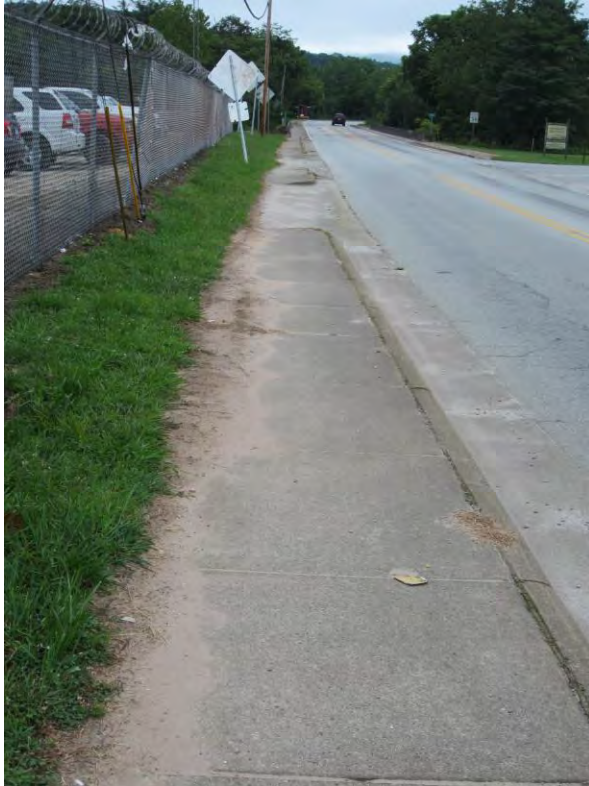
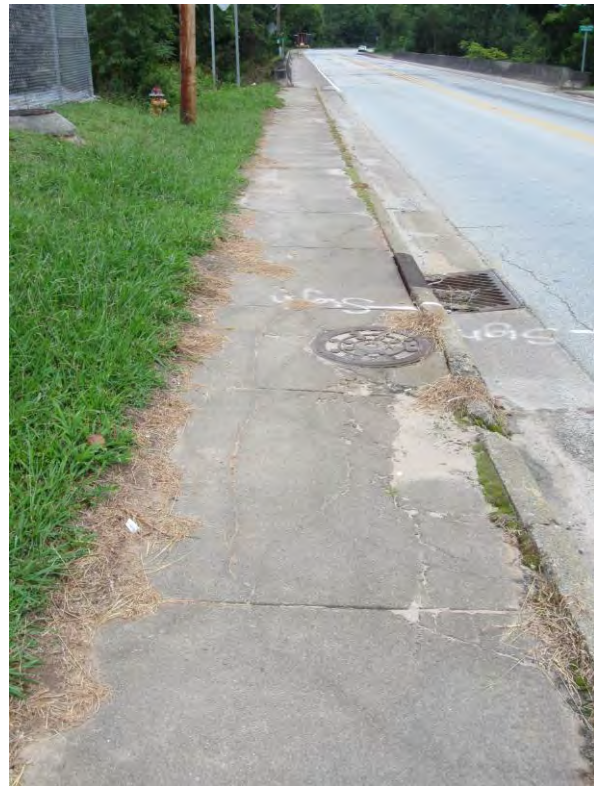
4.59 Wells Grove Road (Depot St. to Phillips Bridge) Ranking Fair & Poor

Some of this sidewalk has been replaced by NCDOT with the construction the new roundabout. The remaining sidewalk ranks **Fair** and **Poor**. It is 5-foot wide with curb and guttering but no utility strip. Multiple driveway entrances are not being used. The sidewalk after the entrance to the flooring plant ranks **Poor**. It is broken and sinking at a storm drain. A large amount of debris and dirt on the sidewalk needs to be cleaned off.

Recommendations: Upgrade sidewalk to 5-foot standard; clean.

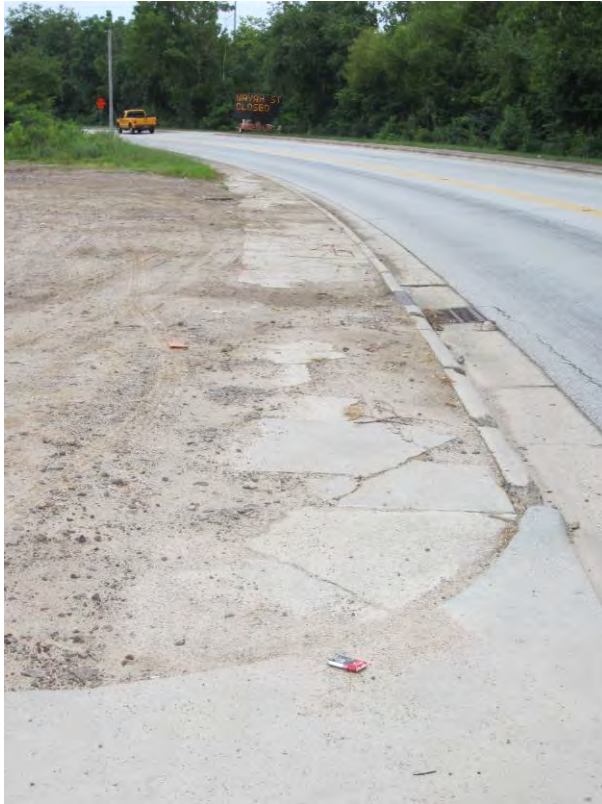
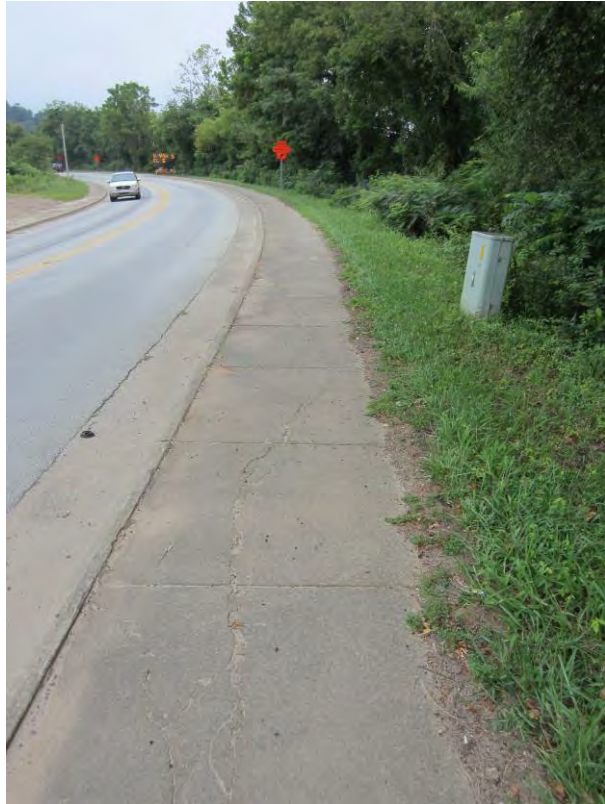
This section of Wells Grove Road sidewalk ranks **Fair** and **Poor**. The sidewalk on the river side of the road ranks **Fair**. Here, it is 5-foot wide with curb and guttering but no utility strip. It has spider cracks throughout. The south-side sidewalk is 5-foot wide and ranks **Fair** also, except for the portion in front of 291 Wells Grove Road, which ranks **Poor**. It is also very dirty here, from large trucks driving over the sidewalk. The sidewalk ends at Old Phillips Bridge Road with a curb ramp without detectable domes.

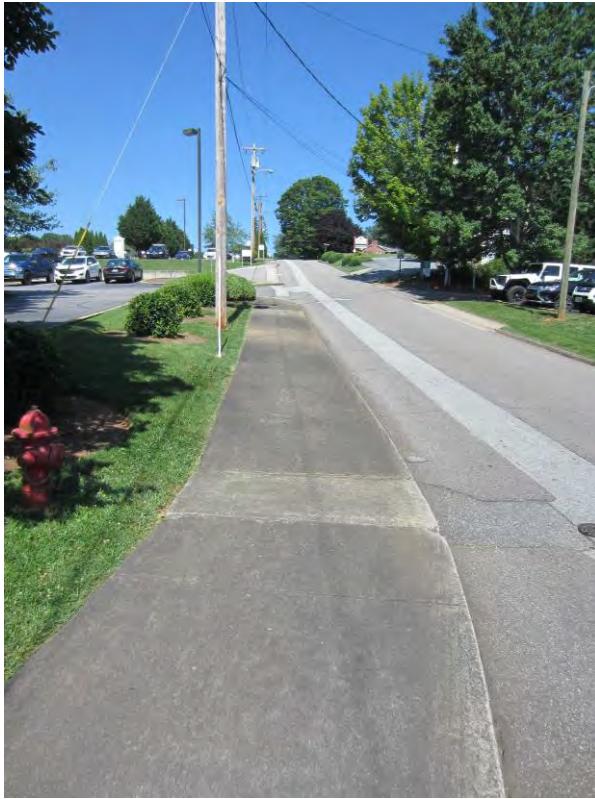
4.61 White Oak Street (Riverview St. to Iotla St.)

White Oak Street sidewalk ranks **Good** for its first 100 feet at Riverview Street. Here, it is 6-foot wide and has guttering, but no curb or utility strip. The sidewalk then become 5-foot wide for another 175 feet, and ranks **Fair**. This section has curb and guttering but still no utility strip. It has some cracks in the concrete. The remainder of the sidewalk is 4-foot wide with a 2.5-foot utility strip and curb and guttering. This last section ranks **Fair**, as it has multiple cracks and sunken places with toe trips. There is a tree obstruction by the physician parking lot. Multiple curb cuts lack ADA-compliant curb ramps at the entrances to parking lots, as on the Riverview Street sidewalk. The sidewalk ends at Iotla Street, almost flush with the road.

Recommendations: Upgrade sidewalk to 5-foot standard; install ADA curb ramps.
